# Examples of pipe failures in Slovak transmission gas pipelines

**Abstract:** The paper deals with some case studies in Slovak high pressure gas pipelines. All cases were caused by an interaction effect of the weld anomalies excessive misalignment, poor workmanship or cold strain hardening, of the metallurgical aspects in pipe production liquid Cu embrittlement, irregular microstructure and by an additional bend loading earthquake, sudden pipe settlement and landslide or site bending.

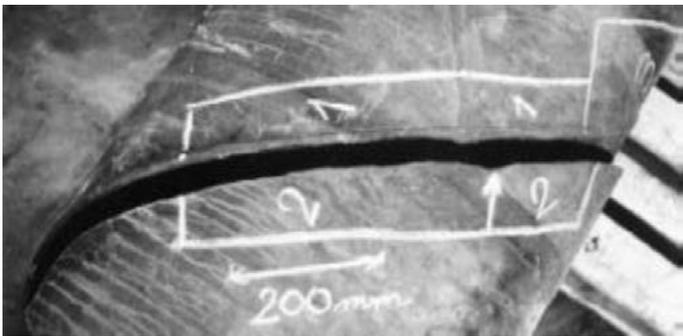
The first case was a 1.8 m long crack running along the spiral weld of spirally welded pipe OD 720 × 8 mm (Fig.1). The initiation point was in the place where the spiral weld meets the tie strip weld. The spiral weld, which exhibits very excessive misalignment of both linear and opposite runs, is shown in Fig.2. The crack was initiated by LME (liquid metal embrittlement) of remelted copper (Fig.3). Copper came from the abrading of copper electric contact plates applied during manufacturing of spiral welds at that time.

Fig. 1. A crack along the spirally weld

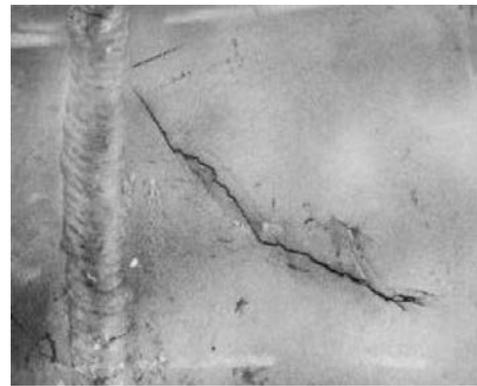
Fig. 4 Crack close to a girth weld

The next case of gas leakage was revealed on the same pipeline after a minor earthquake in East Slovakia. The 180 mm long crack occurred in the parent metal close to the girth weld (Fig.4). The crack was initiated by ssc cracks on the outer pipe surface (Fig.5) where the pipe insulation was damaged. It should be stressed that this section of line is buried in a slightly aggressive soil surrounded by a marsh. The occurrence of ssc was supported by an irregular bainitic – martensitic microstructure of the parent metal at that place (Fig.6). It was found that the appropriate part of the pipe corresponds just to the strip end, which

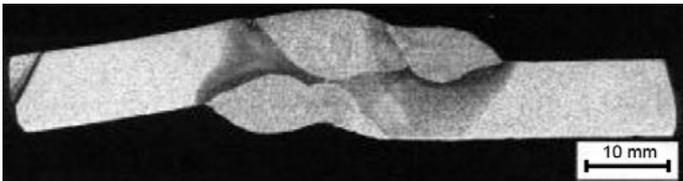
Fig. 2. Linear and opposite runs misalignment – poor workmanship

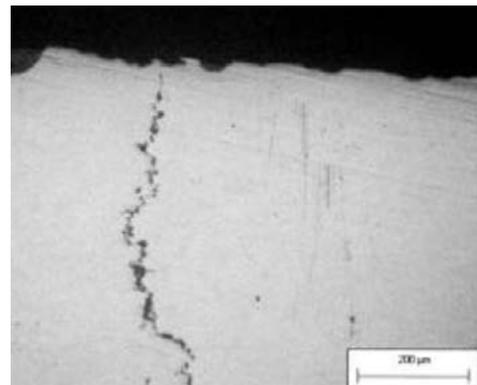
Fig. 5 SCC crack initiated in the outer surface

probably had been exposed to higher cooling rate after winding of the coil. The rest of the pipe had a regular polygonal ferritic – pearlitic microstructure. The fine fissures of ssc on the pipe surface are hardly detectable by pigging. The 15G2S steel also failed at the HIC test according to NACE TM 0284-2003, what means it is not suitable for transport of sour gas.

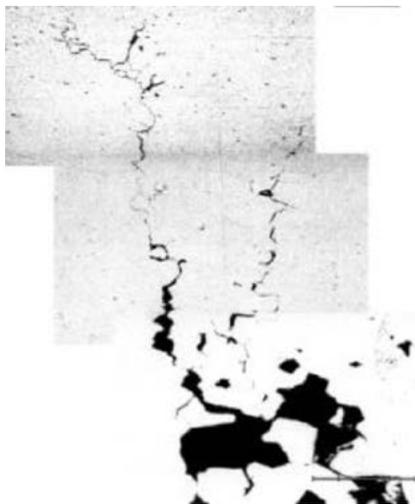
Fig. 3 Liquid metal embrittlement – Cu in the HAZ of repair weld

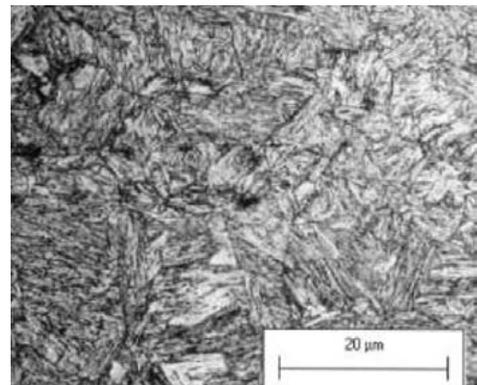
Fig. 6 Irregular microstructure at the end of a strip

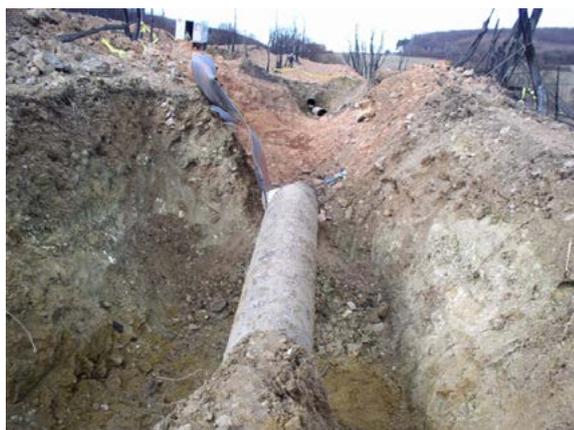
A cause of the excessive explosion (32 m of pipeline were torn out) was an additional bend load due to sudden landslide (Fig. 7). The crack initiated in a poor girth weld between

Fig. 7 Breakdown of the 1<sup>st</sup> international gas pipeline (OD 720 mm)

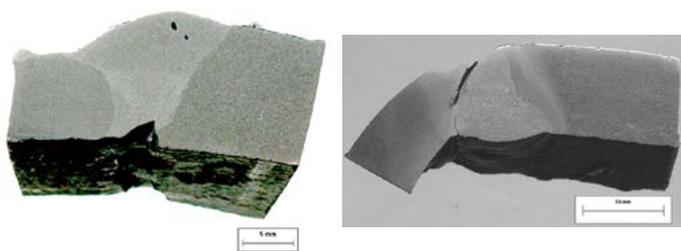
a thicker seamless pipe (L 245 NB,  $t = 12$  mm) and a thinner ( $t = 8$  mm) 15G2S spirally welded pipe (Fig. 8).

Fig. 8 Defective girth weld between seamless pipe ( $t=12$  mm) and spirally welded pipe ( $t=8$  mm)  
a - lack of fusion, b - cold lap

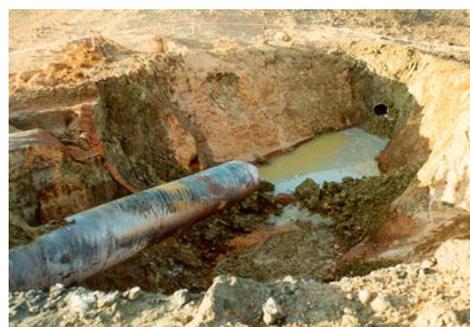
Fig. 9 Situation after explosion

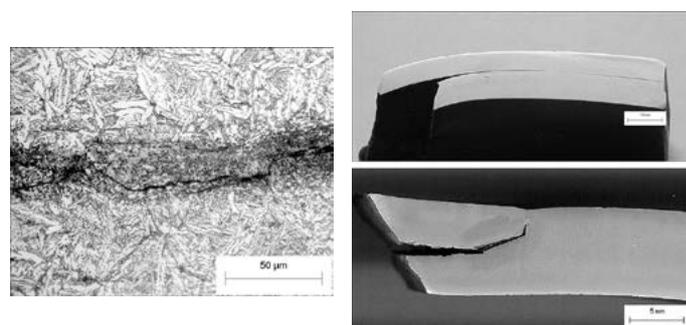
Fig. 10. a: Delamination of pipe wall in the HAZ;  
b: Delamination of the BM

This case deals with a very serious breakdown which happened on the third transmission gas pipeline. The OD  $1220 \times 13.5$  mm spirally welded gas pipeline made of X-70 grades are concerned. At the explosion, an approximately 22 m long section was torn to pieces and an extensive fire was quenched after 12 hours (Fig. 9). The concerned section of pipeline was subjected to insulation repair twice in the past. Thus, it can be supposed that bend loading was brought to the pipeline due to change in setting after burring. The crack initiated in a place where the girth weld meets the spiral weld. The metallurgical cause of cracking were expressive delaminating (partings) of the steel with typical central segregation bands (Fig.10 a and b). The

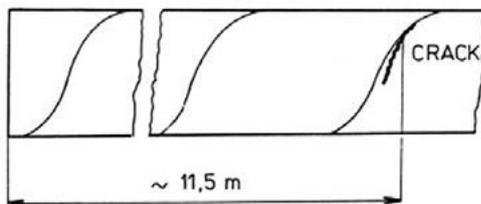
During bending of pipes on site, a few pipes cracked along the spiral welds. The cracks of a length of up to 1 m always appeared in the same distance ( $\sim 11.5$  m) from the pipe end (Fig.11). The crack occurrence corresponded to

Fig. 11 Sketch of the fractured pipe

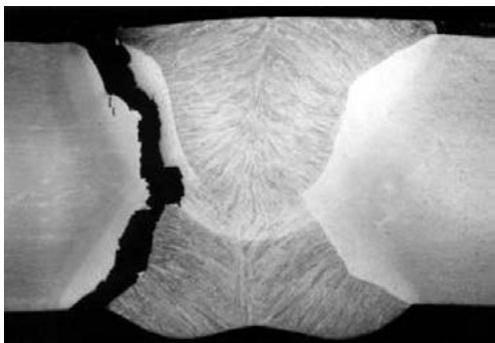
an appearance of a cold impression on the outer spiral weld reinforcement (Fig.12 and 13). It was found that such an impression was formed due to incorrectly installed supporting steel rollers in the furnace used during pipe insulation. In this furnace, the pipes are flame heated up to 300°C prior to PE insulation, where they rotate (about 70 revolutions) on the rollers. In certain periods of manufacture, some pairs of rollers were taken out for repair, and therefore the pipe weight (about 12 tons) was only supported by the remaining pair (in 11.5 m distance). Since all pipe inspection is performed prior to pipe insulation, the impression could not be detected.

Fig. 12 Fracture of the spiral weld

If such cold strain hardening of the weld reinforcement was located on the drawn side of the bend, the pipe cracked. This finding resulted in repeated ultrasonic inspection of all bent pipes manufactured in that period. The problem was, that the concerned pipes were already distributed in a section of about 150 km long, which were already buried under the soil. The 24 defective pipes were detected by UT, and of them, half were repairable and a half had to be replaced.

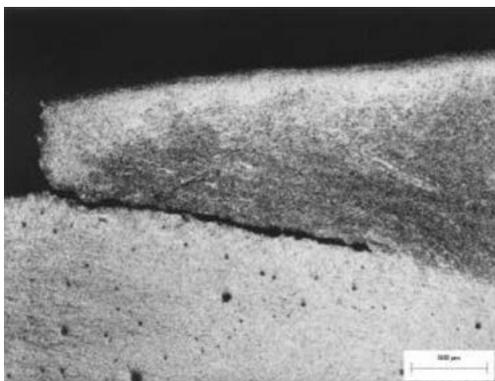
Fig. 13 Overlapping due to an impression
