Repair welding of elements of the sign **ARBEIT MACHT FREI** of the main gate to the former German Nazi concentration and extermination camp Auschwitz I

Editor's note

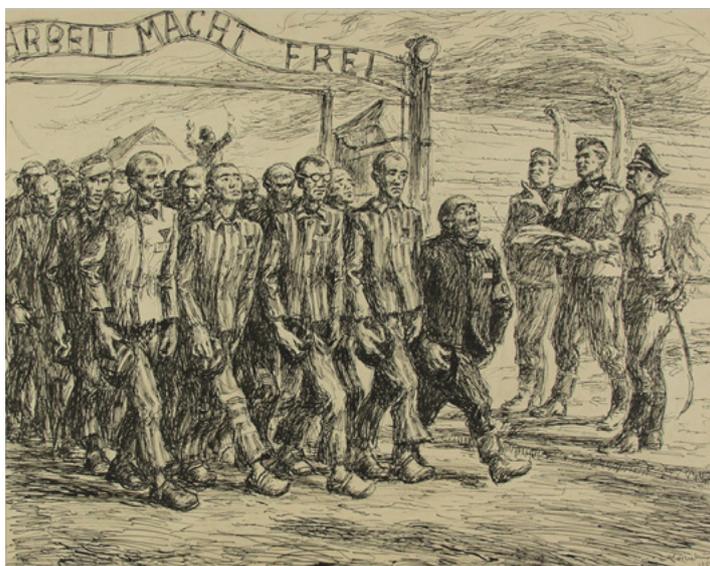
Mieczysław Kościelniak (camp serial number 15261) “Work squads marching out to work”, Poland, 1950, from the collection of the Auschwitz-Birkenau State Museum

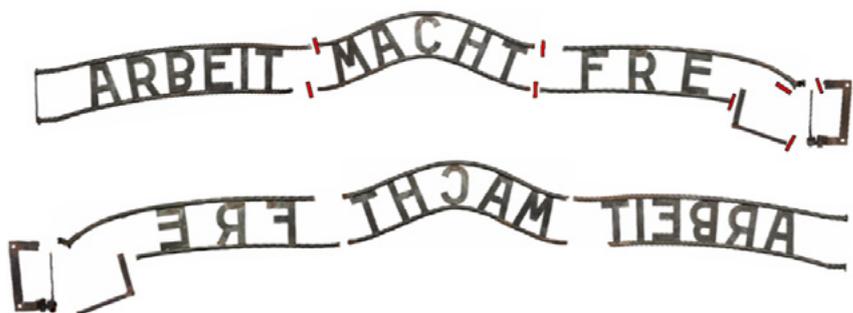
Fig. 1. Front and back of the sign damaged during the theft. Red colour marks spots where the sign was cut or where its elements were torn off [1]

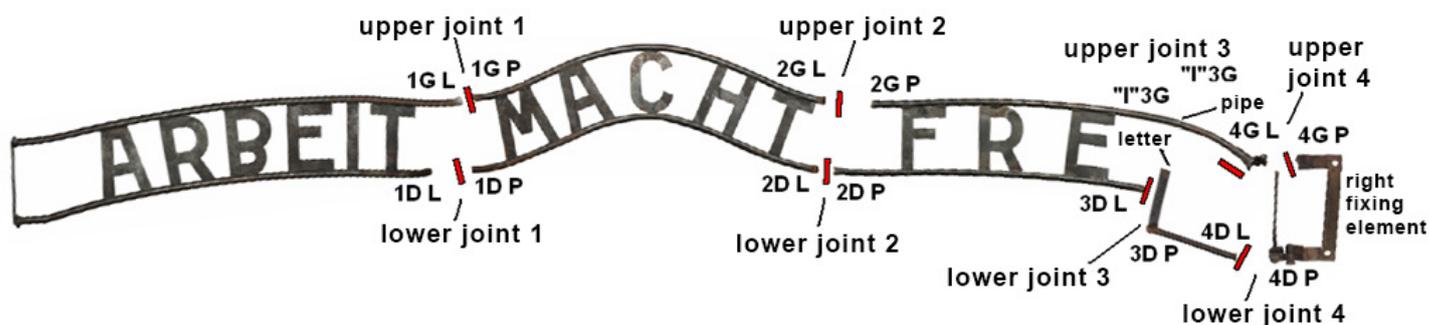
Fig. 2. Fragment of sign with designation of repair welded joints

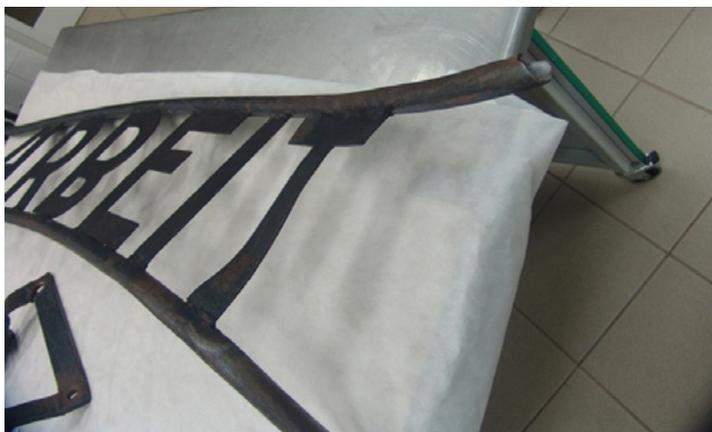
Fig. 3. End of upper part (1GL acc. to 2) after word ARBEIT

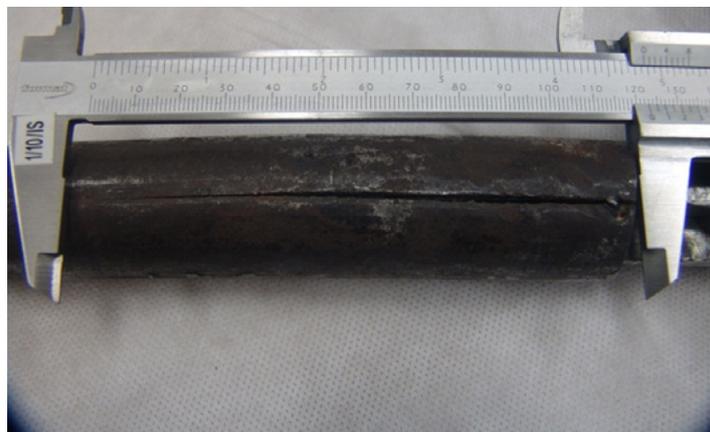
Fig. 7. 120 mm-long crack of lower pipe on section 1DL acc. to Fig. 2

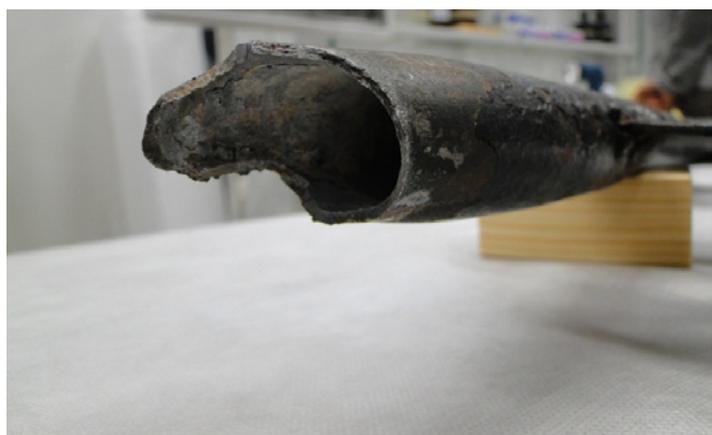
Fig. 4. Broken end of upper pipe (1GP acc. to Fig. 2) before word MACHT

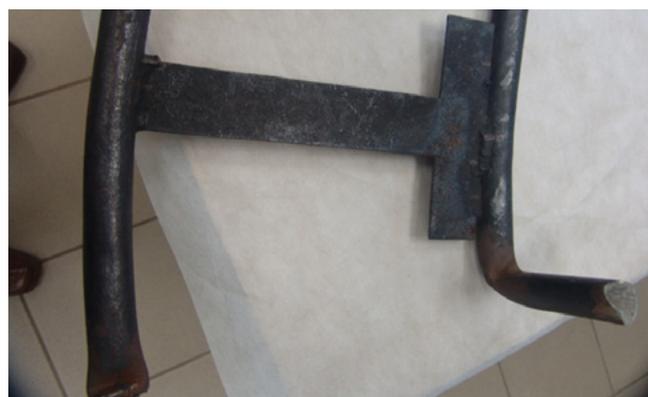
Fig. 8. Ends of upper and lower pipes (2GL and 2DL acc. to Fig. 2) after word MACHT. Visible bending of upper pipe at angle of approx. 90°

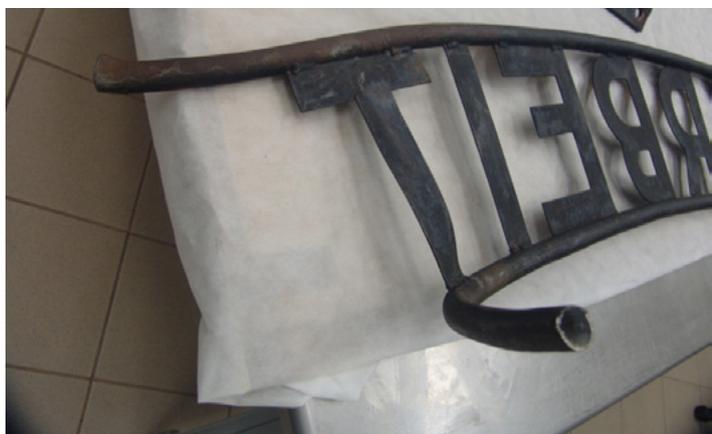
Fig. 5. Bent end of broken lower pipe (1DL acc. to Fig. 2) after word ARBEIT. Visible deformation of letter "T"

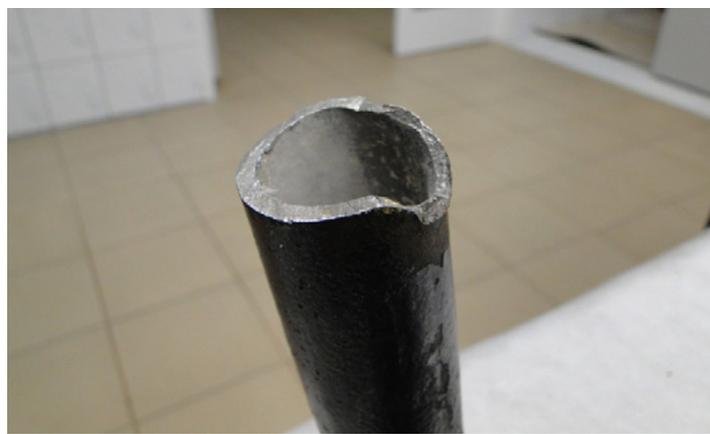
Fig. 9. End of partly cut and broken upper pipe (2GL acc. to Fig. 2) after words MACHT

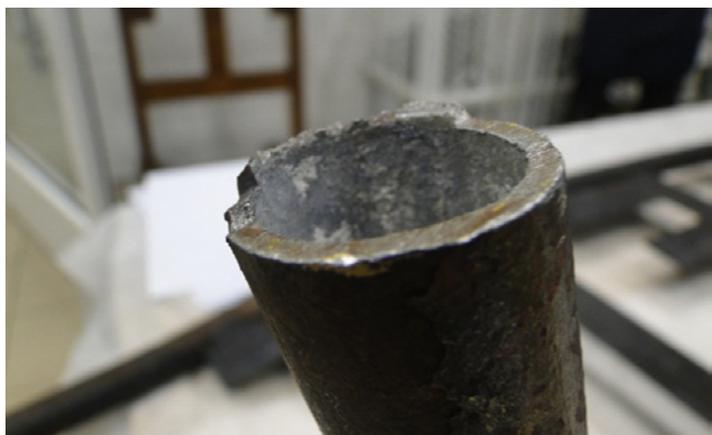
Fig. 6. End of the lower pipe (1DL acc. to Fig. 2) partially cut on along its circumference and then broken

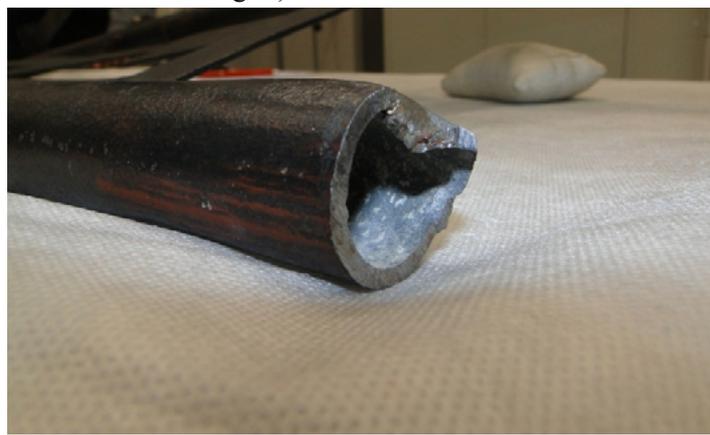
Fig. 10. End of partly cut and broken upper pipe (2GP acc. to Fig. 2) before word FREI

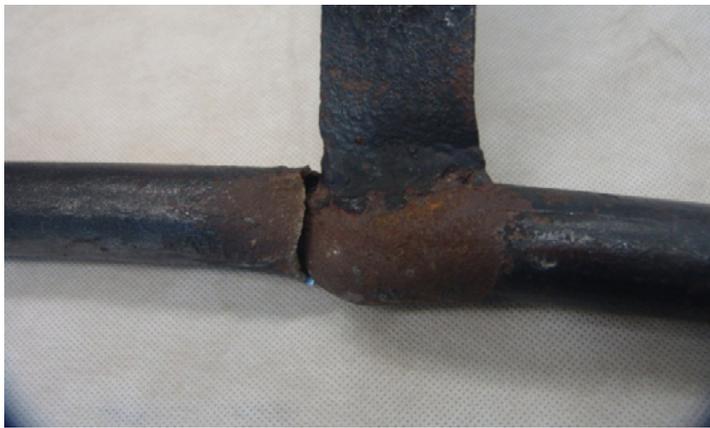
Fig. 11. Broken and deformed lower pipe at weld joining pipe with letter "I" in word FREI

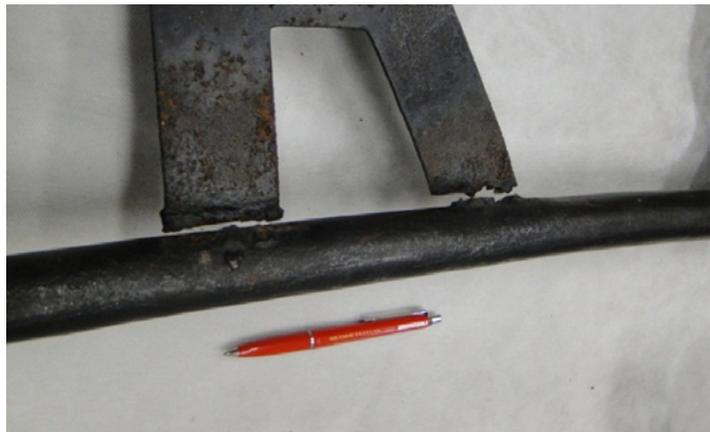
Fig. 12. Torn off welds joining letter "R" with lower pipe in word FREI

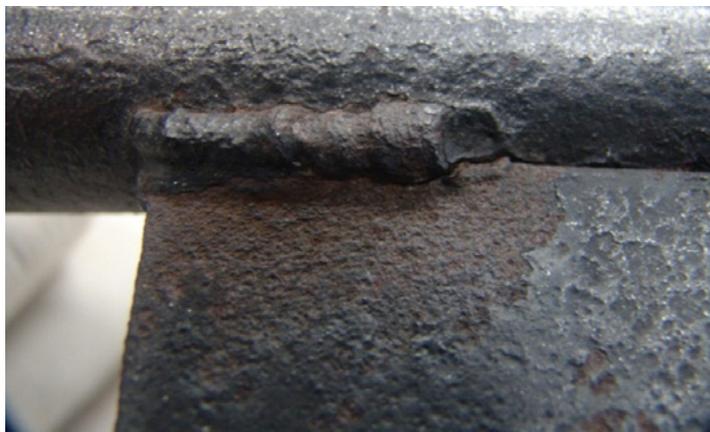
Fig. 13. Crack (partly torn weld) on the length of 15 mm in weld on upper left side of letter "E" in word FREI

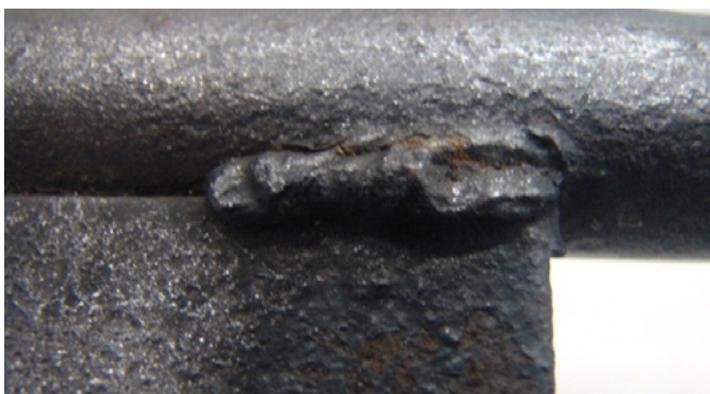
Fig. 14. Weld torn off, located on the upper right side of the letter "E" in word FREI (weld torn of on the length of 37.5 mm)

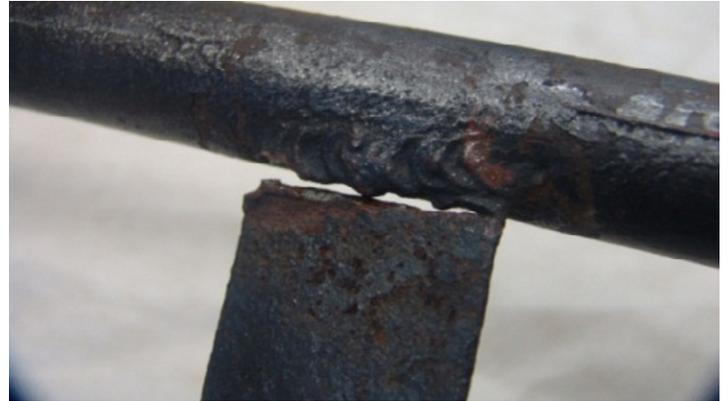
Fig. 15. Weld joining the letter "I" with upper pipe in word FREI – letter broken off on the whole length of welded joint (part of weld remained on pipe)

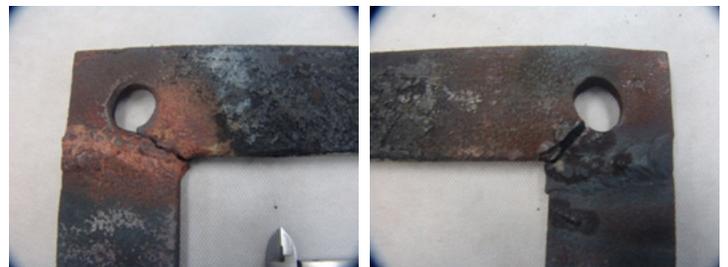
Fig. 16. Cracks in corners of right element fastening sign to pole – view from sign side

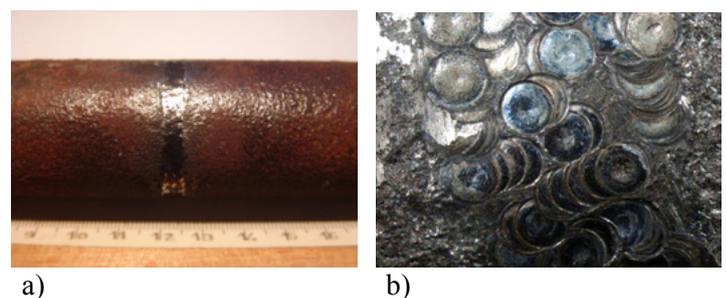
Fig. 17. Joint of pipes (a) and laser-made decorative spots on the face of weld (b)

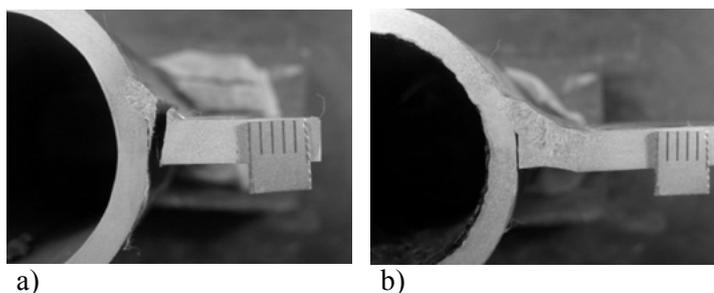
Fig. 18. Cut in fillet weld, modelling crack along the contact line between letter and pipe (a) and macrostructure of plasma-welded cut (b)

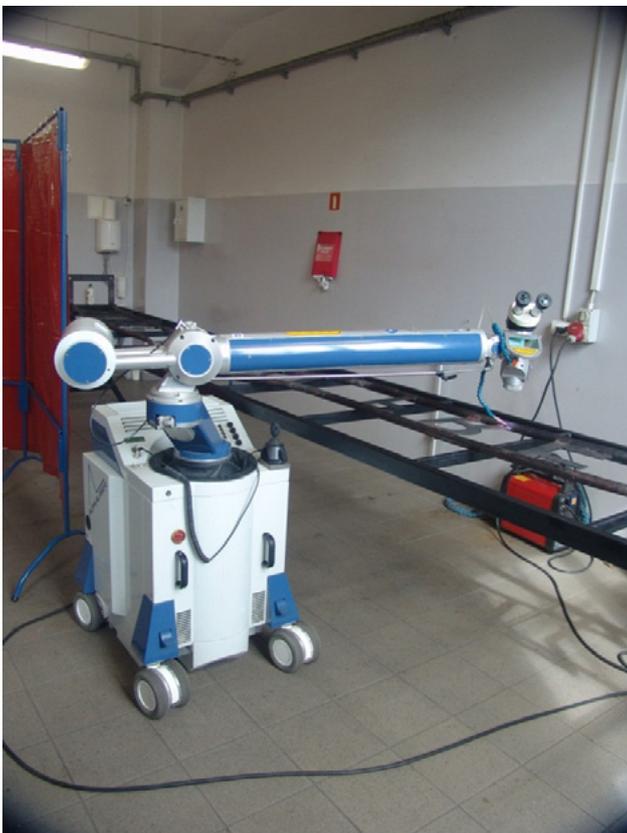
Fig. 20. Mobile laser welding machine ALM 200

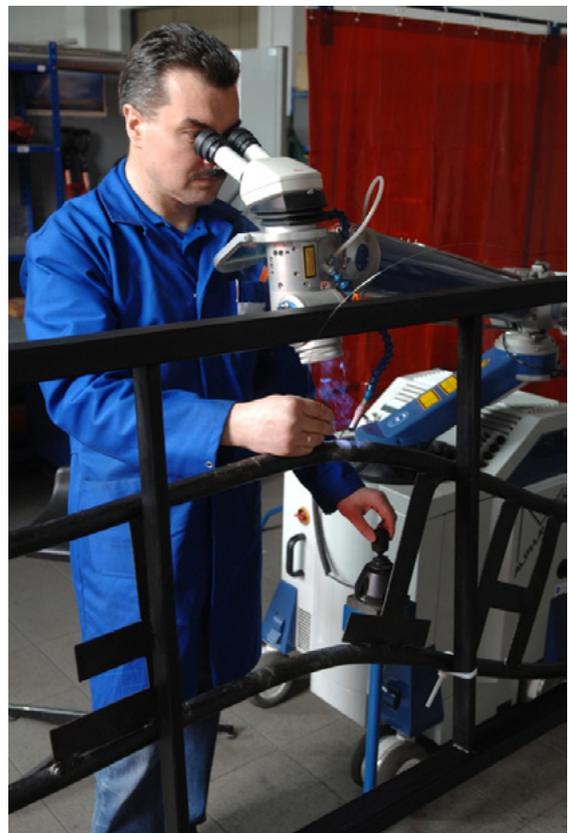
Fig. 21. ALM 200 laser welding of sign fixed on assembly table

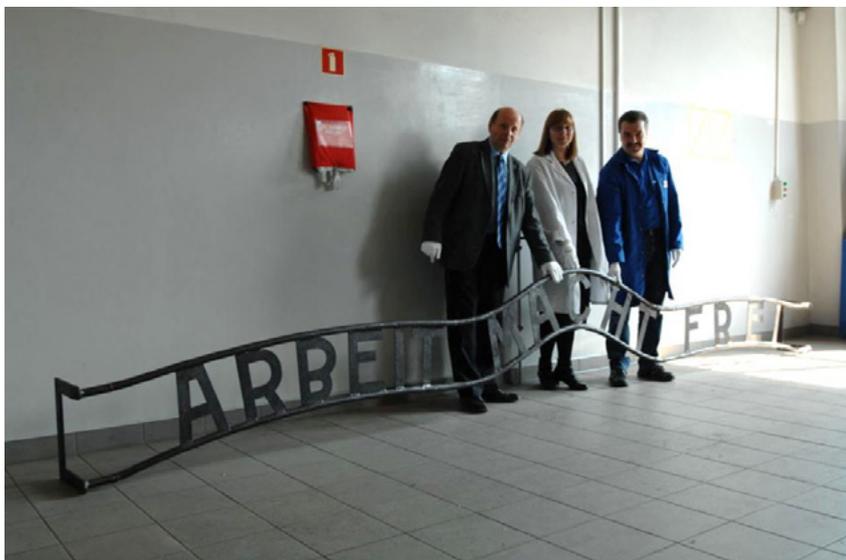
Fig. 22. Sign after welding, removed from assembly table
