Cracking of Welded Structures in Power Engineering Systems

The article presents exemplary problems related to the stress corrosion-triggered cracking of tight wall tubes as well as reasons for the irreversible damage to protective layer of the flue gas desulphurisation (FGD) scrubber (in the flue gas wet desulphurisation system).

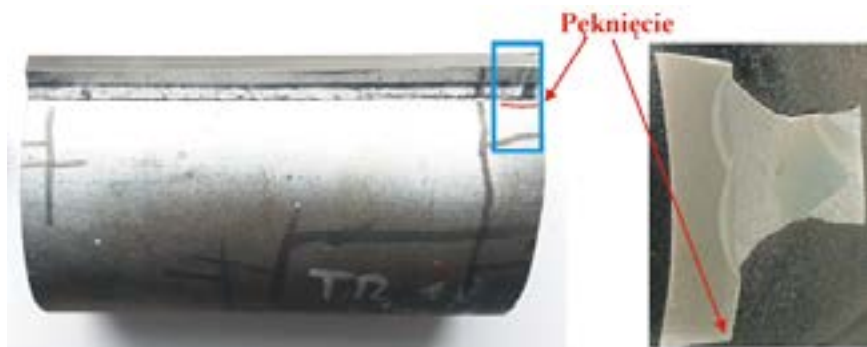
Fig. 2. Specimen sampling area

The tests along with the analysis of their results revealed that the two-sided welded joint of a gas-tight wall (tube-flat bar) made using the MAG + Laser hybrid welding method was proper, free from welding imperfections and satisfied the requirements of quality level B according to EN ISO 13919 (Fig. 2).

The joint structure was typical of hybrid welding. The joint was composed of three characteristic zones, i.e. the base material having the ferritic-pearlitic structure characterised by the band-like morphology, ferritic-bainitic heat affected zone characterised by morphology consistent with the welding thermal cycle (HAZ width below 1 mm) and the weld having the ferritic-bainitic structure in the columnar arrangement of primary austenite grains (Fig. 2).

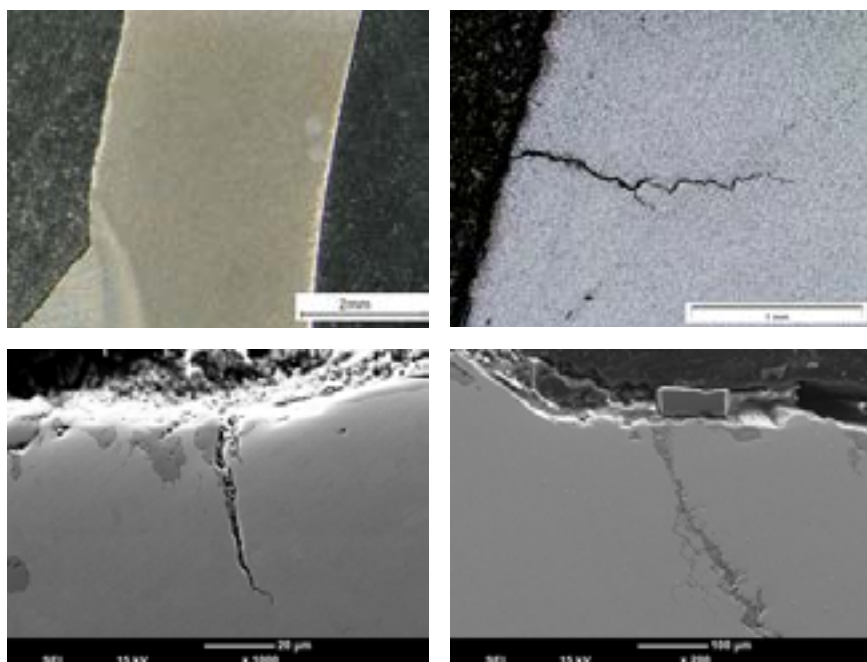
The macro and microstructural tests of the joint did not reveal the presence of welding imperfections such as cracks, incomplete fusions or other forms of discontinuity in the joint area. The detected cracks of the tube were located outside the zone of structural transformations triggered by the hybrid welding process (approximately 3.2 mm away from the end of the weld and 2.3 mm away from the end of the heat affected zone), in the zone of the material containing the granular ferritic-pearlitic structure and were not connected with the welding of the tube-flat bar joint (Fig. 3a,b).

Fig. 3. Structure of the tube-flat bar joint in the area of the detected crack
a) crack areas with corrosion pits and the crack on the side exposed to flue gas (SEM), b) crack in the material of the tube exposed to flue gas (LM), c) crack on the surface of the tube with corrosion products and corrosion pits (SEM), d) crack initiated on the surface with the visible small scrap-induced cracks (SEM)

The crack was triggered by stress corrosion, i.e. the process in which an element is damaged beyond repair as a result of the simultaneous effect of static tensile stresses and the corrosive atmosphere. Usually, a crack is initiated in corrosion pits on the tube surface on the side exposed to flue gas and propagates along grain boundaries in the form of the primary crack and scrap-induced cracks (Fig. 3c, d). The above-presented manner of cracking is characteristic of stress corrosion affecting ferritic-pearlitic steels. Usually, the process of corrosion is very fast, with cracks propagating perpendicularly to the axis of tensile stresses [10].

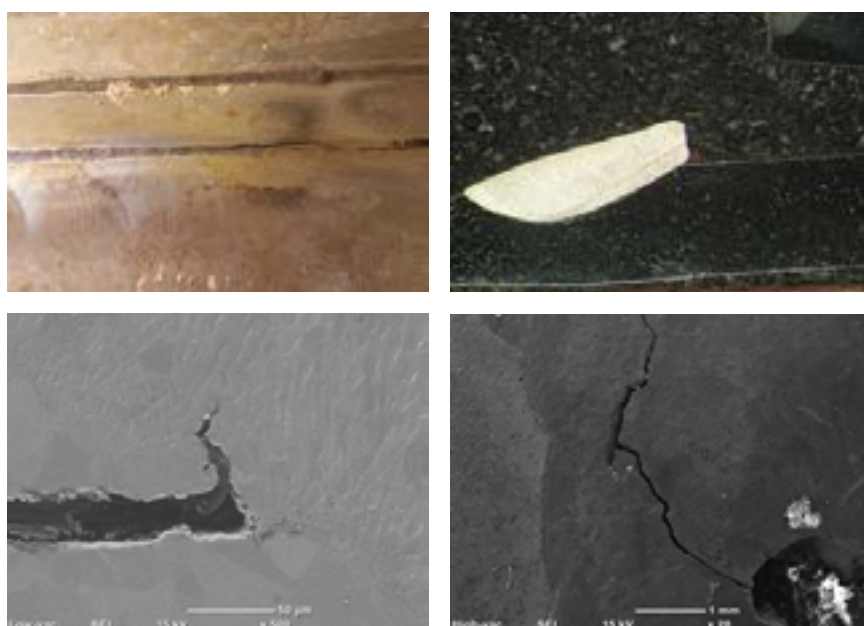
product deposits ($\text{Ca}(\text{SO}_4) \cdot 2\text{H}_2\text{O}$, CaSO_4 , CaCO_3 and $\text{Ca}(\text{OH})_2$). The periodic check of the system revealed numerous cracks both in the girth and plug fillet welds (Fig. 5a).

Fig. 5. Cracks on the surface of the protective layer made of Alloy 59: a) longitudinal crack of the girth weld, b) macrostructure of the damaged joint (SM), c) fatigue crack in the sheet-base joint area, d) low-cycle fatigue crack initiated on the notch in the weld

The visual tests of the damaged joint revealed that the crack was located in the weld axis (Fig. 5a). The location of the crack and its rectilinear trajectory indicated that the crack was induced by low-cycle fatigue triggered by stresses and strains of the joint during its operation (Fig. 5b). The protective sheet made of Alloy 59 was heated by flue gas to a temperature restricted within the range of 170°C to 190°C and, next, cooled by water from the sprinkler several times per hour. The stiffening of the plating structure by means of longitudinal girth joints (2 mm thick sheet made of Alloy 59 and 8 mm plate made of steel S235JR), Alloy 59+Alloy 59 lap joints and plug welds led to cyclic stresses and strains of the entire plating and, consequently, to the cracking of the welded joints (Fig. 5c). The fatigue nature of the cracks is demonstrated by their specific trajectory (characterised by changing directions) (Fig. 5d).

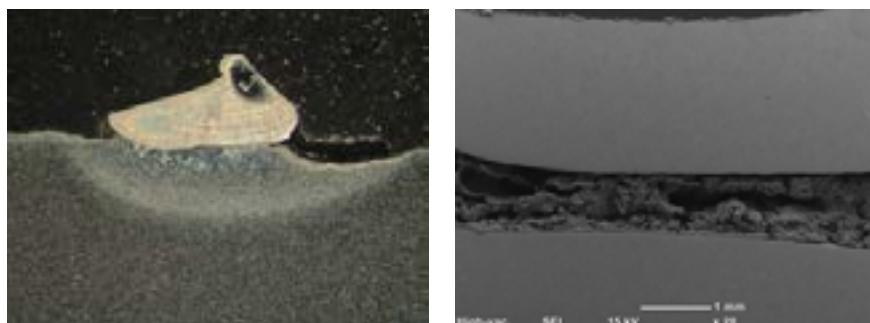
beneath the sheets. The stirring of the material in the welds bonding the sheets made of Alloy 59 and steel S235JR led to their decreased corrosion resistance. In addition to low-cycle fatigue, factors quickening damage (beyond repair) to the plating on the pass floor included surface pitting corrosion (Fig. 6a) and uniform corrosion (Fig. 6b).

Fig. 6. Corrosion of the elements of the flue gas pass of the FGD scrubber: a) corrosion pits in the heat affected zone of the weld, b) products of corrosion and flue gas desulphurisation under the protective sheets and covers made of Alloy 59

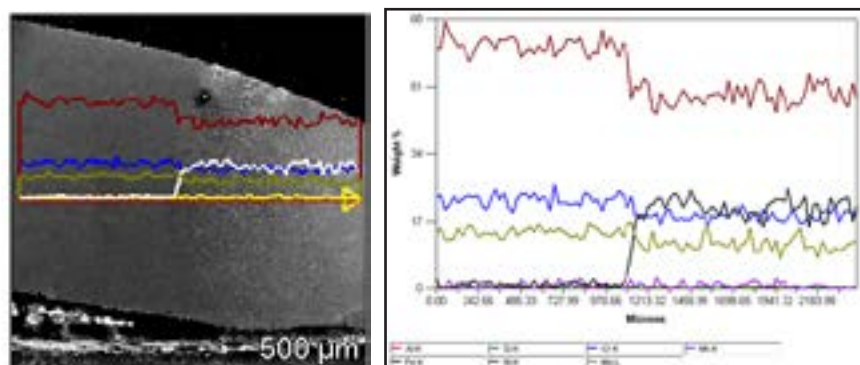
The analysis of the linear distribution of primary alloying elements (Fe, Ni, Cr) confirmed the stirring of Alloy 59 and steel S235JR in the welded joint, resulting in the decreased corrosion resistance of the joint in comparison with that of Alloy 59 alone (Fig. 7).

Fig. 7. Results of the linear microanalysis of the chemical composition (Al, Si, Cr, Fe, Ni and Mo) of the joint made of Alloy 59 and steel S235JR
