Investigation of Reasons for Damage to a Steel Pipeline Used For the Injection of Formation Waters

Abstract: The article presents results of test concerning reasons for the failure of a steel pipeline (DN 80) used for the injection of formation waters. The tests revealed that the perforation and subsequent material losses in the wall of the DN 80 pipeline made of steel L360NB were caused by deposit corrosion.

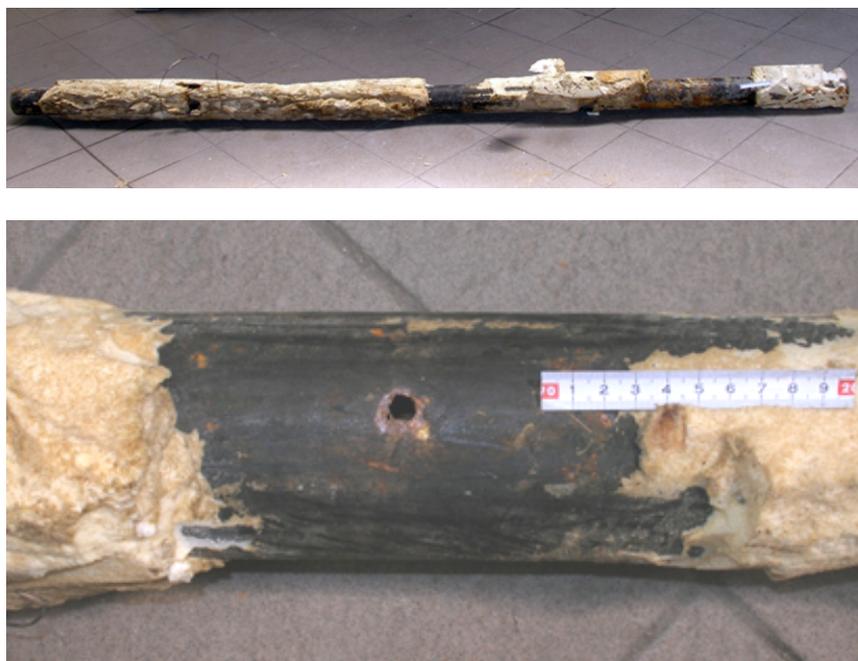
The tests discussed in the article involved a fragment of a pre-insulated steel pipeline used for the injection of waste materials. The diameter of the pipeline made of steel L360NB (PN-EN 10208-2:2011[4]) (Fig. 1a) amounted to 80 mm. The operation of the pipeline was accompanied by leakage. Preliminary visual inspection following the removal of the insulation revealed the presence of damage located in the pipe material (Fig. 1b). The tests aimed to identify reasons for the above-named leaks in the pipeline.

Fig. 1. Fragment of the pipeline (DN 80) (a), visible damage to the pipe wall (b)

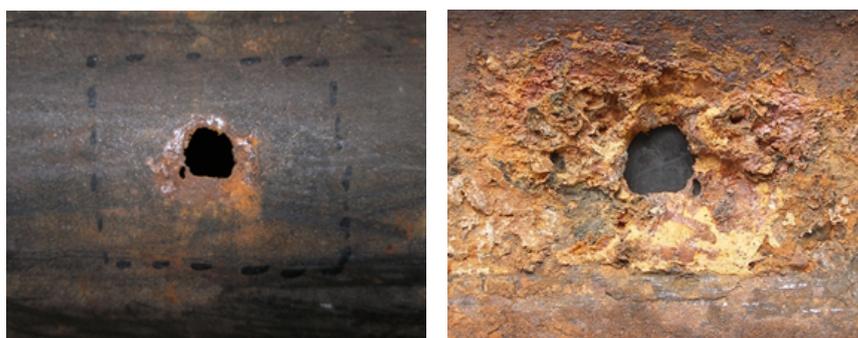
The visual tests concerning the pipeline fragment revealed the presence of a hole having a diameter of approximately 9.0 mm. The edges of the damaged area were irregular. The performance of the visual tests of the internal surface of the pipe required cutting out the damaged area along the dashed line marked in Figure 2a.

The internal walls of the pipe contained rusty deposits (Fig. 2b, 3a), under which pipe material losses were detected. An exemplary pipe material loss is presented in Figure 3b.

Fig. 2. Damage to the pipeline (DN 80), external pipe surface (a), internal pipe surface (b)

Visual tests revealed the presence of pipeline surface perforation having a diameter of approximately 9.0 mm (Fig. 2a). The visual tests of the internal surface of the pipeline revealed the presence of rusty deposits (Fig. 2b), under which it was possible to notice pipe material losses (3b).

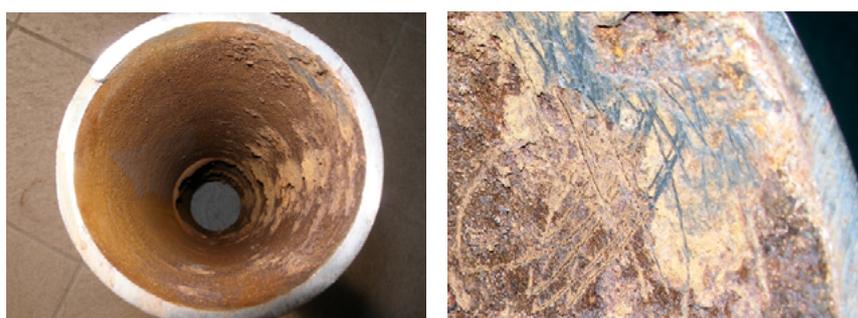
Fig. 3. Main view of the internal surface of the pipeline (DN 80) (a), fragment of the surface with the visible material loss (b)

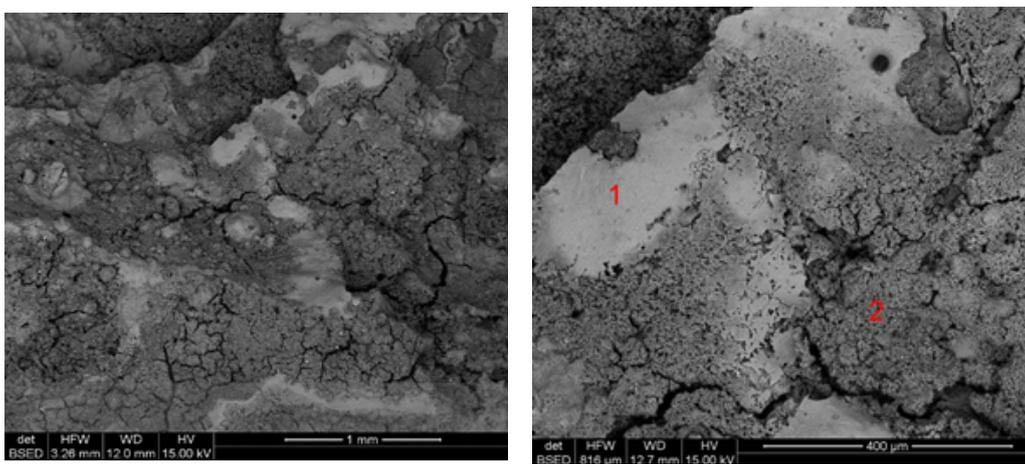
Figures 4 through 6 contain test results concerning the deposits next to the perforation on the internal surface of the pipe. The deposits present on the pipe surface differed both in terms of morphology and chemical composition. The deposits were dominated by iron, oxygen, sulphur and chlorine. The deposits characterised by the expanded surface also contained the significant amount of silicon as well as aluminium, sodium, magnesium, potassium and calcium (Fig. 4 and 5). The area where the surface layer had fallen off the pipe was

Fig. 4. Results concerning the identification of the deposits on the internal surface of the pipe, around perforation

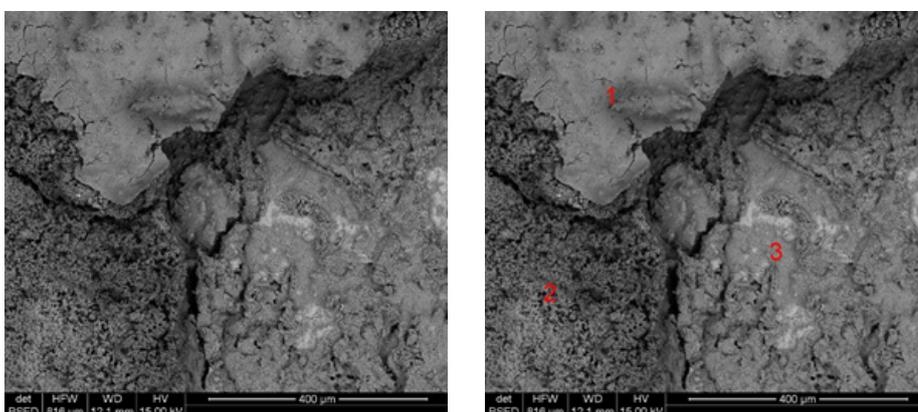
Fig. 5. Results concerning the identification of the deposits on the pipe surface

characterised by the high content of sulphur (Fig. 5). The deposit surfaces contained clusters including primarily oxygen, sulphur and barium (Fig. 6).

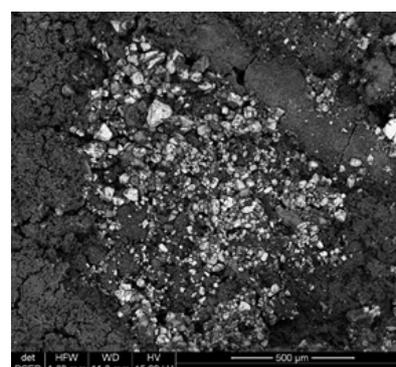
Fig. 6. Clusters of particles containing oxygen, sulphur and barium on the surface of the deposits

thus increasing the area of its penetration into the pipe wall. The deposits also contained a layer characterised by a high carbon content, significantly decreasing the adhesion of corrosive deposits to the surface. Particulates (i.e. particles characterised by high contents of oxygen, sulphur and barium) present in the polluted water were responsible for the removal of the above-named deposits, intensifying the erosive and corrosive effect of water [7, 8].

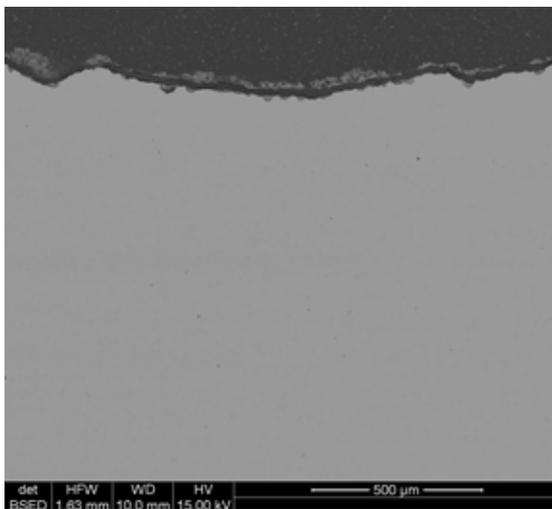
Figures 7 through 10 contain test results related to the deposits on the cross-sectional metallographic specimen. As a result of the preparation of the metallographic specimen, a significant amount of deposits, loosely connected with the base, fell off. The tests involved the layer adjacent to the pit surface (Fig. 7 and 8). The tests revealed that the dominant chemical elements present in the deposits on the surface were oxygen and iron. In addition, the deposit-related tests also revealed the presence of sulphur, restricted within the range of 0.7% to 35% (Fig. 9 and 10).

Fig. 7. Edge of the pit bottom outside perforation

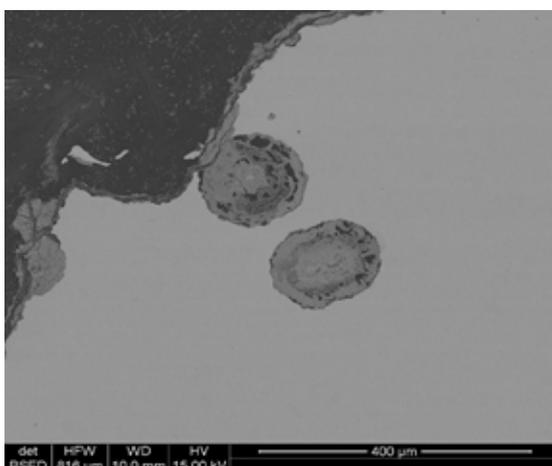
Fig. 8. Side edge – pits

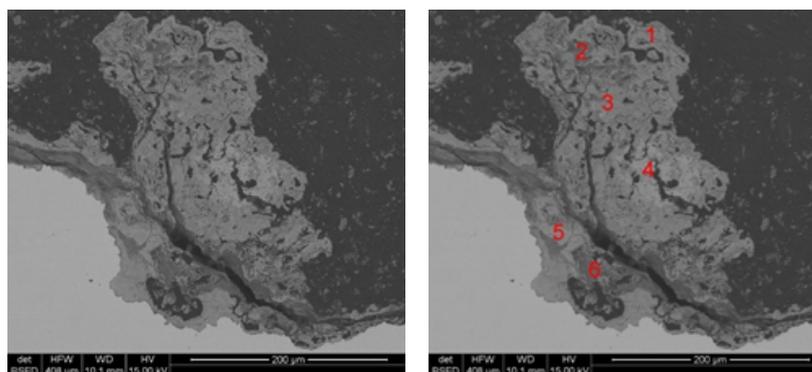
bottom of the pit contained a slight amount of sulphur and significant amounts of oxygen and iron. The deposits were locally characterised by the high content of carbon and chlorine (Fig. 9).

Fig. 9. Results concerning the identification of the deposits on the pit surface

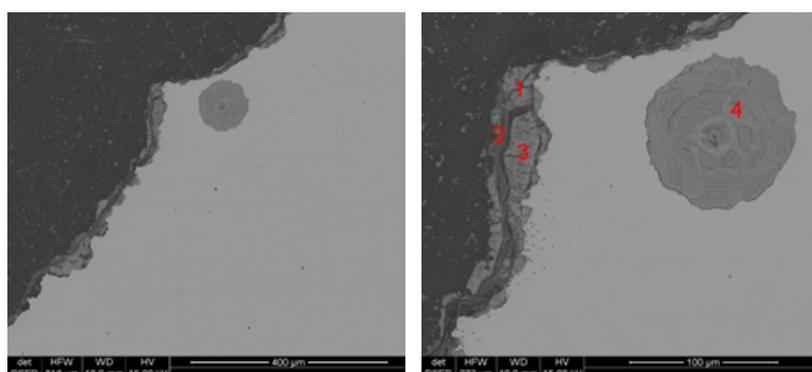
The layer of deposits contained bands characterised by the high content of carbon, significantly decreasing the continuity of the deposit later (Fig. 10).

Fig. 10. Deposits on the pit surface
