Two cases of high alloy austenitic steel failures

Metal dusting of 25/35 CrNi centrifugally cast tubes.

Leakage in air separator unit made of stainless steel

Failure of stainless steel pipeline

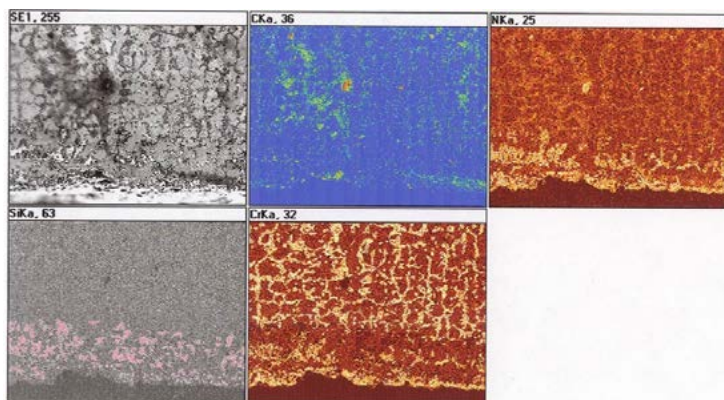
The most often used process is carburization of the pyrolysis tube internal surface during an ethylene production, when creation of the thick carbide network ($M_{23}C_6$ and M_7C_3) is involved, see EDX element mapping in Figure 1, [1]. The thick carbide formation occurs, if a carbon activity $a_c < 1$.

Fig.1 Element mapping of exploited CCT (1000-1050°C/ 70 000 hrs) – inside surface

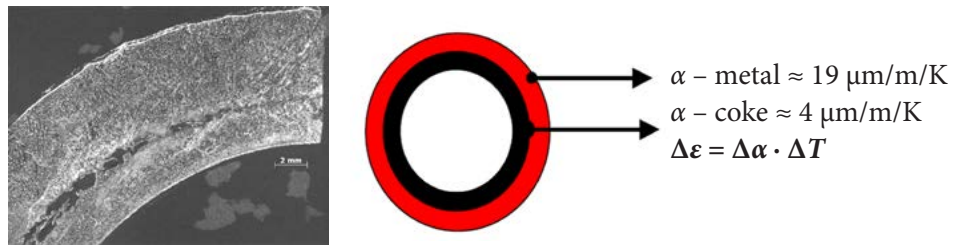
The coking process may result in wall pipe delamination (Fig.2a) during shut-downs due to high stresses created by a thick coke layer with a much lower thermal expansion coefficient (Fig.2b), [2].

Fig. 2. Wall pipe delamination (a) and Coefficient of thermal expansion (b) [2]

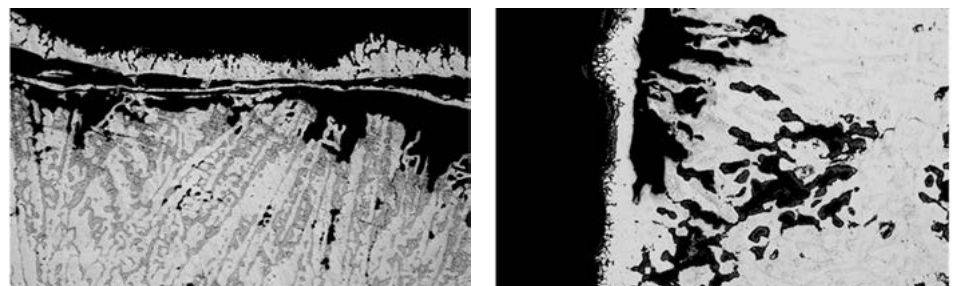
Metal dusting is a localized degradation process that occurs in hot reactive gases containing carbon and hydrogen compounds but almost no oxygen. Local defects in the oxide scale allow carbon diffusion into metal, where firstly stable carbides $M_{23}C_6$ and M_7C_3 precipitate and when a carbon activity rises to values $a_c \gg 1$, graphitization starts. The graphite grows into metal and disintegrates its structure such way, that a metal powder consisting of carbides, oxides and graphite originates [3]. Such a process may result in the formation of surface pitting and sub-surface hollows, see sketch in Figure 3. In our case 25/35 CrNiNb tubes of the hydrogen furnace were examined, Fig. 4 and 5 shows a presence of the graphite in the under surface hollow.

Fig. 4 Hollows at outer tube surface

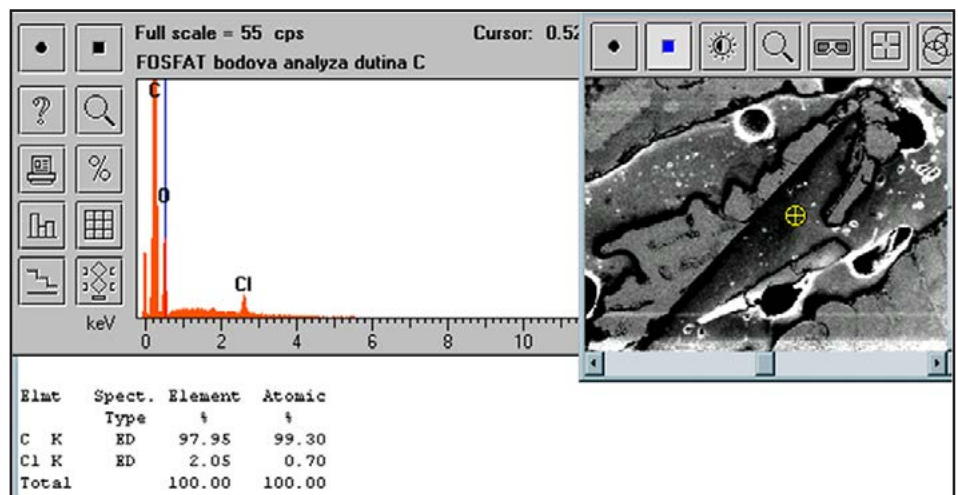
Fig. 5. EDX analysis of the graphite particle in the hollow

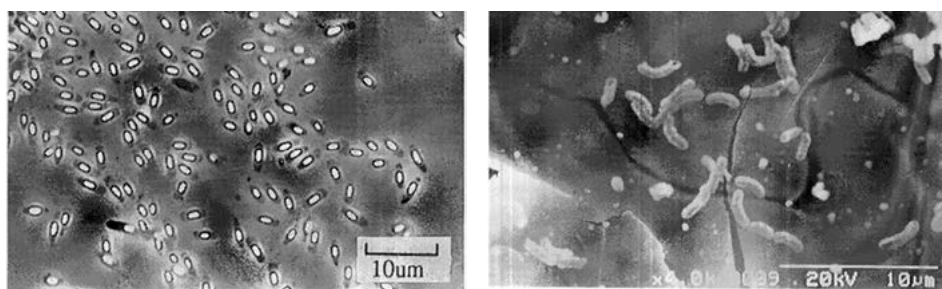
Only specialized laboratories may provide the direct microscopical observation of the SRB on the surface of a corrosion pitting, see Fig.6, [5].

Fig. 6. Bacteria on surface of corrosion pitting of stainless steel weldment [5]

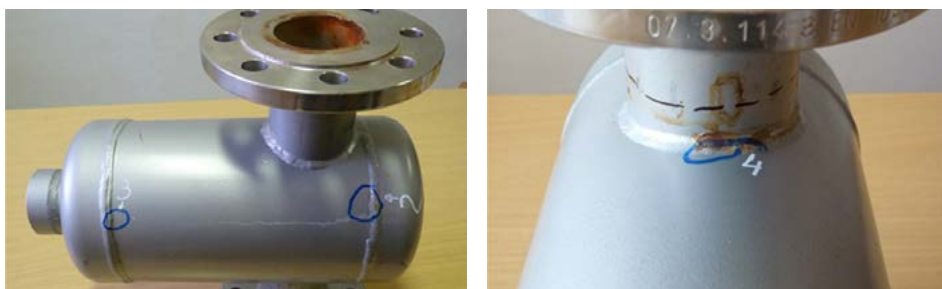
An air separator of the water meter made of 1.4306 stainless steel was concerned [7]. The water meter was a part of a desalting plant in one of the African countries. It

A lot of leakages in the weld were revealed after a year of operation, see Figures 7 and 8.

Fig. 7 Leakages in weld of air separator unit

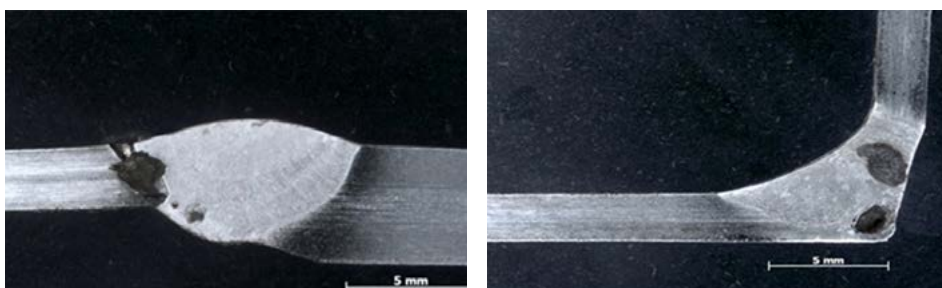
Fig. 8 Macroetches of weld attacked by SRB

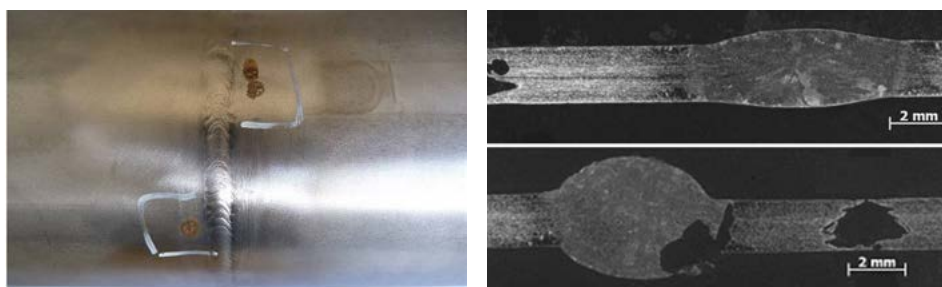
Fig. 9 Leakages around the welds

Fig. 10 SRB attack of welds and around the welds SRB

Girth welds of the φ129×2 mm pipes made of 1.4301 stainless steel were examined [8]. A company applied stainless steel pipeline (instead of the usually used plastic or Zinc coated pipes) for transport of the cooling water from an old well. Already after 4 weeks several leakages were revealed, see Fig. 9 and 10. Especially, if a water unit is not in continuous service with residues of water inside after shutdowns.

Repairing equipment or a pipeline by welding is practically impossible as attacks (inside – outside of welds)

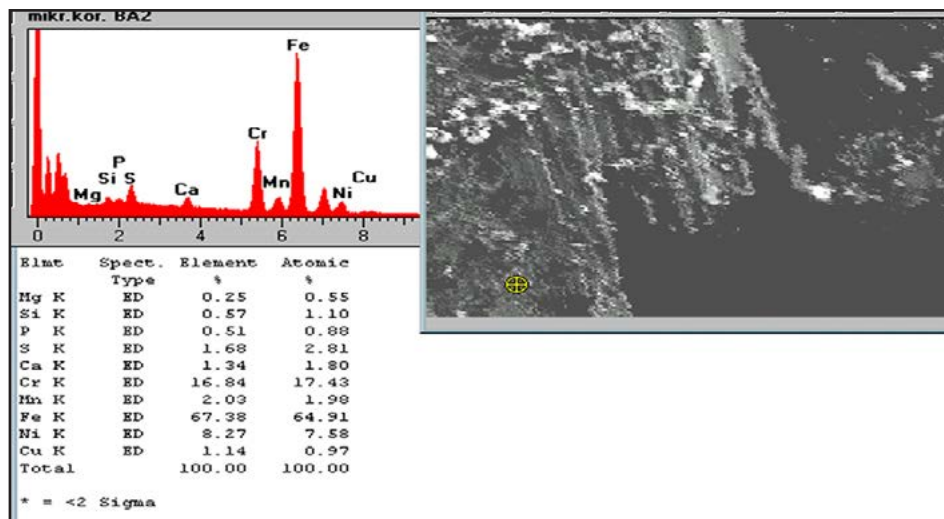
Higher content of sulfur, which probably comes from SRB was identified by EDX microanalysis of corrosion products inside a pit (Fig.11).

Fig. 11. EDX analysis of corrosion products
