Investigations

Welding Imperfections in T-joints of Thin-walled Elements Made Using Mechanised TIG Welding with Filler Metal Wire

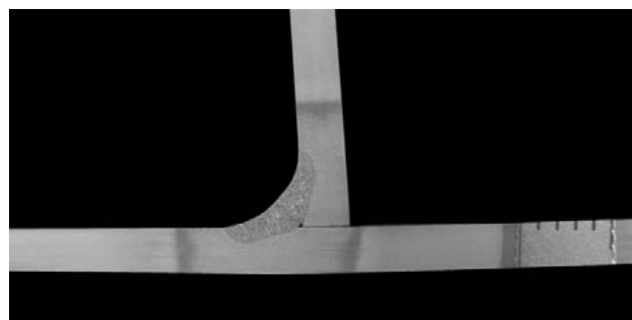
- excessive asymmetry of a fillet weld (imperfection no. 512 according to PN-EN ISO 6520-1:2009);
- irregular width (imperfection no. 513) – irregular weld width fluctuations;
- incomplete root penetration (imperfection no. 4021) in a T-joint (Fig. 1);

Fig. 1. Incomplete weld root penetration caused by a displacement of the filler metal wire axis in relation to the weld axis

The reasons for the asymmetry of fillet weld dimensions and for the lack of penetration in the weld root are deviations of the wire axis from the joint axis, excessive electrode extension and the twisting

of the wire in filler metal wire feeding conduits. The reason for the deflection of the wire at its extension could be the excessive wear of the wire feeder brass conduit guide (replaceable terminal of the filler metal wire feeding conduit). In the event of excessive wire deflection following the long-term operation of a TIG welding torch, the (quickly wearing) wire guide should be replaced with a new one. During technological welding tests it was also determined that improper bead formation was caused by even slight deformations of thin sheets being joined and their displacement in relation to the axis of the weld being made.

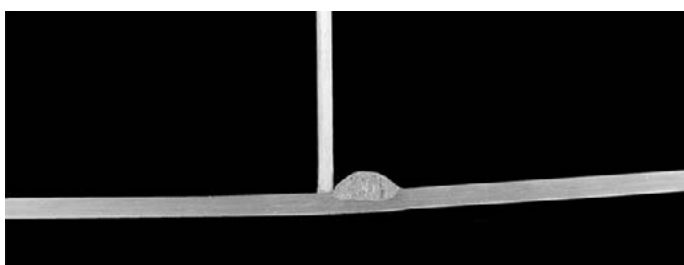
- deviation from the intended geometry of a fillet weld, also classified as incomplete root penetration (imperfection no. 4021). According to the definition provided in standard [2], this imperfection is present if one face (or both faces) of the root groove are not melted (Fig. 2 and 3).

Fig. 3. Macrostructure of a T-joint with incomplete root penetration (4021) – lack of penetration into the vertical wall

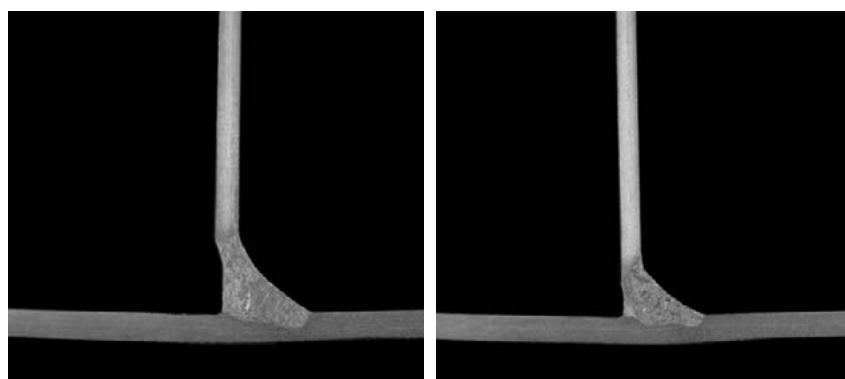
- **fillet weld root concavity with the vertical element undercut** (in a T-joint) when welding in a horizontal position (Fig. 4). The reason for the concavity is an excessively long welding arc (overheating the vertical sheet) and overly low amount of filler metal.

Fig. 4. Examples of fillet weld root concavity with the vertical element undercut

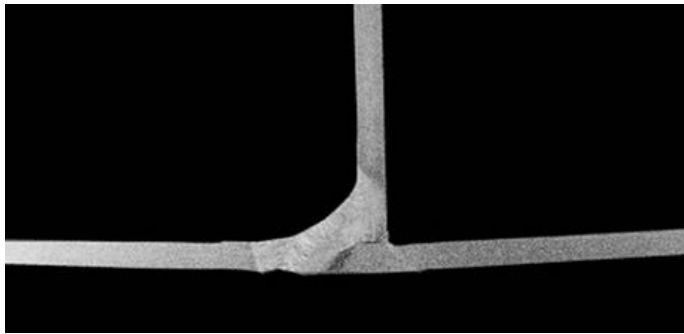
– fillet weld root concavity with the horizontal element undercut (in a T-joint) (Fig. 5);

Fig. 5. Example of fillet weld root concavity with the horizontal element undercut in a T-joint

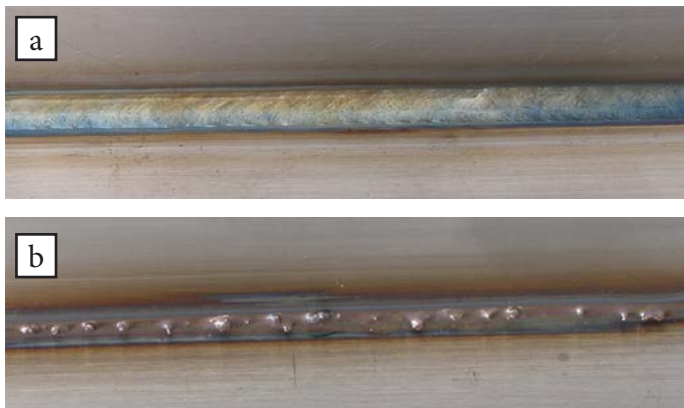
Fig. 6. Face (a) and root (b) of the fillet weld with irregular excessive melt-through of the element being welded and excess penetration beads

– excessive melt-through of the vertical element being welded in a T-joint with excessive penetration on the joint root side (Fig. 6, 7);
 The excessive penetration on the root side of the T-joint with the fillet weld cannot be rated among the group of excessive penetration according to standard [2] as the standard defines excessive penetration (no. 504 and 5041-5043) exclusively for butt joints. As can be seen in Figure 7, this imperfection cannot be rated among weld overlaps referred to as “excess weld metal covering the base material surface without penetration”.

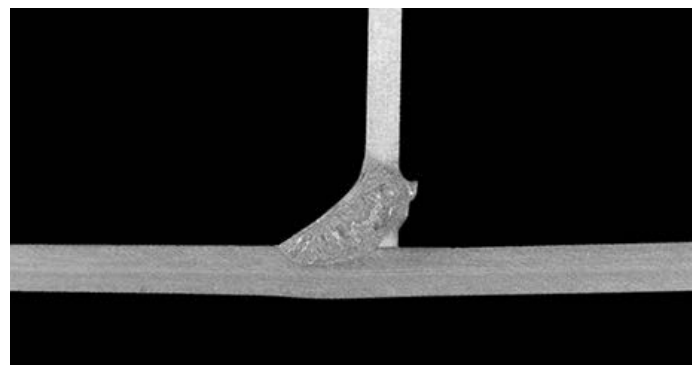
Fig. 7. Macrostructure of a T-joint with excessive melt-through of the vertical element being welded with excess penetration bead on the joint root side

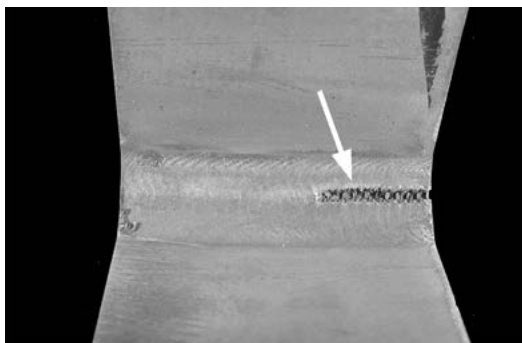
Fig. 8. Fillet weld face with a scratch after making approximately 5 cm of the joint (marked with the arrow)

- **scratch (concavity) in solidified weld metal** due to the immersing of the wire in the weld pool liquid metal, melting of the wire in the pool and, at the same time, leaving a concavity in the solidified metal, on the weld face during disturbances of steady filler metal wire feeding (Fig. 8-12).
- **adhesion of wire** at the end of a welding process (Fig. 13). Similar to MIG/MAG, the reason for adhesion could be an improperly adjusted wire stop delay time during arc termination or the lack of this functionality in the filler metal wire feeding system, but also the deformation of a welded element at the terminal section of the joint, locally decreasing the distance between the filler metal wire guide terminal and the element being welded. The adhesion of wire is considered to be a significant imperfection in welded joints of thin-walled elements

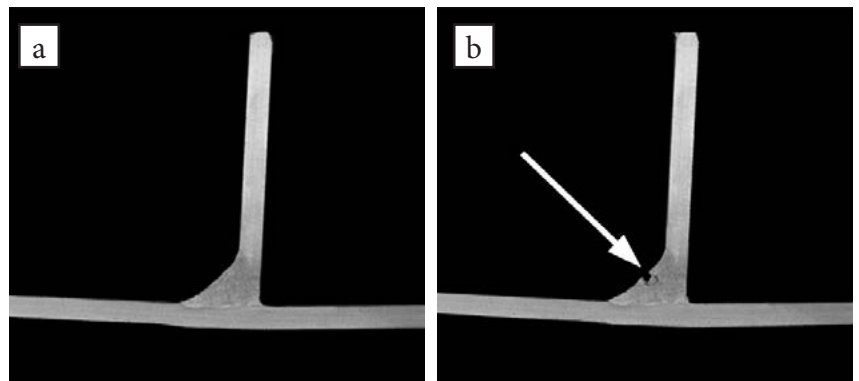
Fig. 9. T-joint macrostructure: a) initial section, b) section with the scratch in the weld face (marked with the arrow)

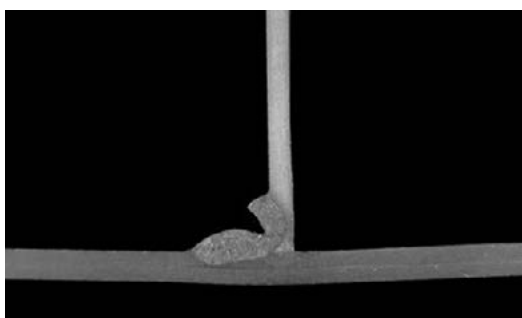
Fig. 10. Macrostructure of the T-joint with a deep scratch in the weld face

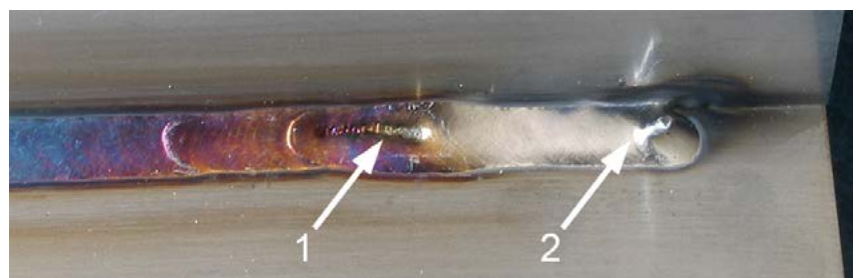
Fig. 11. Weld end during disturbances of steady filler metal wire feeding – visible scratch due to the immersing of the wire in the weld metal pool (1) and the wire adhesion at the weld end (2)

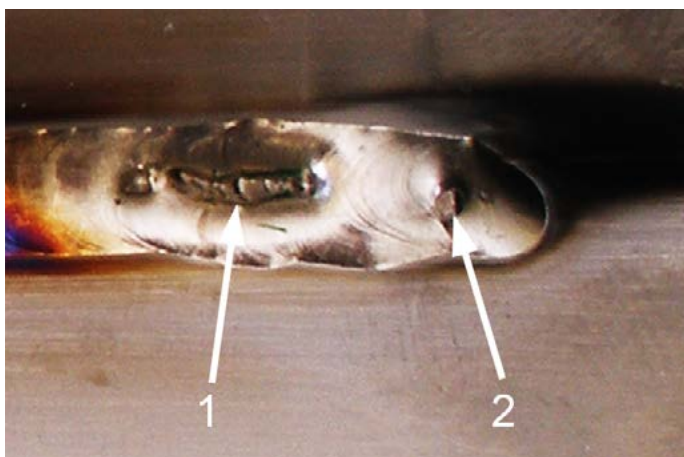
Fig. 12. Weld crater with a scratch (1) due to immersing the wire in the weld pool metal and the wire adhesion area (2) at the end of the weld

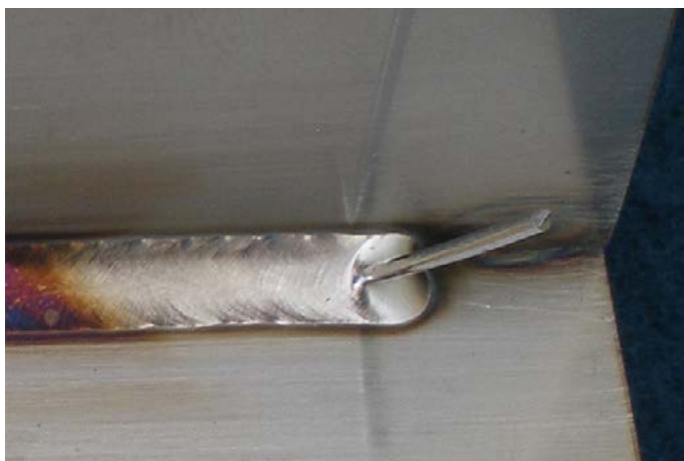
Fig. 13. Wire adhesion in the crater

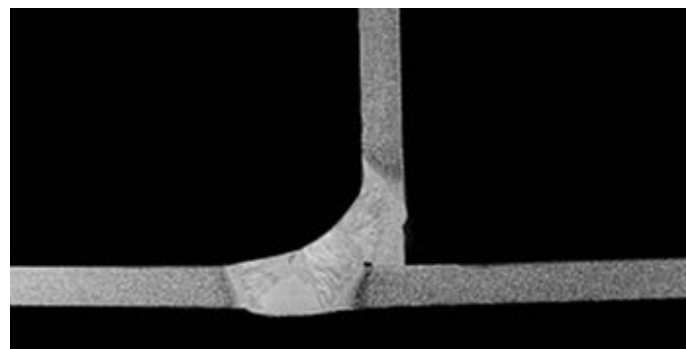
Some tested joints revealed the presence of welding imperfections specified in PN-EN ISO 6520-1:2009 and imperfections not classified in this standard. For instance, in the joint presented in Figure 14 there is incomplete root penetration (imperfection no. 4021), fillet weld root concavity with the vertical element undercut in the T-joint and the excessive melt-through of the horizontal element (as regards butt welds, in the standard this imperfection is designated with no. 5043, yet it is not classified for fillet welds).

Fig. 14. Macrostructure of the T-joint with imperfections, i.e. incomplete root penetration, fillet weld root concavity with the vertical element undercut and the excessive melt-through of the horizontal element
