# Analysis of Cracks in Welded Joints of Pipes with Eyes made of S890QL1 Steel

**Abstract:** The analysis presented in the article was concerned with cracks in MAG (135) robotic welded joints of pipes with eyes made of s890QL1 steel and constituting components of the latticework of self-propelled cranes. The text also presents results of tests concerning chemical composition as well as mechanical and metallographic properties of base materials and welded joints. The article contains an assessment of radial and longitudinal cracks of joints based on fractographic tests of cracks and impact-test specimens. The text also discusses the effect of welding process thermal conditions on joint properties. Test results were referred to the theory of hydrogen-induced cracking (mechanism) according to Professor E. Tasak.

The research-related tests involved MAG (135) robotic welded joints of pipes with eyes constituting components of the latticework of self-propelled cranes.

The tests aimed to define reasons for the sporadic formation of cracks in joints.

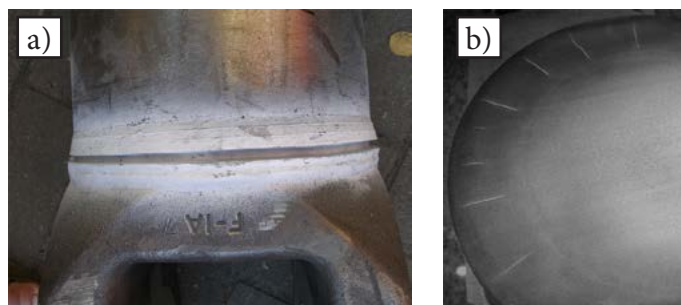
Fig. 2. Cracks in a welded joint: a – view of the joint after a penetrant test (groove indented by the manufacturer facilitated the detection of cracks), b – radial cracks on the joint cut surface along the groove

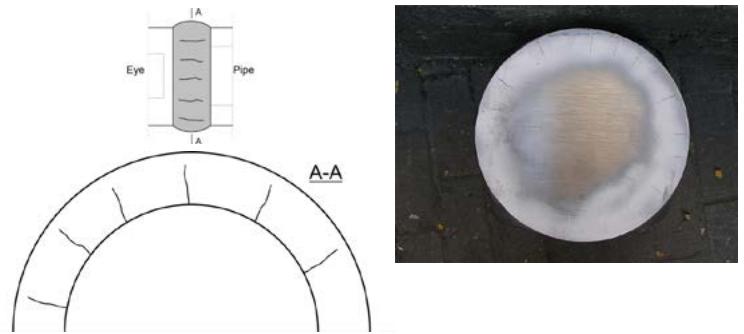
Fig. 3. Radial cracks (across the weld)

Penetrant tests of welded joints performed by the manufacturer revealed the presence of cracks, presented in Figure 3.

On the basis of the cross-sections of joints and magnetic particle tests it was possible to detect radial cracks across the weld and longitudinal cracks located mainly near the weld axis (Fig. 3 and 4). In turn, analyses of the surfaces of impact test specimen fractures revealed cracks at various angles yet perpendicular to the fracture and present on the side surface of the specimen. Therefore, it could be concluded that cracks had been already present in the joint. All of the cracks observed in the impact test specimens were transverse in relation to the girth weld. The estimated number of the radial cracks was significantly greater than that of the longitudinal cracks.

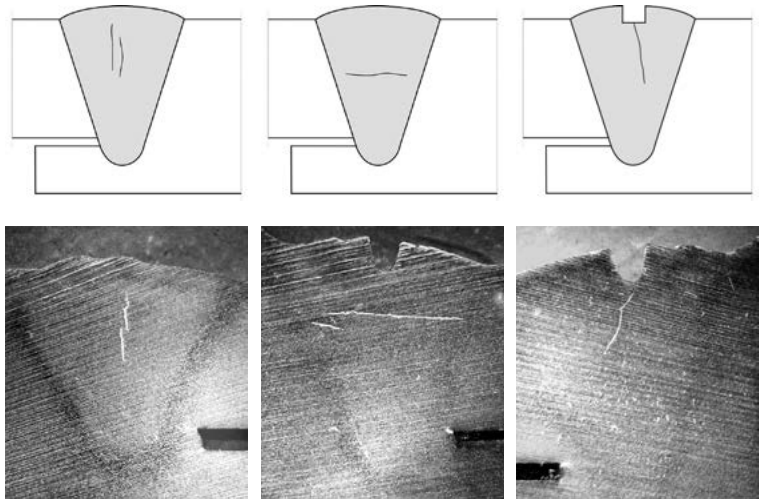
The obtainment of complete information regarding generated cracks required performing magnetic particle tests not only of radial cracks (i.e. cracks on the weld perimeter) but also of longitudinal cracks (i.e. present along the weld, in the cross-sections of the weld). The longitudinal cracks were perpendicular to the radial cracks. The cracks were present in the upper area of the weld. The cracks in transverse metallographic specimens are presented on Figure 4.

Fig. 4. Cracks along the weld – longitudinal cracks (perpendicular to radial cracks)

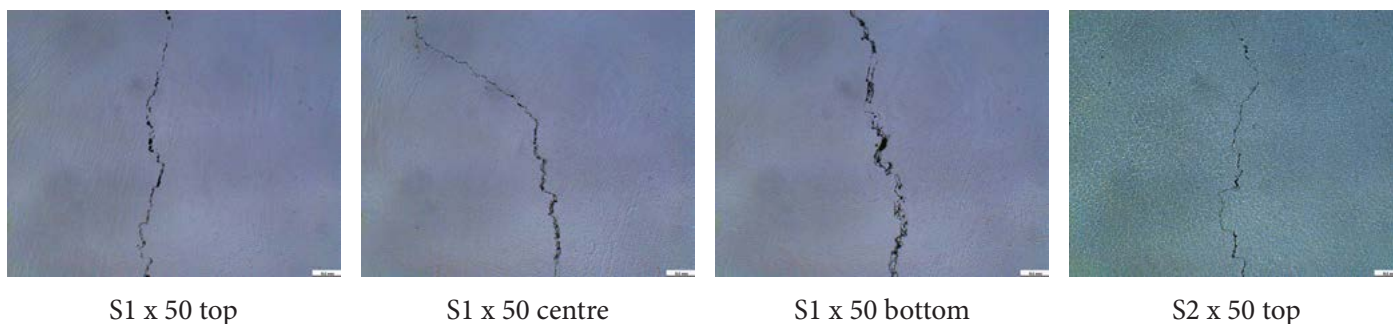
(306-348 HV). Presented below is a radial crack in the cross-section along the weld – S1 and from top view – S2.

Fig. 6. Radial cracks – unetched specimens

The photographs of metallographic specimens present etched and unetched radial cracks (Fig. 3, 6, 7). The cracks zigzag and consist of straight segments perpendicular to interchangeably present fields of martensite and bainite. The fractures and the edges of these cracks reveal the presence of brittle and plastic fracture elements, whereas the cracks themselves are intercrystalline (transcrystalline course is difficult to assess). The material in the area of cracks (examined in the fractographic part) is mainly composed of bainite or tempered martensite of a relatively low hardness (290-300 HV). For this reason, the crack formation should be ascribed not to hardening structures but welding stresses and the negative effect of hydrogen.

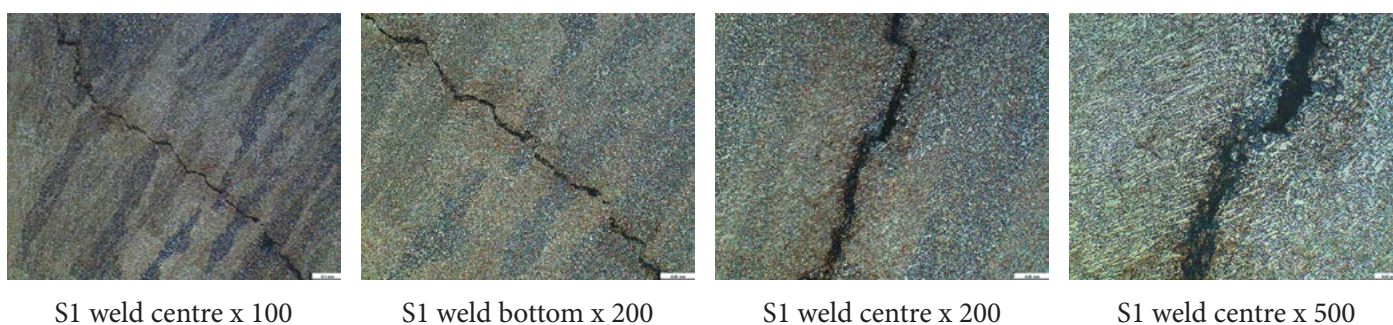
Fig. 7. Radial cracks – etched specimens (Nital)

In the crack area in the weld, there are interchangeably present bright martensite fields (dominant) and dark fields containing bainite + ferrite. The zigzag cracks are perpendicular to these fields.

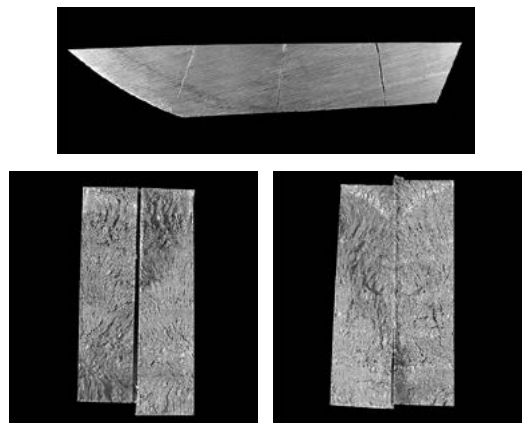
The figure below presents a part of the weld cut on the circumference (thickness of approximately 5 mm) with cracks and their characteristic fractures, i.e. brittle and strain-free.

Fig. 8. Fractures of radial cracks

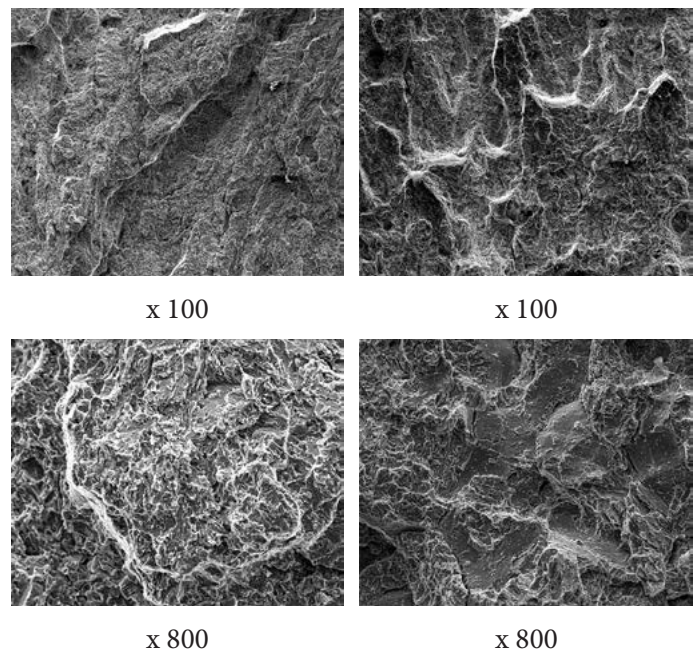
Figure 9 presents the results of tests involving the surfaces of the fractures of two various radial cracks. Plastic fractures dominated in both cases, yet it was also possible to observe locally present brittle fractures. On the surface of the fractures it was possible to notice the dendritic structure of successive layers of the weld.

The surfaces of the radial crack fractures revealed the presence of elongated cracks perpendicular to the radial cracks.

Fig. 9. Fractography of radial crack fracture

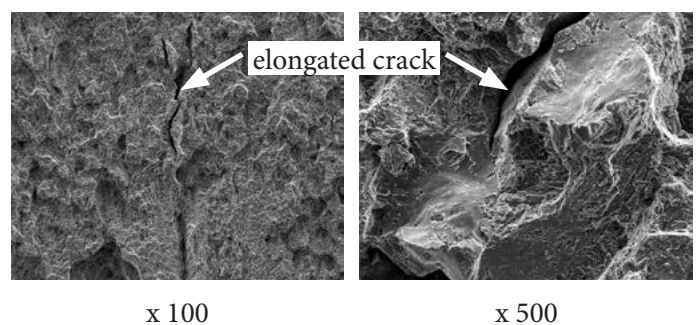
Fig. 10. Elongated cracks revealed on the surface of radial crack fractures

**Longitudinal cracks** were observed on the surface of the transverse metallographic specimens of the joints and on the surface of fractographically examined radial cracks (Fig. 10, 11). The cracks observed were predominantly vertical in the weld axis and, rarely, horizontal. In several cases, the material ductility in the weld axis, verified by hardness tests, proved very low. It should be noted that hardness values of the weld centre were significantly lower than those determined in the HAZ of the joints.

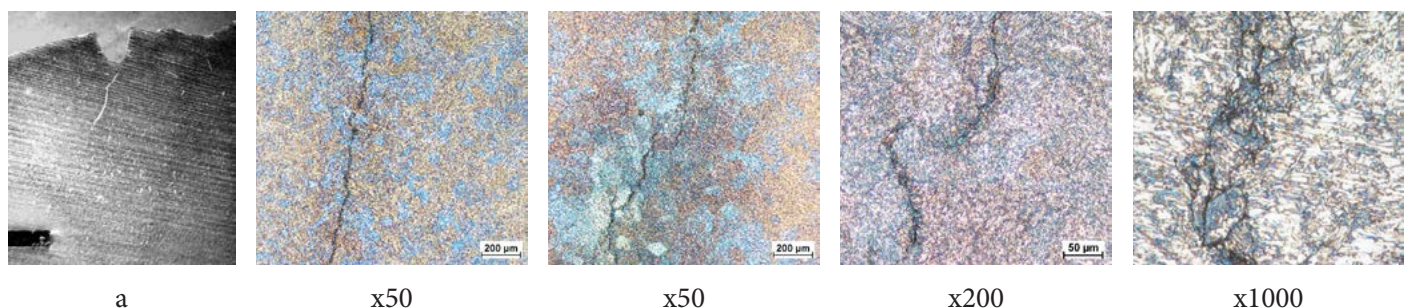
Figure 11 presents a cross-section of the elongated crack “a” from top view.

Fig. 11. Elongated crack

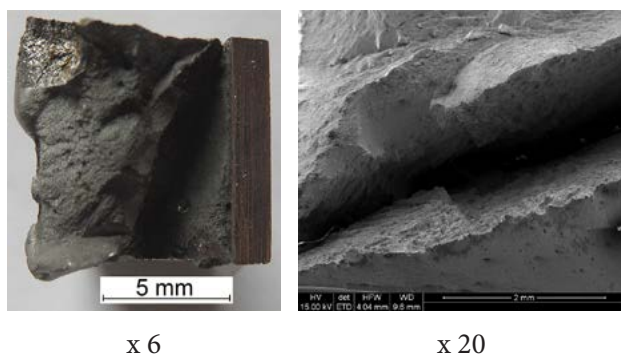
Fig. 14. Macrophotography of the fracture of specimen GS-1 with a crack

The specimen fractured in the notch. The specimen had a crack which, as a result of the fracture, opened partly. Figure 14 presents the macrophotography of specimen GS-1, whereas Figures 15 and 16 present the fractography of the fracture of this specimen. The surface of the fracture revealed the presence of brittle fracture – area “A” and plastic fracture – area “B”. Figure 17 presents how the cracks in the impact test specimens penetrated their side surfaces

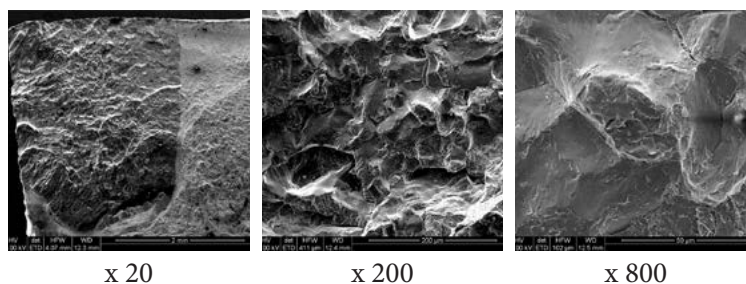
Fig. 15. Area of brittle fracture “A” in impact test specimen GS-1

- cracks skew or perpendicular to the specimen side surface; the cracks were obtuse during the impact strength tests (Fig. 14, 20, 23);
- in the fractographic tests:
  - clearly visible intercrystalline (often “stony”) character (Fig. 15, 21),
  - visible gaps (cracks) between the crystallites implying hydrogen-induced hot cracks (Fig. 21) [1].

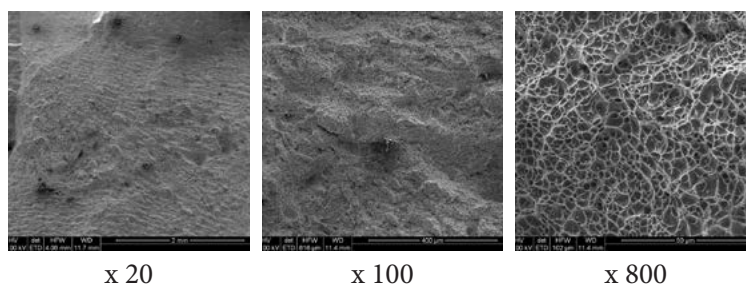
Fig. 16. Area of brittle fracture “B” in impact test specimen GS-1

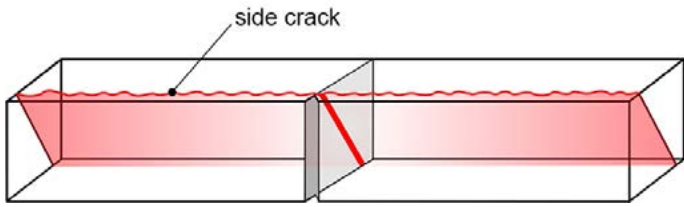
Fig. 17. Cracks on the side surface of the impact test specimen

The character of these cracks, for the sake of simplification referred to as “side cracks”, was also subjected to appropriate analysis. To this end, it was necessary to make fractures of the side surface of the specimen performing macro and, also sometimes, micro observations. The edge of the fracture of specimen GS-1 revealed the presence of both brittle and plastic fracture (Fig. 18).

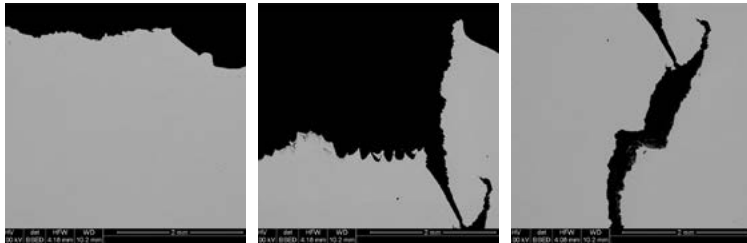
Fig. 18. Edge of the fracture of impact test specimen GS-1 with a crack

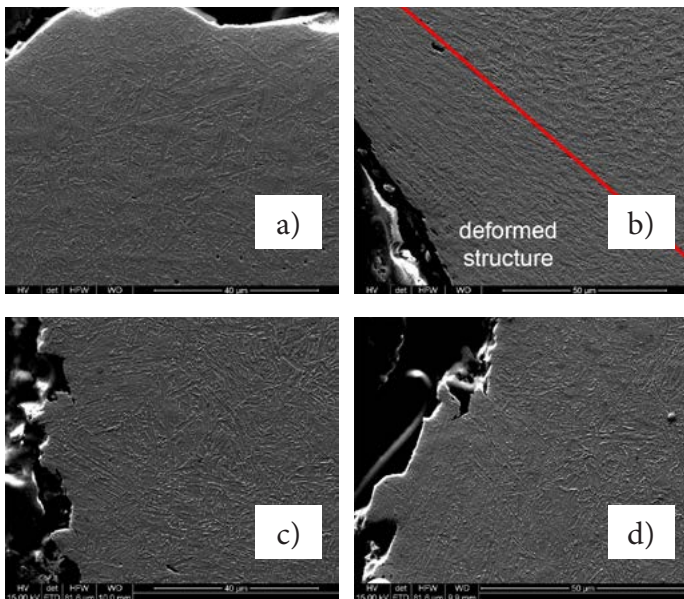
Microscopic examinations of the crack area (Fig. 19) revealed the following: a) – structure of bainite and martensite; b) – mechanical deformation of the structure; c, d) – crack along grain boundaries.

Fig. 19. Metal structure and crack edge in specimen GS-1

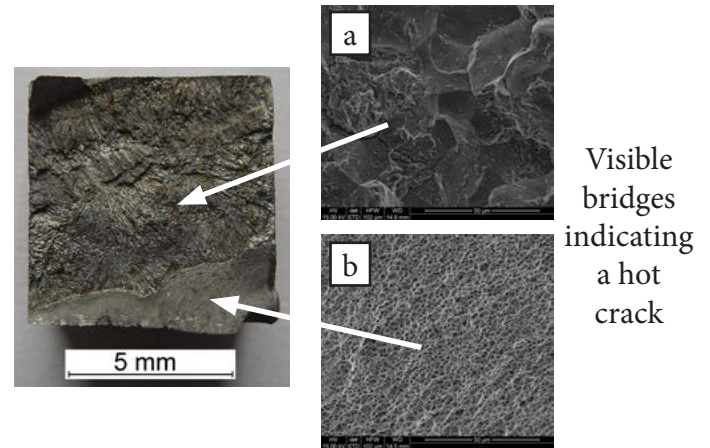
The specimen fractured outside the notch. The fracture was cleavable and the specimen was strain-free.

Fig. 20. Fracture of specimen GS-2 containing brittle – a) and plastic – b) area

In one case (specimen GS2, Fig. 20), a crack was parallel to the specimen fracture surface (along the weld) and the fractography confirmed the hot character of the crack.

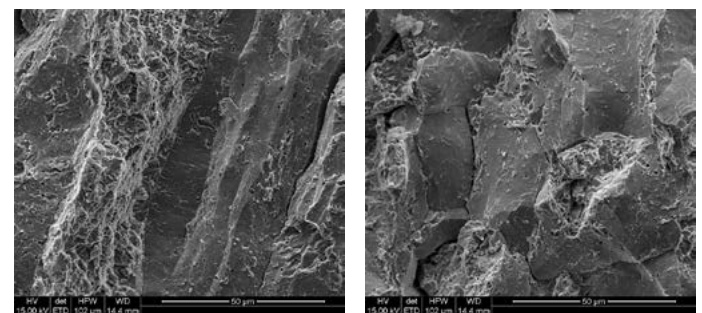
Fractographic tests revealed the presence (on the surface of the fracture) of an increased amount of brittle fracture both along grain boundaries and along boundaries of dendrites (Fig. 20 and 21) formed during the solidification of the weld. A side metallographic specimen – the shape of the upper edge is characteristic of a brittle fracture along grain boundaries (Fig. 22). Etching revealed the propagation of cracks along grain boundaries.

Fig. 21. Fracture along dendrites and grain boundaries with cracks between them

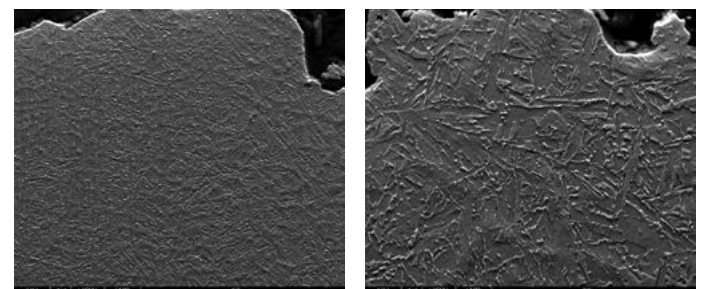
Fig. 22. Bainitic structure with visible grain boundaries

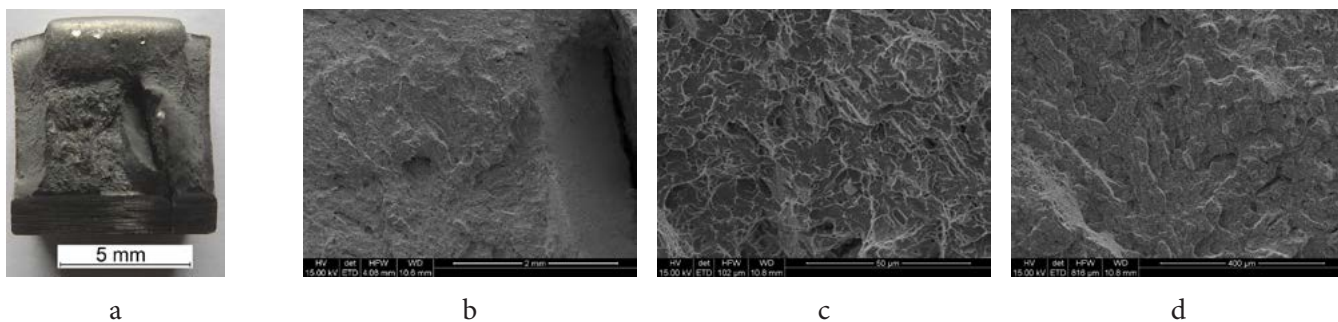
Fig. 23. Macrophotography of the specimen fracture (a, b) with a fractographic illustration: c – primarily plastic fracture; d – at the central part – mixed fracture

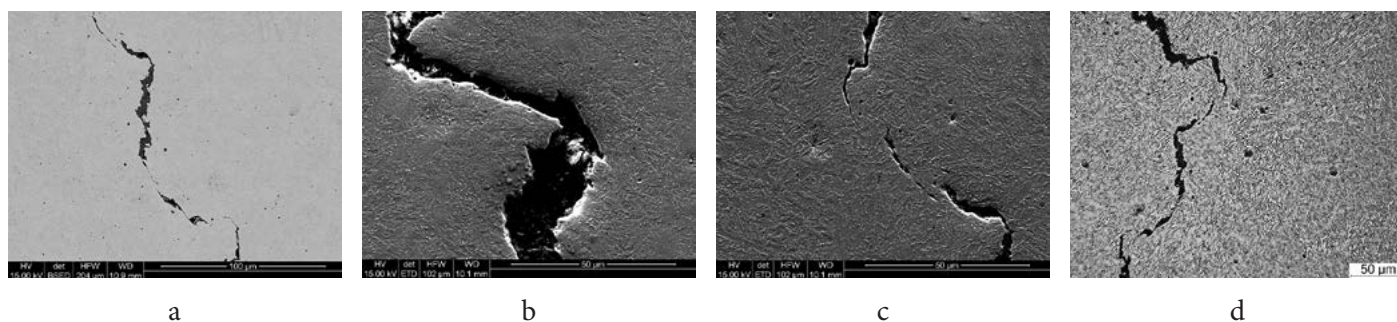
The side surface of the impact test specimen revealed the intercrystalline character of the crack (Fig. 24) (metal structure – bainite).

Fig. 24. Crack on the side surface of the impact test specimen

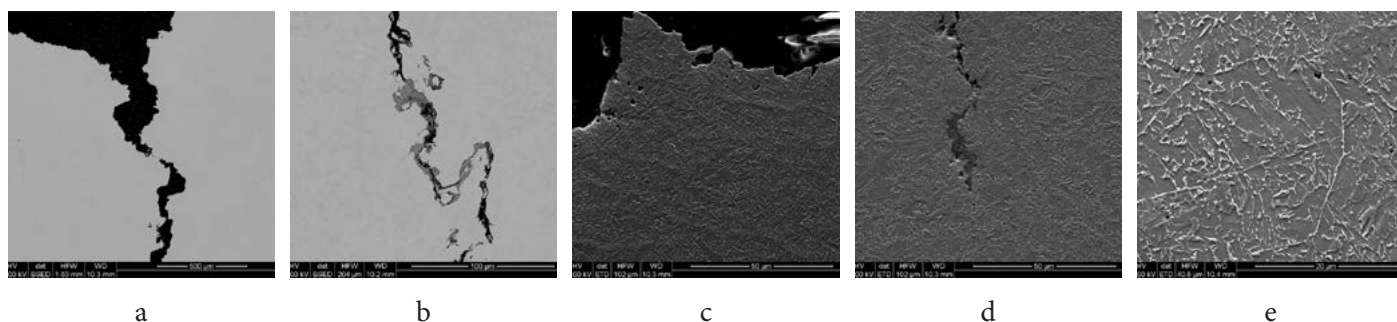
A fracture similar to that of specimen DX was also a slight crack: structure – bainite with precipitates of, probably carbides, along grain boundaries and slight amounts of tempered martensite. On the side of the metallographic specimen of specimen DX there was an intercrystalline crack.

Fig. 25. Crack on the side metallographic specimen – a, b; upper edge of the specimen – c; a crack in the bainite area – d; bainite with precipitates of, probably carbides, along grain boundaries – e
