Problems Accompanying Repairs of Chemical Equipment

Keywords: welding, steel SA204Gr.B, reheat cracking, boiler repairs

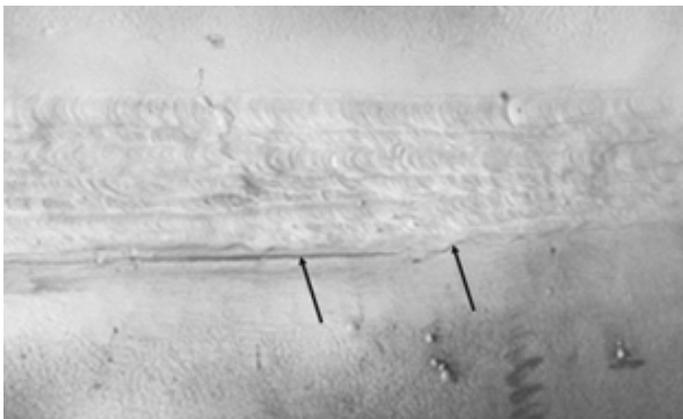
Ultrasonic tests performed after heat treatment revealed the presence of 13 discontinuities failing to meet acceptance level 1 in accordance with PN-EN ISO 15626:2014-01E. The depth of indications (from the weld face surface) determined using the ultrasonic method was restricted within the range of 7 mm to 14 mm. An exemplary crack observed under the face of the girth weld is illustrated in Figure 1.

Fig. 1. Girth weld with visible crack from the edge of the weld under the weld face (MT)

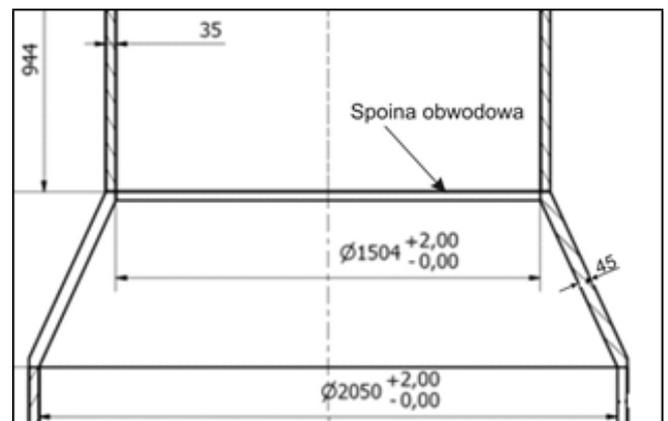
Fig. 2. Fragment of the upper part of the boiler shell with the girth weld (marked) containing the highest number of cracks

The analysis of the results of the ultrasonic tests performed before the repair revealed that most of the indications (cracks) were detected in the girth weld joining a 35 mm thick cylindrical element with a 45 mm thick conical element. The fragment of the boiler shell containing the weld subjected to analysis is presented in Figure 2.

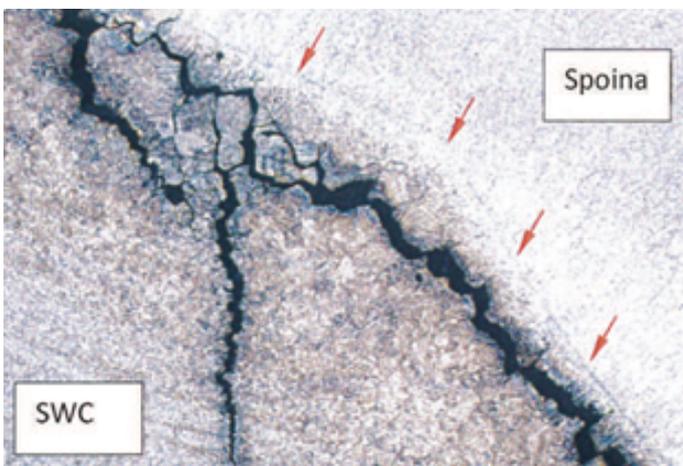
The specimen cut out of the joint were subjected to tests [1, 2, 3, 4] revealing that the material satisfied related requirements of the standards in relation to properties and structure. The material did not contain traces of degradation resulting from operational exposure to hydrogen atmosphere at higher temperature. As a result, there were no contraindications as to the further use of the material. Reports [1 and 3] contain photographic documentation confirming that cracking in the heat affected zone was of annealing (relaxation) nature. The cracks (and their nature) are presented in Figures 3 and 4.

In addition to the chemical composition, welding stresses were the primary factor responsible for cracking during heat treatment. Most of the stresses were located at the edge of the interface between the weld and the base material.

Fig. 3. Annealing crack formed in the coarse-grained area of the HAZ; fusion lines are marked with arrows [1]

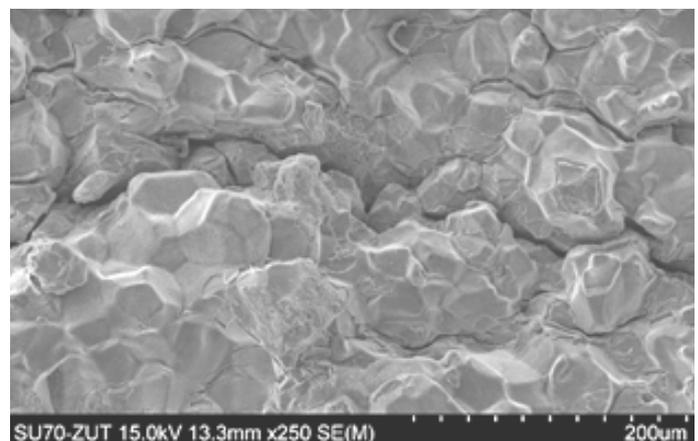
Fig. 4. Intercrystalline nature of reheat cracking [3]

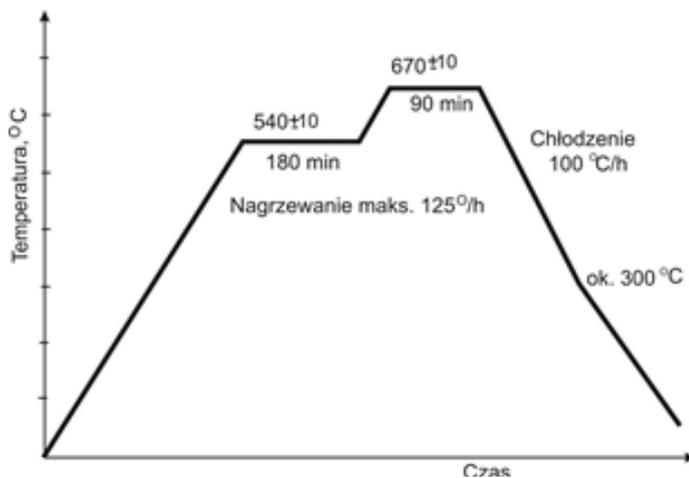
Fig. 5. Schematic diagram of heat treatment after the welding of 45 mm thick steel SA204Gr.B (Cr-Mo) susceptible to reheat cracking

Because of the fact that the chemical composition of a given steel grade is specified and cannot be modified, the only way enabling the reduction of cracking during heat treatment is by decreasing the level of welding stresses. This aim can be achieved by applying appropriate post-weld heat treatment. As regards steels susceptible to reheat cracking, stress relief annealing should be performed in two stages. Up to a temperature of approximately 550°C, welded joints should be heated slowly and held at the temperature for a time necessary for the partial relaxation of stresses. Usually, this time is twice as long as the time calculated from dependence $t = 2 \text{ min/mm}$ of the weld thickness. At the second stage, in order to obtain appropriate structure and continue the process of stress relaxation, the weld should be heated up to a stress relief annealing temperature restricted within the range of 680°C to 700°C. If only possible (to prevent cold cracking), post-weld heat treatment should be performed directly from the temperature of welding. A typical diagram of the stress relief annealing cycle following the welding of steel Cr-Mo or Cr-Mo-V is presented in Figure 5. The gradual heating to stress relief temperature involving a “stop” at a temperature of approximately 550°C was necessary to initially reduce the level of welding stresses and, consequently, minimise susceptibility to cracking during further heating up to the proper stress relief annealing temperature.

During the repair, the chemical composition of the boiler steel necessitated the use of a special welding technology involving the peening of runs and aimed to initially reduce stresses present in the weld. Post-weld heat treatment should be performed in two stages. The first stage of annealing should be carried out at temperature below that marking susceptibility to cracking (approximately 550°C). Annealing at the aforesaid temperature is accompanied by

the relaxation of stresses. The proper annealing temperature amounting to approximately 680°C is responsible for the further relaxation of stresses (to a low level) and enables the obtainment of desired plastic and mechanical properties.

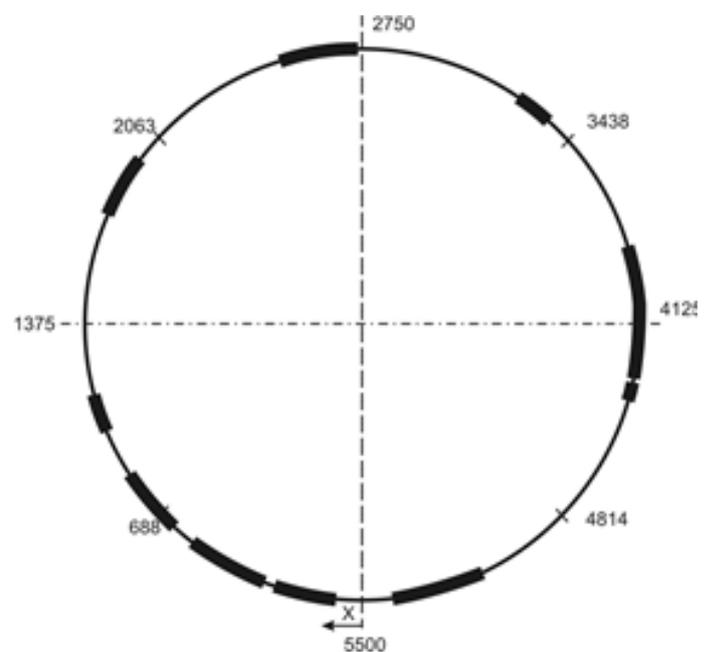
The report from CLDT-based ultrasonic tests [5] presents the location of imperfections around the perimeter as well as the length of the imperfections and their depth below the surface. The analysis was concerned with 11 cracks (indications) located, on average, 26.5 mm away below the surface. The relatively regular location of indications (cracks) around the perimeter is presented in Figure 6. The difference between the beginnings of indications was the multiple of a distance restricted within the range of 250 mm to 350 mm (i.e. the approximate distance between successive tack welds). The comparison revealed that the indications (cracks) were formed on the tack welds. The analysis of the weld macrostructure (Fig. 7) made it possible to determine the depth at which the root of the tack weld was situated and the manner in which beads were made. As the weld root was approximately 26 mm from the weld face, there was nearly ideal correlation between the location of the indications (cracks) and the position of the first (tack) back weld.

Fig. 6. Schematic diagram of the location of indications (cracks) and their length in the weld at a depth of approximately 26 mm

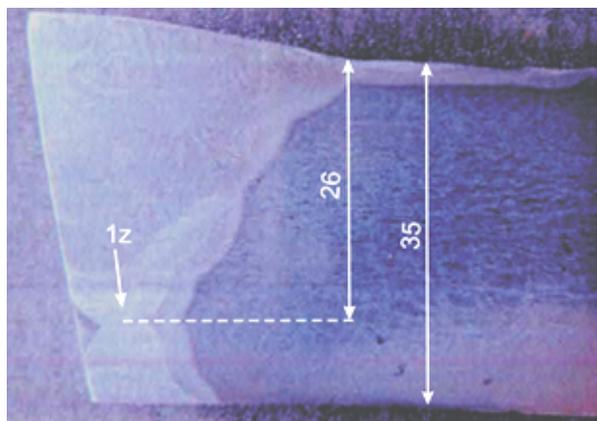
Fig. 7. Macrostructure of the weld fragment; 1z – first (tack) weld in the root; the macrostructure of the weld was obtained from report [2]

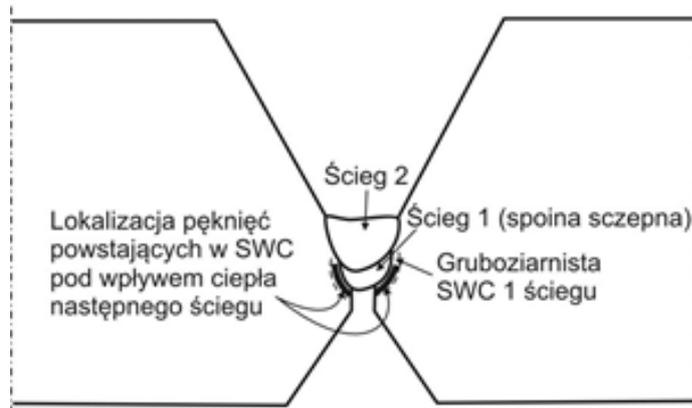
Fig. 8. Mechanism of relaxation crack formation when making the first runs in the root on the tack weld

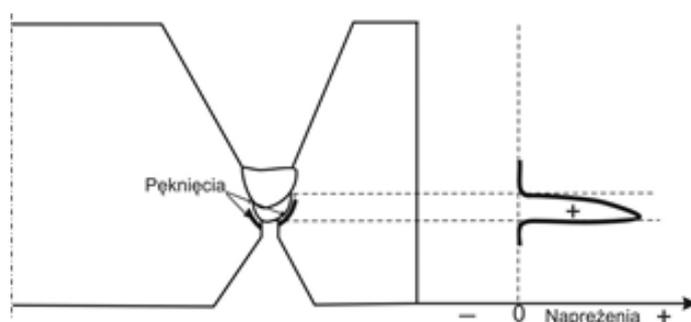
The analysis of the data related to the location and the size of indications (cracks) made it possible to identify the mechanism responsible for the formation of cracks in the weld root as early as during the making of the boiler. The mechanism of crack formation in the weld root is presented in Figure 9. The edges of the truncated cone and of the upper shell were subjected to non-uniform X-shaped preparation. Distances between successive tack welds made around the perimeter were restricted within the range of 250 mm to 350 mm. The heat affected zone of the tack welds near the fusion line contained the martensitic structure formed during post-weld cooling. Significant thicknesses (weight) of the elements subjected to welding combined with the small area of the tack welds generated very high tensile stresses in the area of the tack welds (Fig. 9).

Fig. 9. Schematic diagram of hypothetical stresses after the making of the tack welds

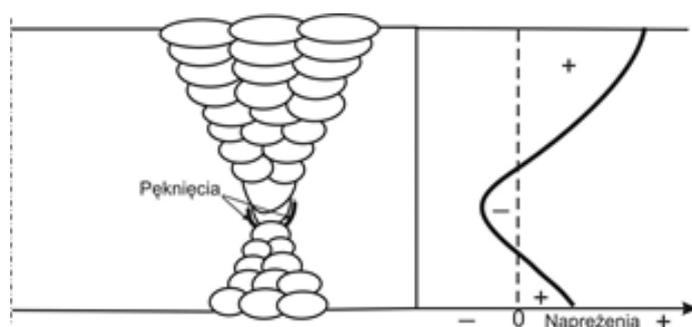
Fig. 10. Schematic diagram of stresses across the joint thickness of the making of the entire weld

Initially high tensile stresses in the zone of the first run were reduced by the shrinkage of the runs on the weld face side and the weld root side. As a result, the weld face area and the inside surface of the boiler contained significant tensile stresses, whereas the area of the tack welds and the first girth run contained compressive stresses. The aforesaid state of stresses did not translate into the further development of the existing cracks during the operation of the boiler.
