The Quality of Butt-Welded Joints in Steel Railway Bridges in Szczecin

DOI: <u>10.17729/ebis.2018.4/7</u>

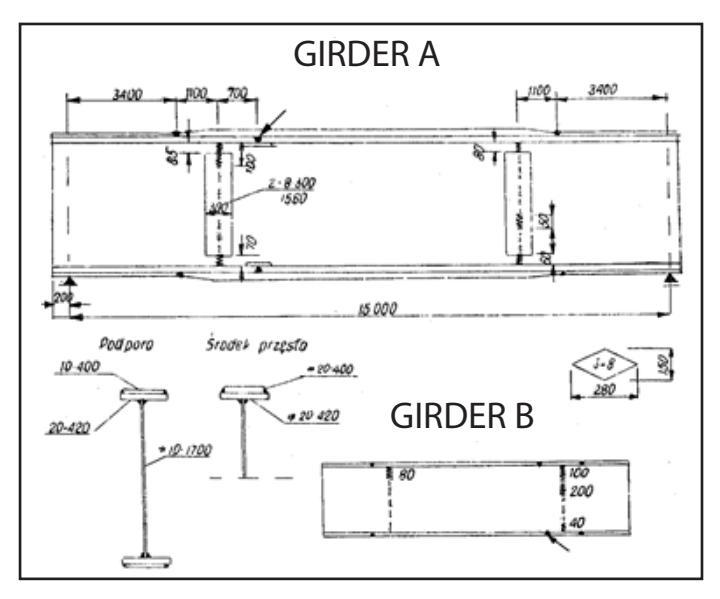
The above-presented number includes 141 segments of butt welds in the compressed zone and 136 segments of welds in the extended zone. One hundred and twenty two (122) X-ray photographs (14.9% of all of the photographs taken) revealed weld cracks of various lengths (Fig. 4). In addition to the cracks, the primary welding imperfections disqualifying the test welds included the lack of penetration and slag lines. Weld cracks were revealed in bridges number I, II and III built in the years 1935–1948 (see Table 1). Welds representing significantly higher quality were revealed in the bridges built in the years 1958-1977, i.e. number V-XI. Apart from one X-ray photograph in bridge number V, all the remaining 498 X-ray photographs of the above-named bridges revealed welds representing quality levels B+, B and C (99.8% of the photographs taken in the objects).

Fig. 4. Girders A and B of track no. 1 of bridge no. III with cracked welds [12]
