Detectability of Welding Imperfections in Non-Destructive PA and TOFD Ultrasonic Tests

Keywords: non-destructive tests, visual tests, ultrasonic tests, radiographic tests, PA, TOFD, welding imperfections, boiler steel P265GH

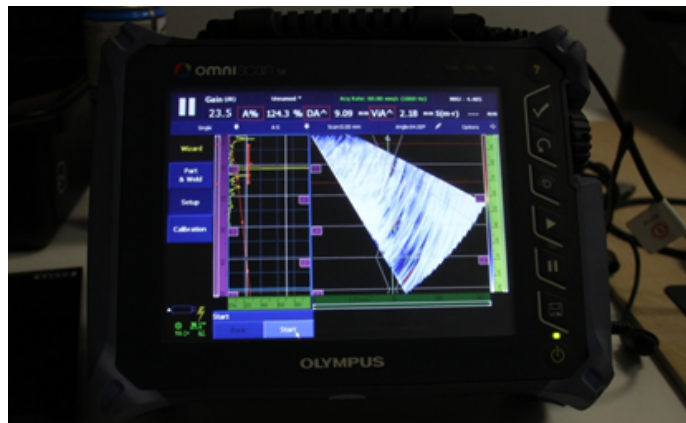
Fig. 2. OmniScan SX during phased-array ultrasonic tests (visible S-scan and A-scan)

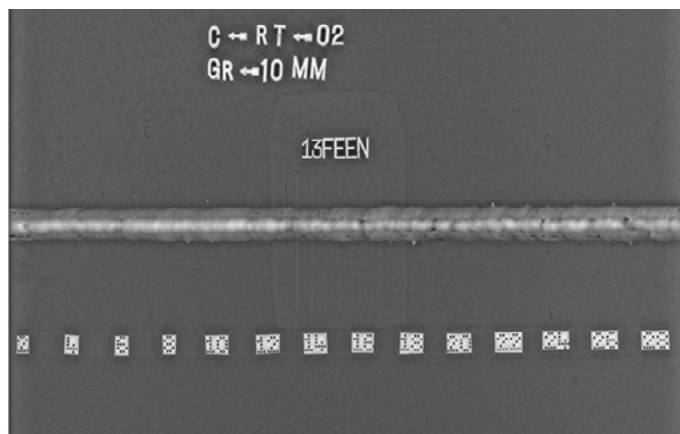
Fig 5. Radiogram of the joint subjected to tests – incomplete fusions were detected along nearly the entire length. It should be noted that the weld was turned horizontally by 180°. Therefore, in the above-presented image, the previously determined zero point is located on the right.

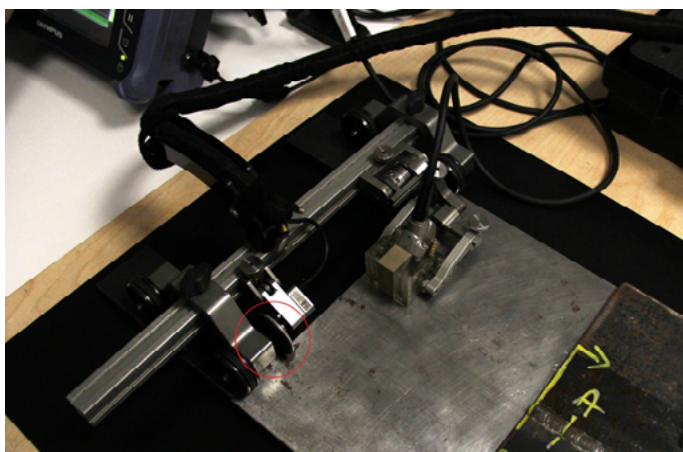
Fig 6. Standard master-based calibration process: run-out plates are located under the scanner wheels; the encoder is marked with the red colour

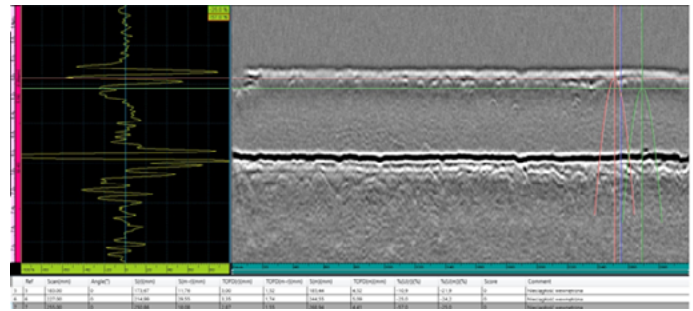
Fig.9. Defectoscopic image in the weld face test: A-scan (left) and B-scan (right)

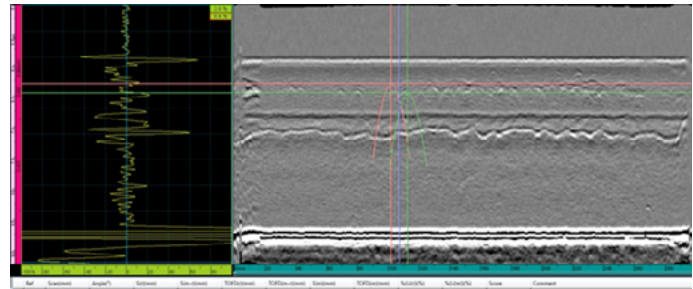
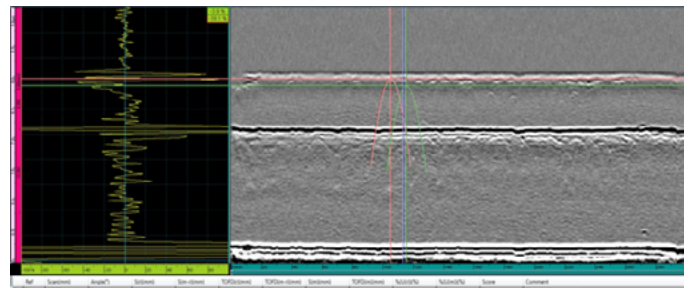
Fig. 10. Image of the same discontinuity from the weld face side (top) and the weld root side (bottom)
