## Determination of reasons for crack generation in hinge welded elements

**Abstract:** The purpose of the study was to determine reasons for damaging welded pins in hinge elements and to recommend activities which can limit the incidence of pins breaking out of hinges. In order to develop a welding technology ensuring a good and repeatable quality of joints it was necessary to analyse the previously used joining technology and a weld design as well as to carry out macroscopic metallographic tests, hardness measurements and observations of the fractures of damaged elements. On the basis of the tests conducted it was possible to develop a welding technology ensuring the required quality of joints.

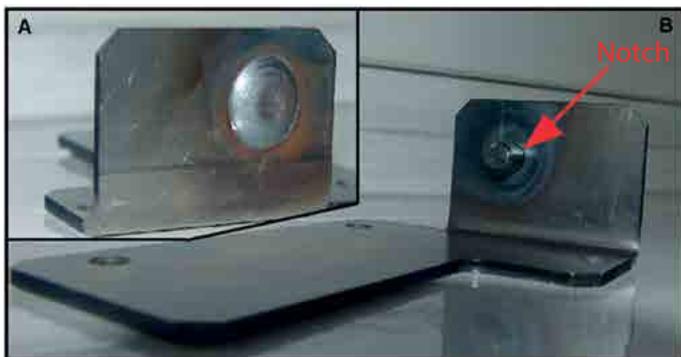
Fig. 2. Element of hinge directly after welding: A – view from plug weld face, B – view from pin (visible notch)

3.00 mm thick steel grade DC01 sheet (Fig.1, 2). By means of a special tool, a pin is placed 1.5 mm deep in the shape opening; next it is welded manually using the MAG method (plug weld). After making the joint, the face of the weld is subjected to grinding, the purpose of which is to obtain the required weld reinforcement height. Afterwards, the element undergoes electrogalvanising.

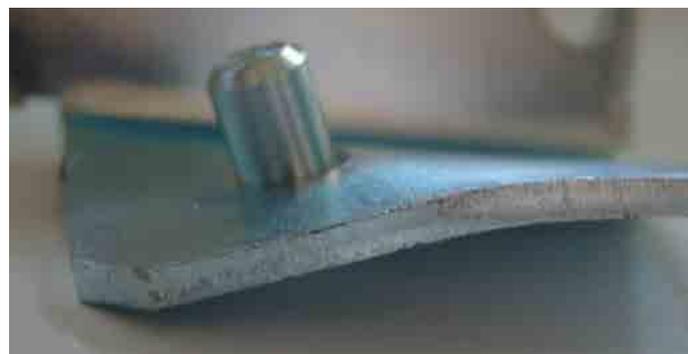
Fig. 4. Hinge element after workshop mechanical strength test; test result was positive

- hinges after welding,
- elements which were not broken or cracked during joint strength tests (Fig. 4),
- hinges damaged during workshop joint strength tests.

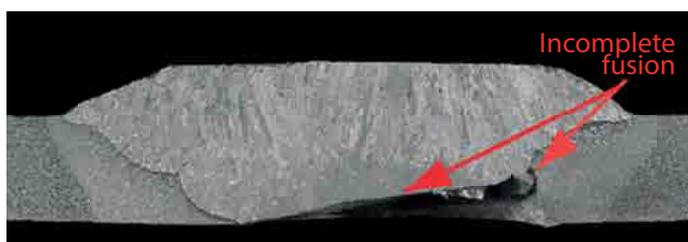
welded joint root (Fig. 8 and 9). The gaps, incomplete fusions and the inadequate joint penetration constituted a geometrical notch leading, under load, to cracking and resultant destruction of the hinge welded joint during the mounting of a gate or in the strength test.

Fig. 5. Macrostructure of sample no. 2. Mag. 6.5x

The metallographic specimens of the damaged samples revealed an inadequate joint penetration and incomplete fusions (Fig. 5 and 6). The excessive diameter of the opening in which the pin was placed is the reason for the generation of gaps in the

- hinge element damaged during gate mounting (sample no. 2, Fig. 5);
- element damaged during the workshop strength test (sample no. 3, Fig. 6);
- hinge meeting the requirements (sample no. 4, Fig. 7);
- hinge element which underwent allowed damage during the workshop strength test (sample no. 5, Fig. 8);
- element meeting the requirements, (sample no. 6, Fig. 9).

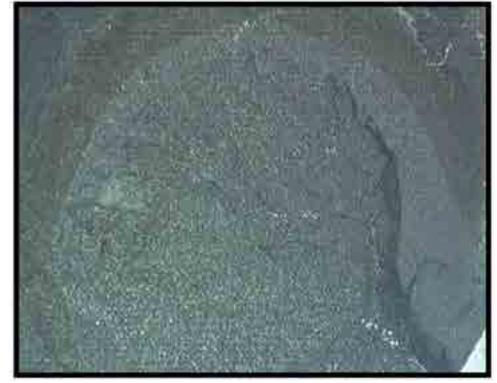
Afterwards, the fractures were observed by means of a stereoscopic microscope. It was revealed that the character of the fractures was brittle. An example of the fracture of sample no. 2 is presented in Figures 10 and 11.

On the fractures it is possible to observe the area of the pin material and the weld fragment. The fracture area underwent cracking due to an insufficient penetration depth, which might be attributed to improper welding technique and the excessive diameter of the opening in which the pin was positioned.

Fig. 10. Structure of fracture of sample no. 2:  
A: shape, B: pin, magnification 9.0x

Fig. 11. Structure of fracture of pin,  
sample no. 2, magnification 12x

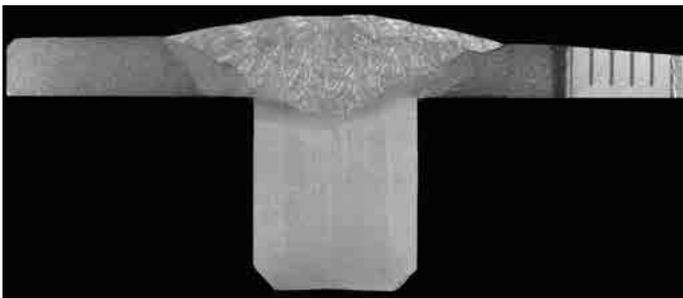
(Fig. 16, 17) present the macrostructures of the joints made by means of the modified welding technology and altered process parameters.

Fig. 16. Macrostructure of spot welded sample no. 18

Fig. 17. Macrostructure of spot welded sample no. 19

The welding tests involved the use of welding consumables (electrode wire and shielding gas) in accordance with a related Welding Procedure Specification. The tests conducted using the electrode wires with diameters of  $\varnothing 0.8$  mm,  $\varnothing 1.0$  mm and  $\varnothing 1.2$  mm revealed that a proper welding process (repeatable arc ignition precisely in the central part of the pin and a deep penetration) can be obtained by using a wire having a diameter of  $\varnothing 1.2$  mm. The tests involved making joints of pins with a diameter of 7.9 mm placed at different depths in the shape opening with a diameter of 10 mm and 8 mm. During the tests various current and welding times were used. The figures below

2. The proper penetration of a plug weld, satisfactory quality of the joint connecting a pin with a shape and the repeatability of a process can be obtained by means of spot welding based on the technology developed. Application of the technology entails the modification of the instrumentation fixing elements before welding and the reduction of the opening in the shape as well as the use of an electrode wire with a diameter of 1.2 mm.
