Robotic CMT arc braze welding of 10CrMo9-10 steel tubes with internal copper lining

Abstract: The article presents issues related to arc braze welding of tubes made of 10CrMo9-10 (10H2M) boiler steel lined inside with copper. In addition, the study points to possibilities of producing joints using conventional and innovative welding methods as well as presents results of radiographic, metallographic and mechanical tests (static tensile test, technological bending test, hardness measurements) of braze welded joints made using a robotic braze welding stand and the CMT (Cold Metal Transfer) method.

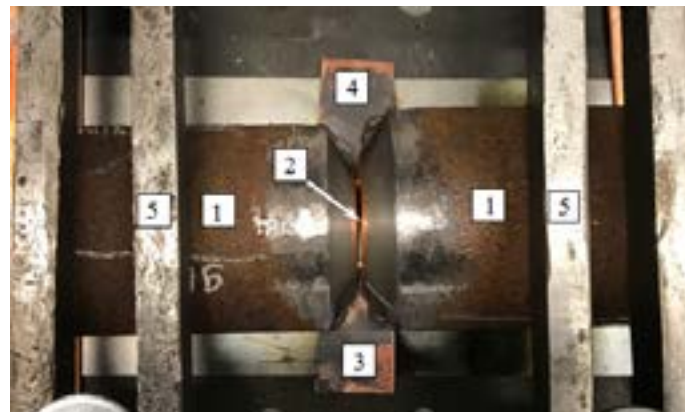
Fig. 5. Preparation of specimens for braze welding: 1- tube made of steel 10CrMo9-10, 2- lining made of Cu, 3- run-on sheet, 4- run-off sheet, 5- fixing clamp

not braze welded around the entire circumference but were cut across into four equal parts, i.e. 90 mm long quadrants. Afterwards, before the performance of braze welding tests, copper (run-on and run-off) sheets were TIG-welded to the specimens (Fig. 5).

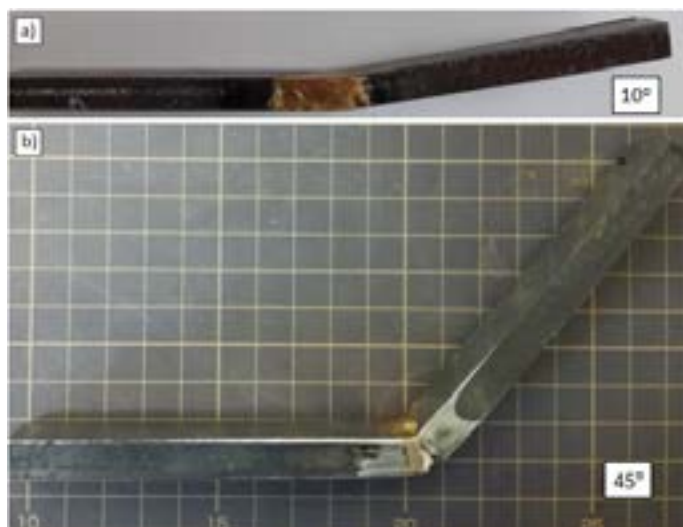
Fig. 13. Braze welded joint made in steel 10CrMo9-10 lined with copper after the technological bend test: flame braze welding (a) and CMT arc braze welding (b)

The tests obtained in the technological transverse bend tests also differed significantly and revealed that better results could be obtained using the CMT arc braze welding technology (Fig. 13). The bend test was performed until the appearance of the first cracks in the joint or in its vicinity. In relation to the CMT brazed welded joints, the bend angle was four times greater and amounted to 45°, which was a very good result given the significant thickness of tubes being joined and the use of the CMT arc braze welding technology.
