## Hardening Surfacing with Flux-Cored Wire Increasing the Service Life of Rotating Discs of Defiberiser for Mineral Wool Production

**Abstract:** The article discusses the MAG method-based surfacing of discs of a mineral wool defiberiser performed using self-shielded arc and submerged arc. In addition, the article presents results of tests concerning the service life of discs in relation to the chemical composition of the surfaced layer.

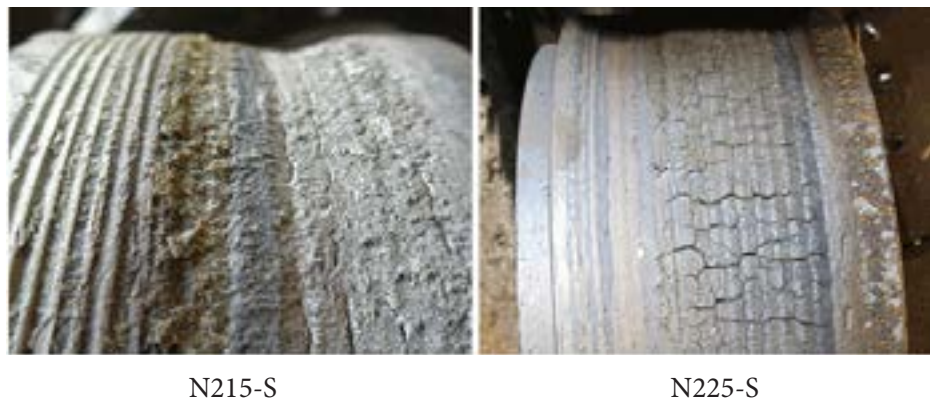
Fig. 1. Surfaces of discs surfaced using N215-S and N225-S after a period of operation

The test results revealed that in cases of surfacing processes performed using wires N215-S and N225-S, the discs were subjected to wear and the lattice of cracks was present in the areas of contact with the molten basalt mass. In

turn, the use of wire N225-S was accompanied by the increased wear of the disc surface and the formation of the lattice of annealing cracks in the above-named areas (Fig. 1). The most intensive wear could be observed in cases of the disturbed cooling of discs. The structure of the layer surfaced using flux-cored wire N215 was austenitic-ferritic, whereas that subjected to surfacing performed using wire N225 was ferritic-austenitic (Fig. 2).

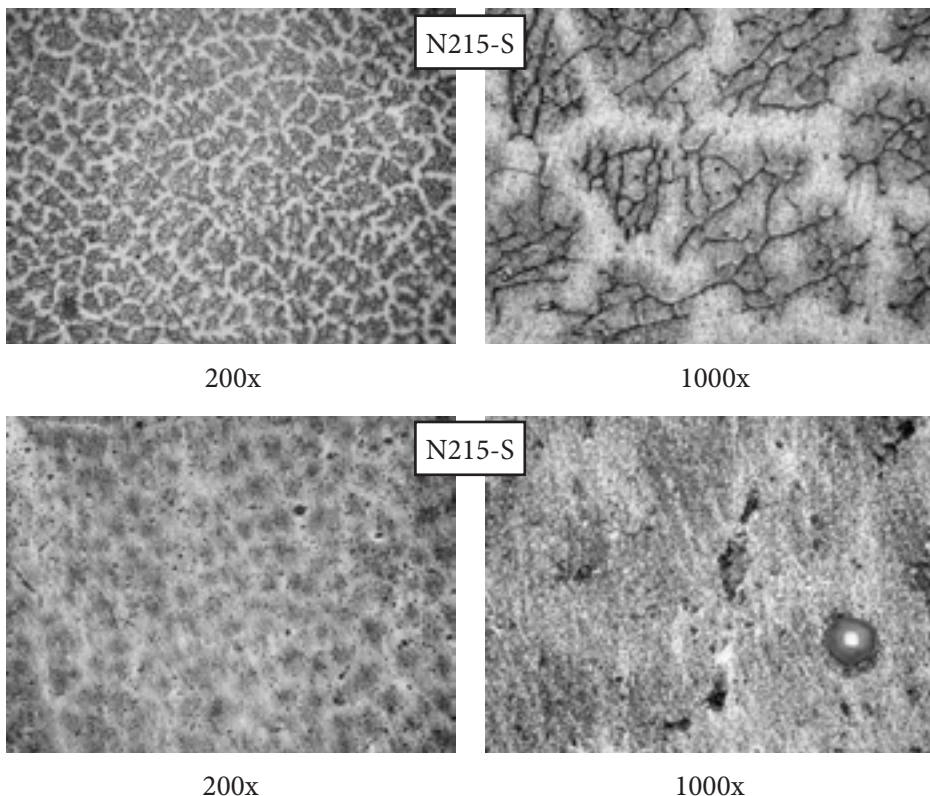
Fig. 2. Microstructure of the layer surfaced using wire N225-S and N215-S

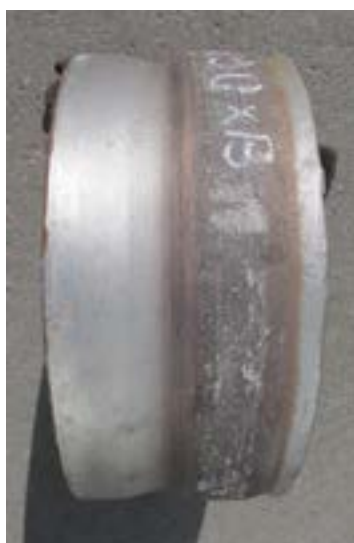
Fig. 3. Disc surfaced using wire N225.04-S after a period of operation

As regards wire N225.03-S, it was possible to notice the lack of wear location and minimum uniform wear along the entire work surface of the disc. During operation, the surfaced layer of the disc revealed the presence of transverse cracks. The cracks did not penetrate the base material of the disc. The outer face of the disc revealed slight wear without the formation of the lattice of annealing cracks (Fig. 3 and 4).

As regards wire N225.04-S, it was possible to notice the slight location of wear in the central zone of contact with the basalt alloy. The central zone of contact with liquid basalt and the outer face of the disc did not reveal the presence of annealing cracks or the lattice of annealing cracks.

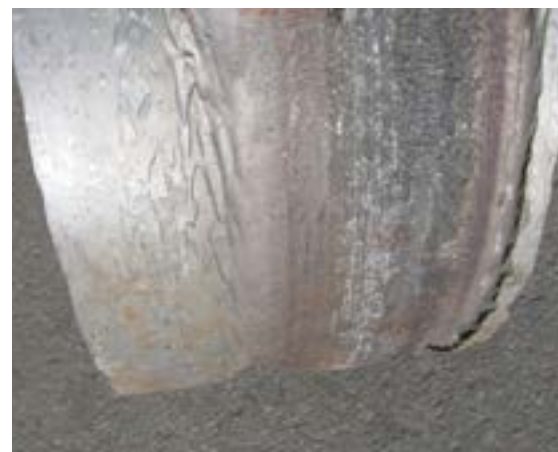
Fig. 4. Disc surfaced using wire N225.05-S after a period of operation

As regards wire N225.05-S, it was possible to observe a significant change in the shape of the wear of the disc surface in

the zone of contact with the liquid. The outer face of the disc revealed narrow and deep wear, whereas along the edge of the zone of contact with the basalt mass it was possible to notice a change in the shape of wear. The surfaced layer did not reveal the presence of transverse cracks.
