# Analysis of Low-Amplitude Indications in Ultrasonic Tests of Thick-Walled MAG-Welded Butt Joints

**Abstract:** The article presents an attempt at the clarification of low-amplitude indications, i.e. below the level of assessment, frequently detected in ultrasonic tests of welded joints. The above-named indications, non-evaluable in accordance with requirements of related standards used in ultrasonic tests, are often present in MAG-welded joints. The attempted clarification of the above-named exemplary indications required the performance of tests involving thick-walled MAG-welded butt joints.

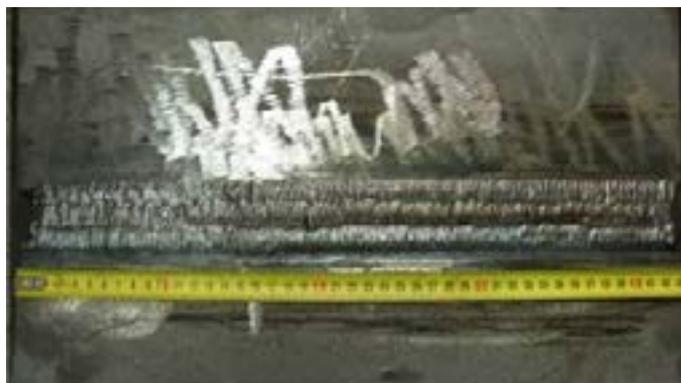
Fig. 3. Test joint (weld face side)

made following the above-presented guidance is presented in Figure 3.

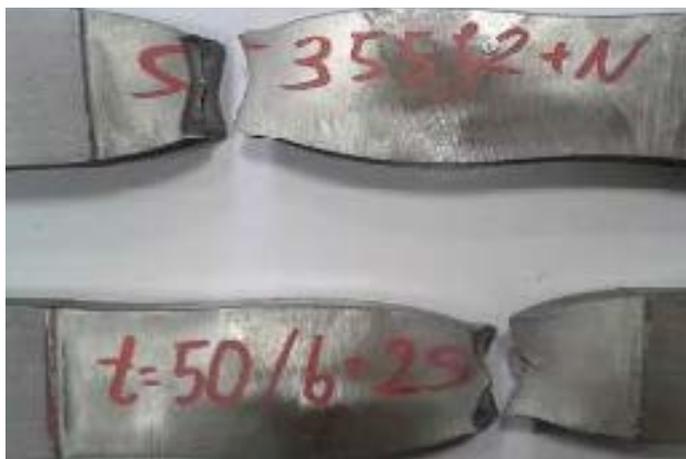
Fig. 6. Specimens after: a) tensile test, b) bend test (on the size the zone subjected to tension)

criteria (Table 4.). Similar to the two specimens after the side bend test, the visual inspection of the specimens after the tensile tests did not reveal the presence of material discontinuities or welding imperfections. However, the two subsequent specimens subjected to the bend test revealed the presence of slight laminar imperfections (less than 3 mm in length) in the specimen tension zone, or, more precisely, in the fusion line area. As can be seen, the requirements related to the welding technology test were satisfied. The specimens after the tensile test and the bend test are presented in Figure 6.

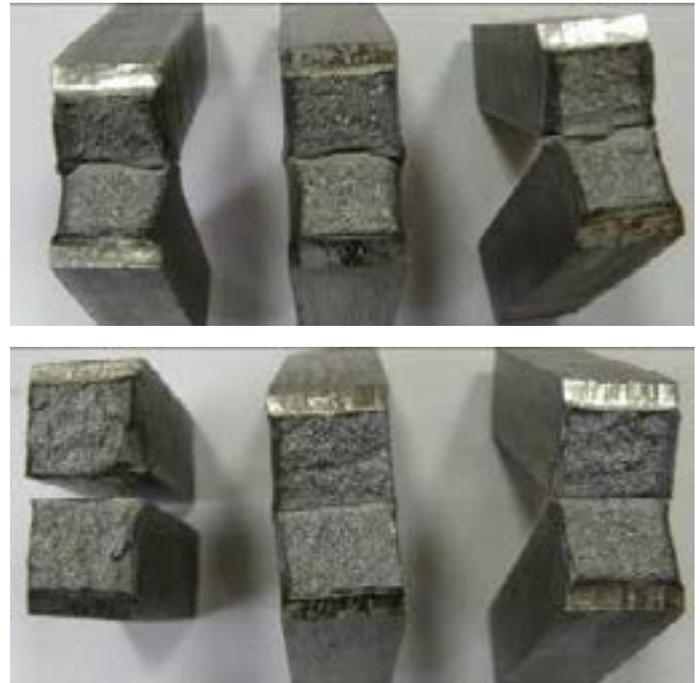
Fig. 7. Fractures of the fracture test in relation to: a) weld, b) HAZ

The impact strength tests were performed in accordance with the requirements of the standard Charpy V test at a temperature of -20°C. Specimens used in the tests were sampled from the bottom part of the joint, from all of the zones of the joint, i.e. the weld, HAZ 1 and HAZ 2 as well as the materials of the plates being joined. The obtained impact energy results restricted within the range of 35 J to 122 J demonstrated the favourable plastic properties of the test joint. The visual inspection of the specimen fractures did not reveal the presence of material discontinuities or brittle structure (see Figures 7a and 7b concerning the weld and the HAZ).

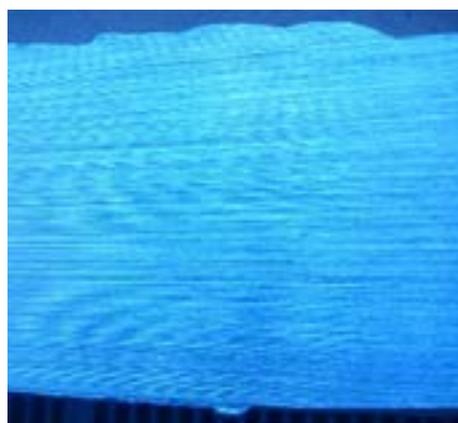
Fig. 9. Surface of specimen no. 1 directly after machine cutting

*The first specimen* was subjected to the visual test of the cross-section directly after cutting, followed by a dye penetrant tests and a fluorescent magnetic particle test in the internal magnetic field of the coil. Specimen no. 1 directly after machine cutting is presented in Figure 9.

The surface subjected to the visual tests did not reveal the presence of material discontinuities or welding imperfections. Identification proved impossible even after the application of magnification restricted within the range of 10 to 20 times. The identification was impeded by, among other things, surface roughness and numerous scratches left by machine cutting.

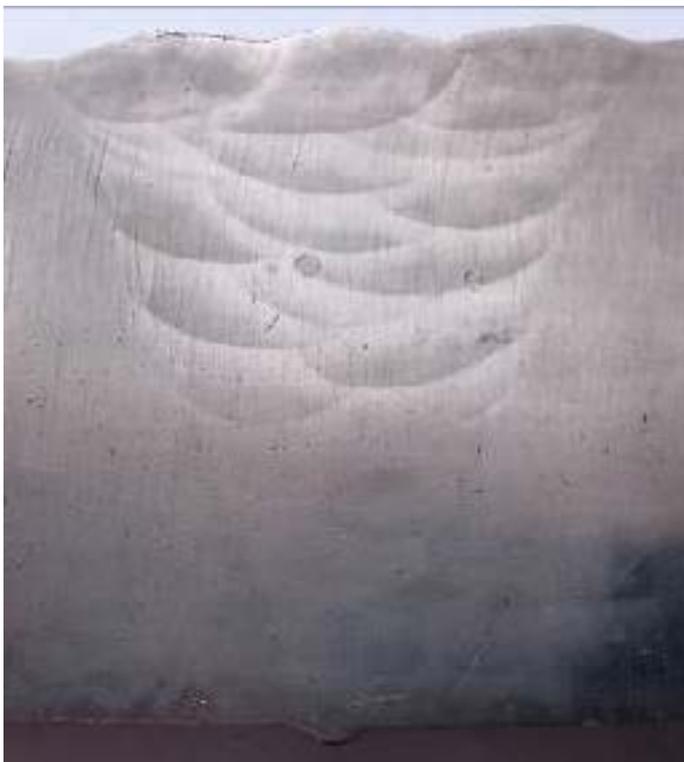
Fig. 11. Surface of the specimen after the macroscopic test and the penetrant test

*The second specimen* was sampled using the second cross-section and subjected to a macroscopic test. To reveal the joint structure in detail, the test surface (of the related cross-section) was subjected to grinding followed by etching. The surface was first subjected to a visual test followed by a penetrant test. Neither the visual nor the penetrant test revealed visible indications generated by material discontinuities or welding imperfections. The specimen after the penetrant test is presented in Figure 11.

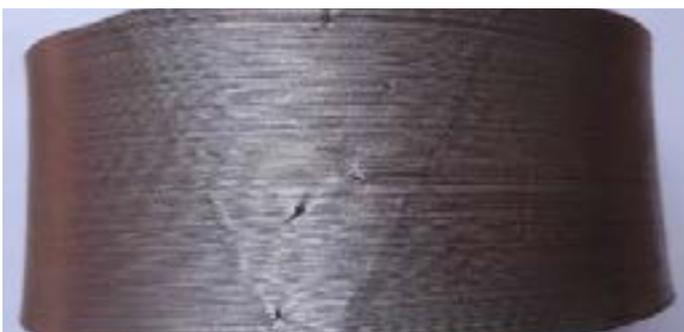
Fig. 12. Specimen after the side bend test visible from the surface subjected to tension

cross-section determined in the previously performed ultrasonic test. The angle obtained in the bend test amounted to  $180^\circ$ . The zone subjected to tension revealed the presence of five slight discontinuities being less than 3 mm in size. The visual tests preceding the bend test did not reveal the presence of discontinuities. They were revealed as late as during the bend test, as a result of the significant strain triggered by the tension accompanying the process of bending. The test result was positive and consistent with the required criteria in spite of the presence of several insignificant discontinuities. The specimen after the side bend test seen from the side of the surface subjected to tension is presented in Figure 12.
