The World's First Road Truss Welded Bridge in the Light of NDTs

Abstract: December 2018 marks the 90-th anniversary of the construction (1928) of the world's first road truss welded bridge (put into operation in August 1929). The bridge designed by Professor Stefan Bryła is a truss bridge with the deck below the arch, having a span length of 27 metres. The article discusses the technical condition of the bridge during non-destructive acceptance tests performed in 1929 and the results of diagnostic tests performed in 1958 and 1960 by the Gdańsk University of Technology and the West Pomeranian University of Technology in Szczecin.

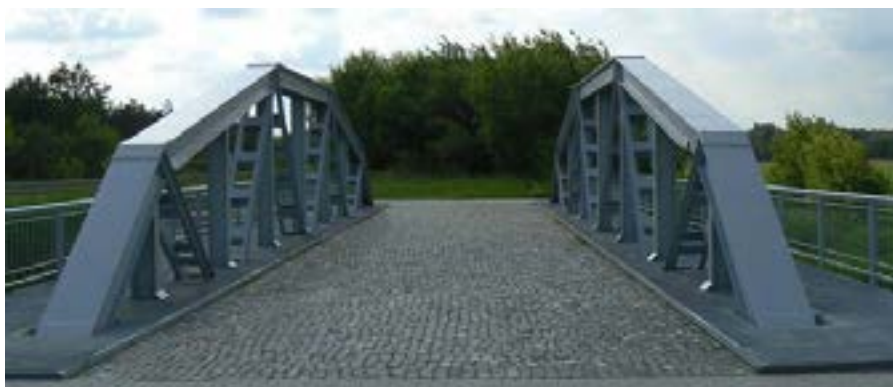
up the river by 25 metres. Initially, the bridge was used as a by-pass bridge during the construction of a new wider bridge. Presently, the bridge is a historic monument and an exhibit of great value (Fig. 1).

Fig. 1. Historic bridge in Maurzyce

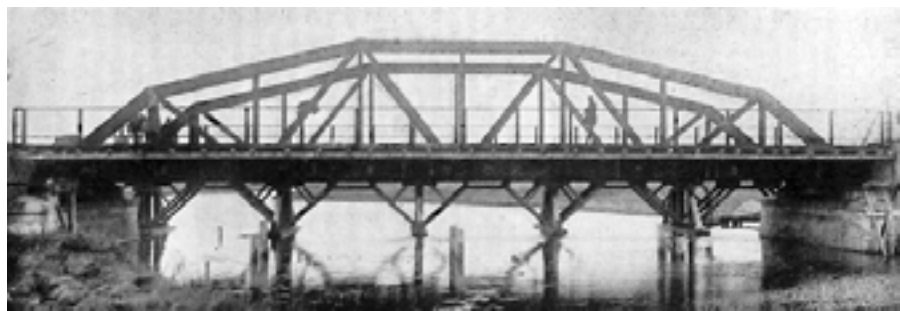
Fig. 4. Main view of the bridge during assembly in 1928 [8]

The assembly of the steel structure is presented in Fig. 4 and 5. The bridge span structure was made of cast steel characterised by strength restricted within the range of 370 MPa to 420 MPa and a minimum unitary elongation of 20%. Permissible strains in the steel adopted for the main girders amounted to 98.1 MPa, whereas those adopted for deck elements amounted to 81.5 MPa. The elements of the bridge structure were prefabricated at the K. Rudzki i S-ka Sp. Akc. (company) in Mińsk Mazowiecki.

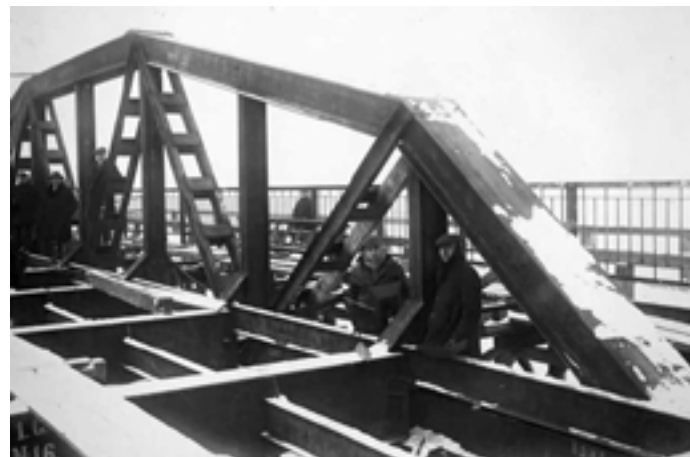
Fig. 5. Assembly of the bridge deck in 1928 [8]

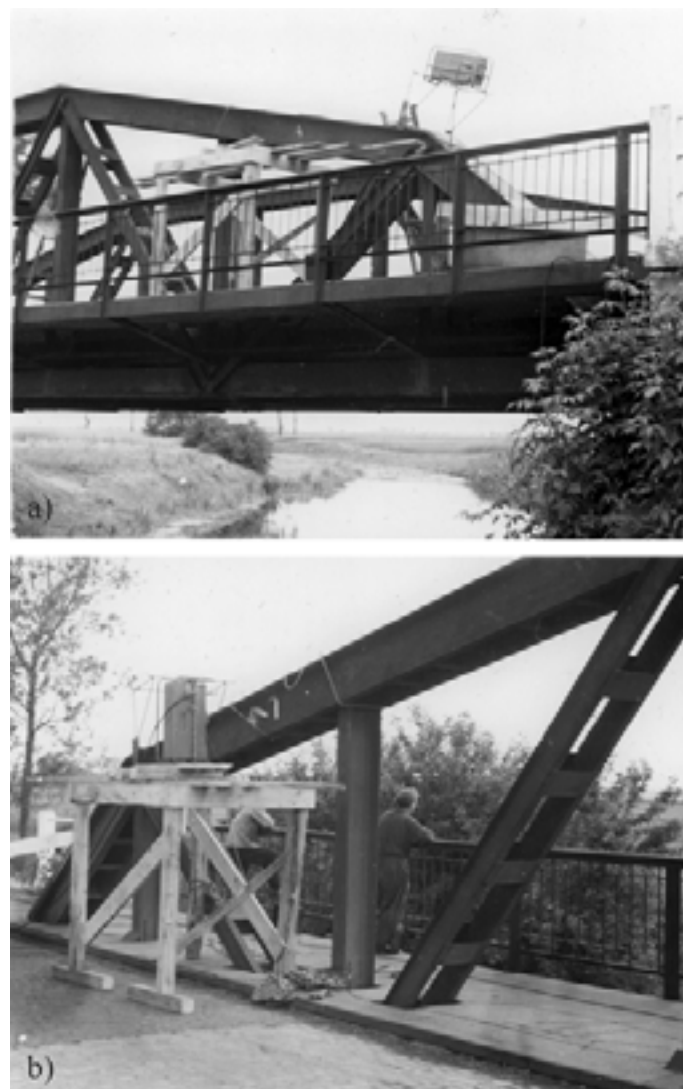
Fig. 7. X-ray tests of the butt joints of the upper chord: a) horizontal transverse weld; b) vertical weld

The X-ray photographs revealed the very low quality of the butt welds in the bridge structure. Out of 76 sections of the welds, as many as 72 contained welding imperfections representing quality level D or lower. The above-named number corresponded to 94.7% of the joints subjected to the tests. In turn, in 17 cases, welds contained longitudinal cracks. The aforesaid observations concerned particularly the horizontal transverse welds of the upper truss chords. The above-named welds (of thicknesses $t = 20$ and $t = 24\text{ mm}$) were covered by a one-sided shoe ($500\text{ mm} \times 20\text{ mm}$ in

cross-section). The welds contained 13 longitudinal cracks, which corresponded to 54.12% of the sections of the welds subjected to the tests.

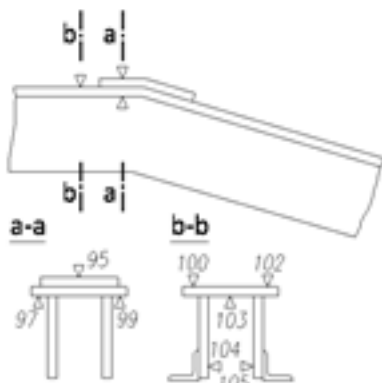
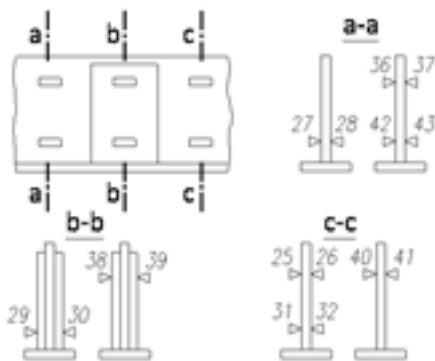
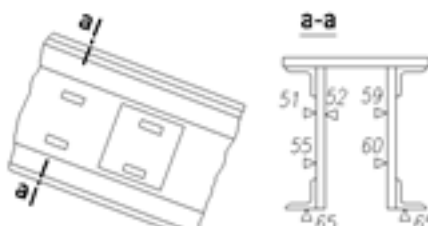
Node ¹⁾	Cross-section	Point no.	σ (MPa)			Arrangement of measurement points
			Measured	Mean	Calculated	
G3 (G2)	a-a gross	95	3.85	6.58	-

97	8.70			
		99	7.20			
	b-b net	100	11.62	11.80	11.30	
		102	11.30			
		103	11.50			
		104	13.10			
		105	11.50			
K2 (K3, M3)	b-b gross	29-30	4.08	3.94	-

38-39	3.80			
	a-a c-c net	25-26	8.04	8.23	17.3 (8.0) ²⁾	
		27-28	8.80			
		31-32	7.82			
		36-37	7.96			
		40-41	8.12			
		42-43	8.62			
M0	b-b gross	58-59-60	7.06	7.48	-

66	7.90			
	a-a net	51	11.50	11.45	9.8	
		55	11.25			
		65	11.60
