The Welding of Steel Road Bridges in the Past and Today

Abstract: The article discusses the construction of Europe's first welded bridge (over the river Śludwia in Maurzyce near Łowicz), design assumptions of the welded joints and the present condition of the welded joints made during the post-war repair of the bridge. For comparative purposes, the article presents today's welded solutions used in the footbridges of Most Szczytnicki (Szczytnicki Bridge) on the Stara Odra river arm in Wrocław. In addition, the article contains information related to the welding-based repair (if any) of structures of old riveted bridge structures.

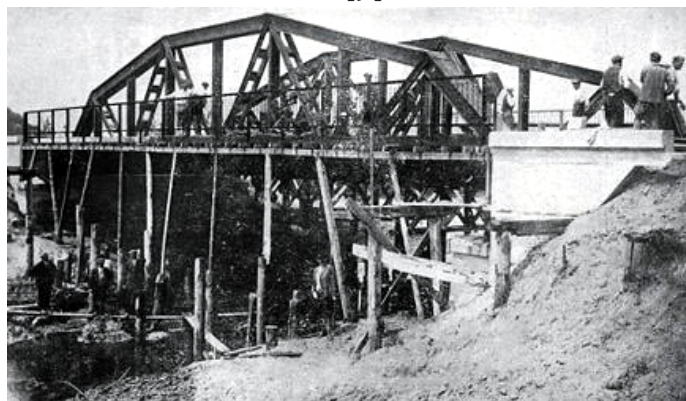
Fig. 3. Wooden scaffolding under the span of the bridge over the Słudwia river in Maurzyce [13]

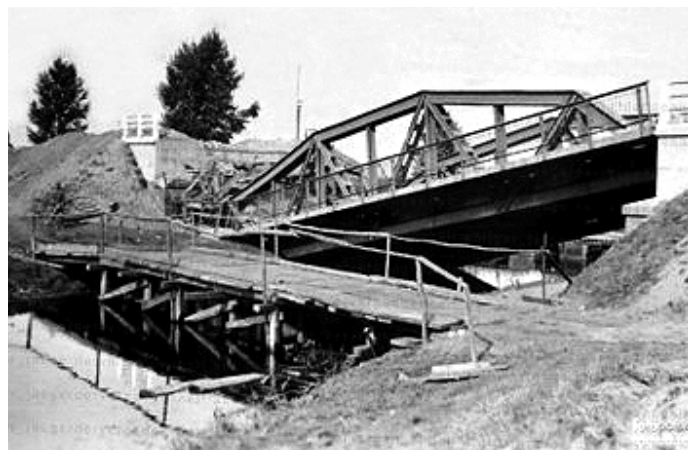
Fig. 4. Bridge damaged during the defence war in 1939 [13]

The bridge, commissioned in 1929, was in operation until the outbreak of World War 2. At the second stage of the battle of Bzura (13–15 September 1939), the troops of the “Poznań” army when retreating towards Warsaw blew up the bridge support shoes on the right bank of the river and, consequently, also destroyed extreme segments of the upper and lower flanges so that the entire bridge structure on this side fell into the river with the opposite side of the bridge remaining on its bearings (Fig. 4).

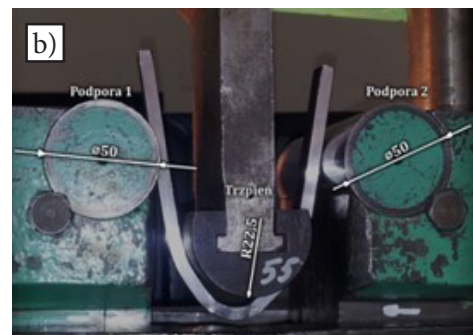
Fig. 7. Specimen in the bending test of butt welded joints, reverse system of bending probes (a), present-day technological bend test (b)

(b) specimens used today. Figure 7 presents the bending of the specimens, whereas Figure 8 presents stages of the preparation of a specimen for a weld elongation test.

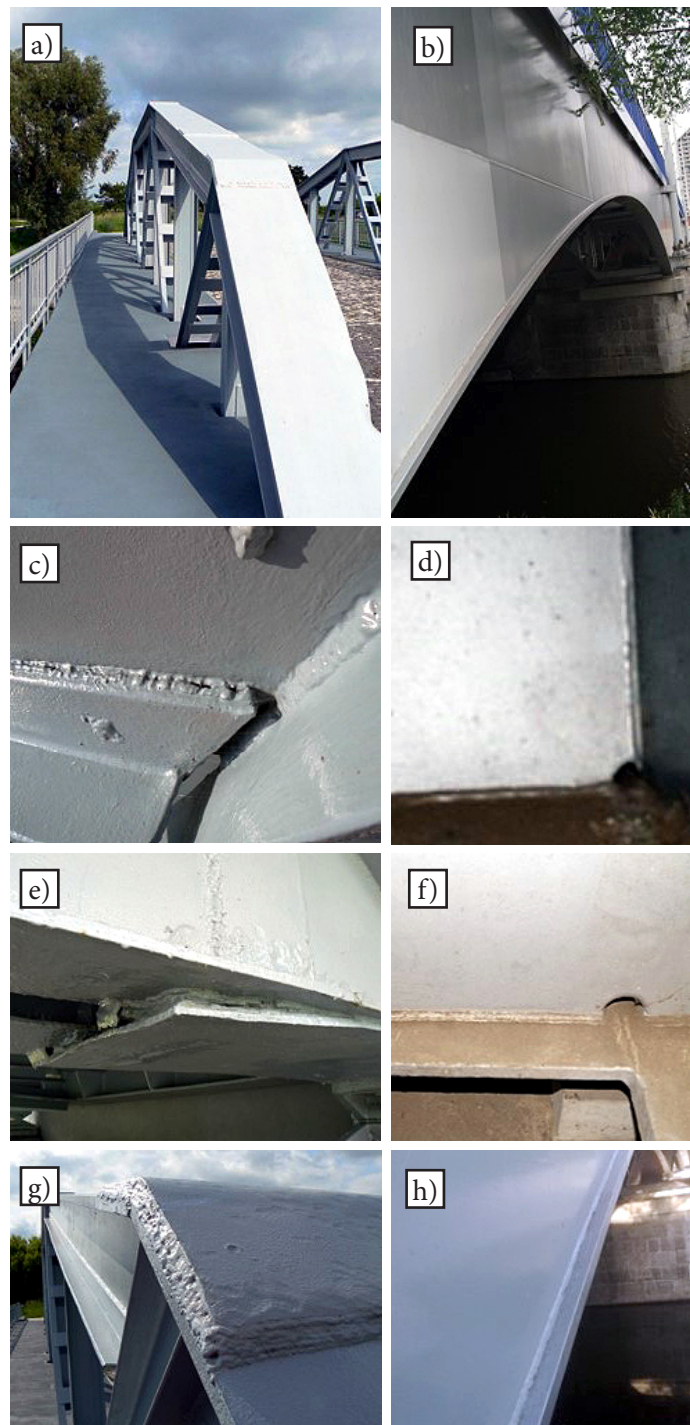
Fig. 10. Welded joints of load-carrying structures: the bridge over the river Słudwia in Maurzyce (a, c, e, g) and the footbridge on the Szczytnicki Bridge in Wrocław (b, d, f, h)

Figure 10 presents the welded joints of the load-carrying structures of the bridge over the river Słudwia before and after WW2 and the welded joints of the footbridge on the Szczytnicki Bridge over the Stara Odra river arm in Wrocław, subjected to retrofit in the years 2006-2008.
