Quality Criteria for G3Si1 and G4Si1 Electrode Wires

Abstract: The article presents test results concerning the quality of ISO 14341-A-G₃Si₁ and G₄Si₁ electrode wires based on electrode wire-related quality criteria in accordance with the requirements specified in the PN-EN ISO 14341 and PN-EN ISO 544 standards. The article discusses the critical defects of the wires (non-conformities with standard requirements) as well as defects not covered by the requirements of the standards, yet decisive as regards the assessment of electrode wires by the user.

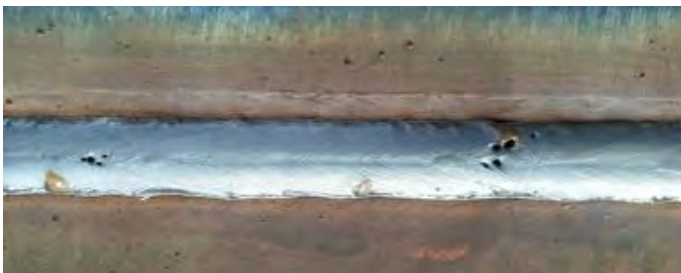
Fig. 1. Surface porosity of the MAG butt weld made using the EN ISO 14341-A-G 46 4 M21 3Si1 wire no 61; quality level NSD

wire EN ISO 14341-A-G 46 4 M₂₁ 3Si₁ no. 61 failed to meet the requirements of the PN-EN

ISO 14341 concerning the 3Si1 wire in relation to contents of manganese (0.46% instead of 1.3–1.6%) and silicon (0.03% instead of 0.7–1.0%),

The complaint was justified by radiographic test results concerning welded joints made using the above-named wires (quality level NSD) as well as visual test results and fractographic test results concerning fillet welds (Fig. 1 and 2).

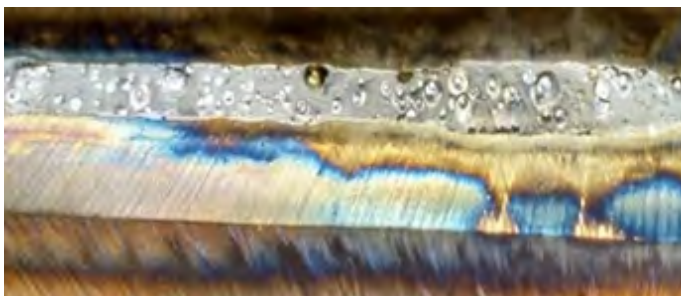
Fig. 2. Gas pores in the fracture of the MAG fillet weld made using the EN ISO 14341-A-G 46 4 M21 4Si1 wire no. 62 (a) and the sketch of a test joint (b)

- wire EN ISO 14341-A-G 46 4 M21 4Si1 no. 62 failed to meet the requirements of the PN-EN ISO 14341 concerning the 4Si1 wire in relation to contents of manganese (0.50% instead of 1.6–1.9%) and silicon (0.041% instead of 0.8–1.2%).

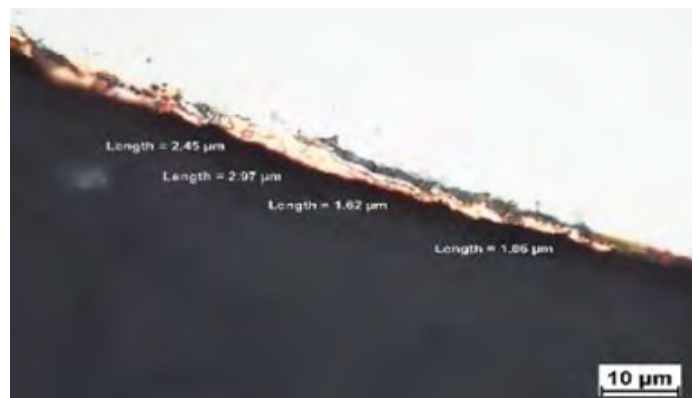
Fig. 3. Fragment of the cross-section of wire no. 3_04/20 – visible impurities under the copper coating; thickness of the copper coating restricted within the range of 1.06 μm to 2.97 μm

The reduction of oxygen and hydrogen contents after the removal of the coating indicated the presence of organic impurities (technological lubricants) (Fig. 3) under the coating of the wire. For comparison, Table 1 presents results concerning the contents of gases in wire no. 2, representing quality level B (in terms of weld porosity). It should be noted that the PN-EN ISO 14341 standard does not specify requirements related to contents of gases in electrode wires.

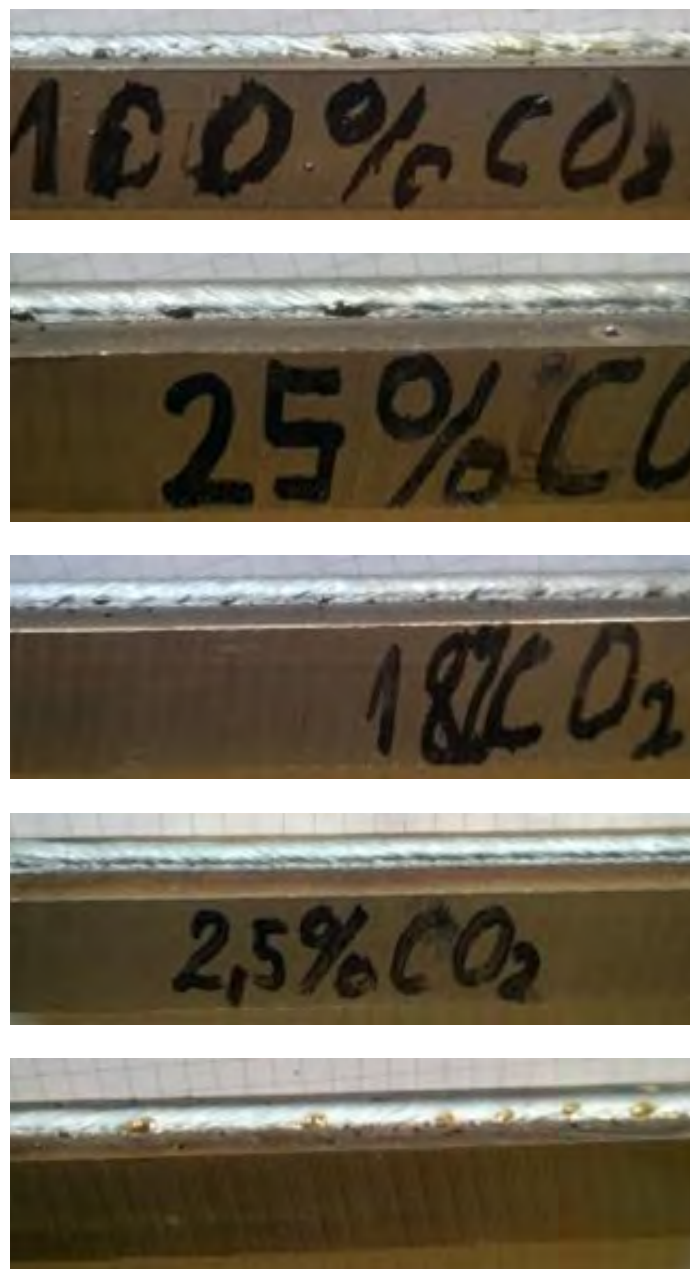
Fig. 4. Slag islets on the surface of the padding weld (side view) made using the following shielding gases:
 a) CO₂ (I₀ = 100) b) Ar + 25% CO₂ (I₀ = 25);
 c) Ar + 18% CO₂ (I₀ = 18); d) Ar + 2.5% CO₂ (I₀ = 2.5);
 e) Ar + 8% O₂ (I₀ = 4)

In turn, islets of slag (welding imperfection) on the surface of the beads made using the MAG method (slag residue in accordance with PN-EN ISO 6520-1) are usually associated with the improper chemical composition of the electrode wire. Slag is composed of oxidation products formed as a result of metallurgical reactions taking place in the zone of welding arc and of the weld pool. According to publication [5], the products of such reaction “are partly removed as welding fumes, partly form slags, whose parts coagulate and come up to the surface forming slag islets and partly remain in the weld as non-metallic inclusions”. According to publication [6], non-metallic inclusions are primarily composed of oxides: SiO₂-MnO-Al₂O₃. During the CO₂ + O₂ mixture-shielded welding process, the slag contained 29–32% SiO₂, 23–25% Fe₂O₃, 40–42% MnO and 3–4% Fe_{met.} [8]. The number and the size of slag islets depended not only on the chemical composition of the electrode wire but also on the welding process parameters and the composition of the shielding gas. The conclusion presented above was confirmed by results of surfacing tests involving the use of the ISO 14341-A-G4Si1 wire (φ 1.2 mm), welding current restricted within the range of 210 A to 220 A, arc voltage restricted within the range of 21 V to 23 V, a welding rate of 40 cm/min and a gas shielding of varied oxidation index I₀ (Fig. 4).

The test welding process performed using the ISO 14341-A-G4Si1 wire and a gas shielding having oxidation index I_0 ($I_0 = 1/2 O_2 + CO_2$ [5, 8]) (within the range of 100 to 2.5) revealed that presence of slag in all of the padding welds. The highest amount of slag was observed in relation to the CO₂-shielded welding process (Fig. 4a), whereas the lowest amount of slag was formed when the welding process was shielded using the Ar+2.5%CO₂ mixture (Fig. 4d). However, a change of the shielding gas did not entirely prevent the formation of slag in the weld face. The formation of slags during welding was connected with the specific nature of metallurgical processes accompanying the MAG welding process [8] and did not indicate the improper chemical composition of the wires (i.e. inconsistent with the requirements of the PN-EN ISO 14341 standard).

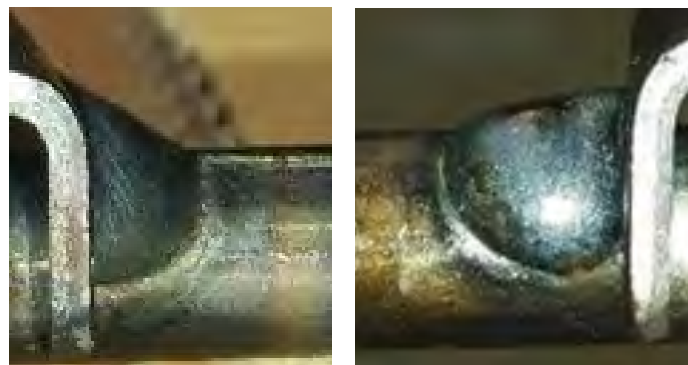
Fig. 5. Proper (a) and improper (b) shape of the support fillet weld

The excessive lift is accompanied the “helical” unwinding of the wire, i.e. where the wire leaving the contact tube moves in various directions away from the contact tube axis. The aforesaid situation could lead to bead shape and dimension-related imperfections, incomplete fusion, incomplete root penetration etc. Figure 5b presents an example of the excessive asymmetry of the fillet weld (imperfection 512 in accordance with PN-EN ISO 6520-1) caused by the deviation of the wire tip from the contact tube axis during the MAG robotic welding of support elements.

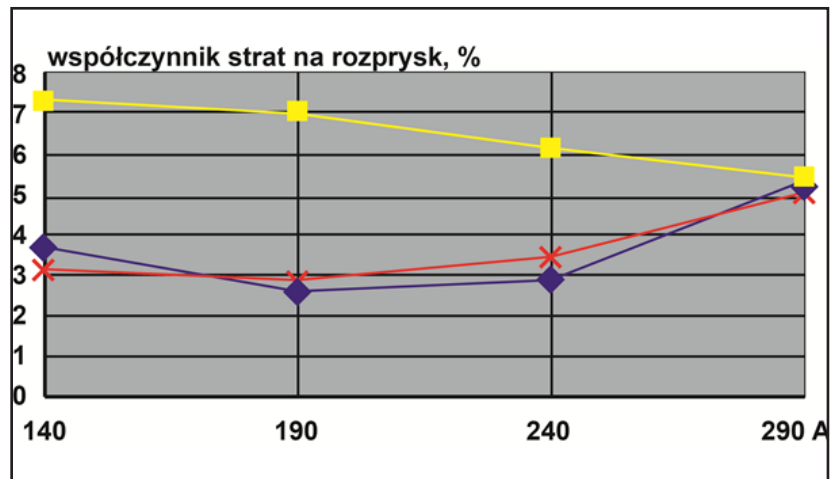
Fig. 9. Correlation between the coefficient of spatter-related losses and welding current: \blacklozenge – wire no. 619, \blacksquare – wire no. 623, \times – wire no. 604 (wire ISO 14341-A-G3Si1, shielding gas ISO 14175-M21-ArC-18)

Measurements concerning the coefficient of spatter-related losses (Ψ_r) of tens of ISO 14341-A-G3Si1 wires (having a diameter of 1.2 mm) in relation to welding parameters (mechanised welding; a KEMPPI PRO 5000 semi-automatic welding machine) and welding current (restricted within the range of 100 A to 340 A) revealed that $\Psi_r = 2.3\text{--}87\%$ in relation to 56.6% of the wires (evaluated as good, example in Fig. 9), $\Psi_r = 5.9\text{--}12.3\%$ in relation to 37.7% of the wires (evaluated as satisfactory) and $\Psi_r = 7.0\text{--}15.5\%$ in relation to 5.7% of the wires (evaluated as unsatisfactory). The overlapping ranges of coefficient Ψ_r resulted from the scatter of spatter during the welding process performed using a specific electrode wire and a preset welding current range. According to users (welders), the welding process performed using wires from group $\Psi_r = 7.0\text{--}15.5\%$ proved unstable and the wires were the subject of a complaint. Excessive spatter is a wire-related defect, yet it is not mentioned in a standard.

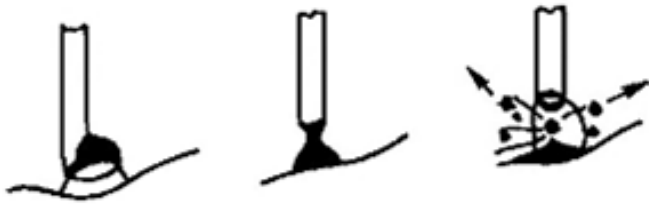
Fig. 11. Spatter resulting from the distribution of droplets following the rupture (explosion) of area reduction [12]

Fig. 12. Spatter resulting from the distribution of droplets from the wire in relation to higher short circuit current values [12]

maximum values of short circuit current in individual current waveforms, at moments when arc burning stability was disturbed. In relation to identical average values of welding current, the maximum values of short circuit current were higher as regards wire no. 6F than wire no. 7W. The foregoing explains the differences related to the size of spatter (Figures 11 and 12).

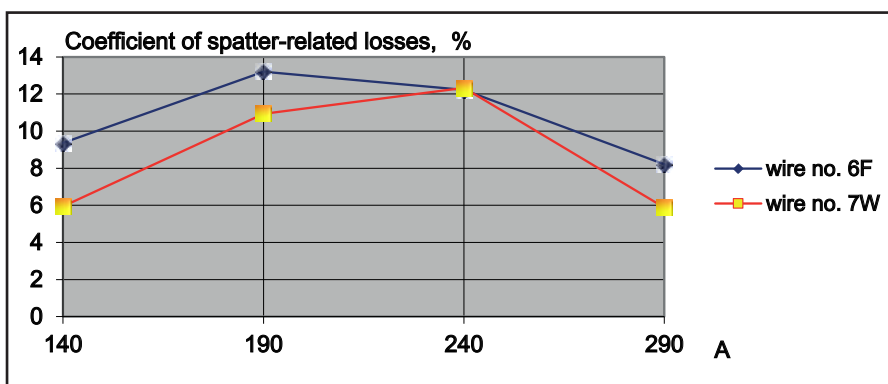
Fig. 13. Correlation between the coefficient of spatter-related losses and welding current during welding performed using wire no. 6F and no. 7W

no. 7W. The average value of the coefficient of spatter-related losses, identified on the basis of three measurements for a given welding current value, is presented in Figure 13.

The nature of the correlation between the coefficient of spatter-related losses and welding current restricted within the range of 140 A to 290 A was identical in relation to both wires. In relation to a current of 140 A and that of 190 A, wire no. 6F was characterised by the higher coefficient of spatter-related losses than wire no. 7W. In relation to a current of 240 A, the value of the coefficient was nearly the same. In turn, in relation to a current of 290 A, wire no. 6F was characterised by the higher coefficient of spatter-related losses than wire no. 7W.
