# The Development of a Technology for the Conventional Welding of Butt Joints (of Membrane Walls) of Composite Tubes

**Abstract:** The article presents results of tests leading to the development of a technology enabling the welding and conventional cladding (methods 141/111) of butt joints of composite tubes made of Sanicro 38/4L7 (nickel alloy/carbon steel) and 3R12/4L7 (stainless steel/carbon steel). In addition, the article discusses process parameters used in the welding of the inner layer and in the cladding of the outer layer of the tube made of Sanicro 38 and 3R12. The article also presents results of macro and microscopic metallographic tests of the joints.

**Keywords:** butt joints, membrane walls, conventional cladding

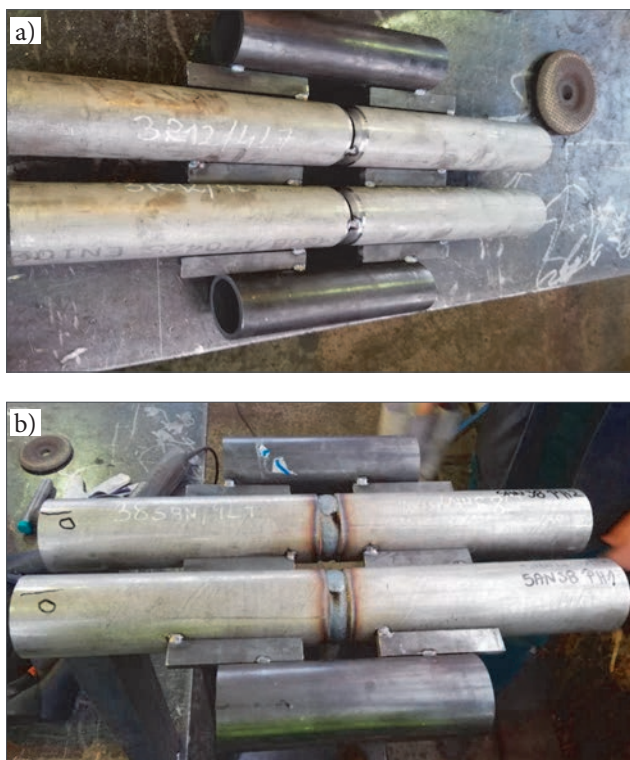
Fig. 4. Weld face view of the joints obtained using the conventional welding process: a) tube 3R12/4L7 and b) tube Sanicro 38/4L7

The test joints are presented in Figure 4.

The welded joints were subjected to visual tests and assessment performed in accordance with the requirements of the PN-EN ISO 6520:2009 and PN-EN ISO 5817 standards [6, 7]. The visual tests revealed that the joint of tubes 3R12/4L7 and Sanicro 38/4L7 was characterised by the uniform and spatter-free weld face and the properly shaped weld root around the entire circumference. The joints represented quality level B in accordance the quality requirements of the PN-EN ISO 5817:2014 standard [7].

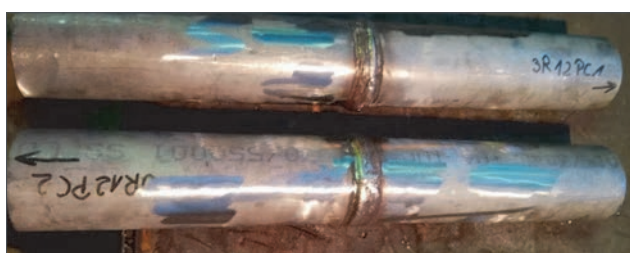
Fig. 5. Weld face view of the joint after the cladding process - tube 3R12/4L7

The overlay welds made using welding method 111 are presented in Fig. 5.

performed in accordance with the requirements of the PN-EN ISO 6520:2009 and PN-EN ISO 5817 standards [6,7]. The visual tests revealed that the overlay welds were characterised by a proper geometric shape (Fig. 5). The joints represented quality level B in accordance with the quality requirements specified in the PN-EN ISO 5817:2014 standard [7].

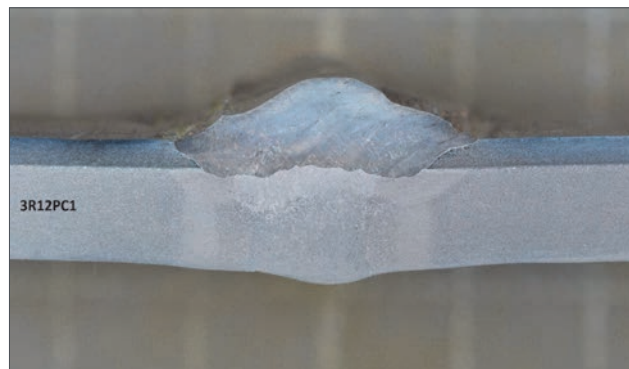
Fig. 6. Macrostructure of the overlay weld of Sanicro 3R12/4L7; external layer was obtained using the cladding process and rutile electrode Cromarod 309MoL

Figure 6 presents the macrostructure of the joint of tube Sanicro 38/4L7. The macroscopic tests did not reveal the presence of internal welding imperfections.
