# Corrosion Resistance of Laser Beam Welded Joints in Ferritic Stainless Steel

**Abstract:** The primary goal of the research work was to determine the corrosion resistance of laser beam-welded joints made of ferritic stainless steel X2CrTiNb18 (1.4509) having a thickness of 1.5 mm. In some of the test joints, the weld was subjected to rolling. In addition, some other joints were subjected to heat treatment involving the use of a prototype induction heating welding station. The research work-related test results revealed that the test joints with the weld subjected to rolling were characterised by a significantly lower rate of linear corrosion progression (linear corrosion rate  $V_p = 0.008672$  mm/year) compared to the test joints only subjected to laser beam welding and those subjected to heat treatment ( $V_p = 0.011052$  mm/year).

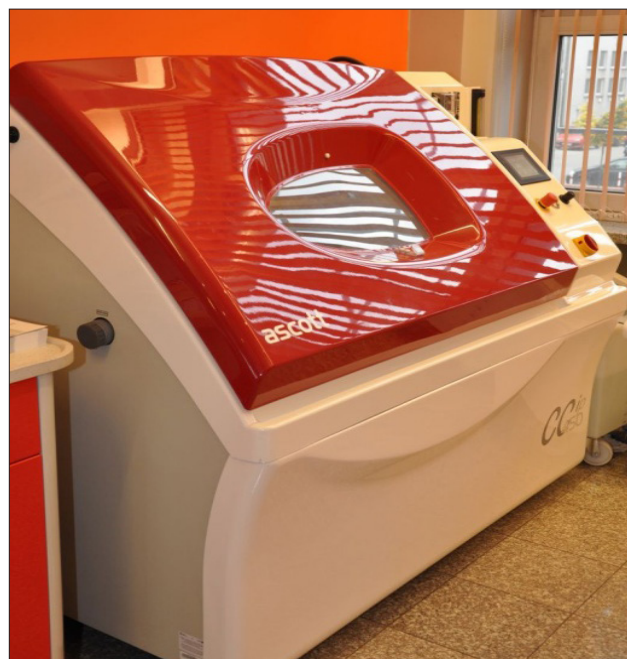
**Fig. 2.** Chamber (CCP450ip) used in cyclic corrosion tests in the laboratory of the Faculty of Mechanical Engineering of the Silesian University of Technology in Gliwice

- disc cutting machine (Metkon SERVOCUT-M300),
- grinder (ATM SAPHIR 250 M2),
- microscope (Nikon ECLIPSE MA 100),
- chamber for cyclic corrosion tests (CCP450ip) (Fig. 2).
