MMA Repair Welding of Nodular Cast Iron GJS 350-22

Abstract: The article presents results of the MMA repair welding of nodular cast iron GJS 350-22. Casting defects were simulated mechanically (through milling), whereas repair welding was performed using selected filler metals (low-carbon filler metal, austenitic filler metal, Monel alloy and nickel alloy) and the manual metal arc welding method (MMAW). Test welds were subjected to visual, penetrant, macro and microscopic tests as well as hardness measurements and were compared in terms of the colour with that of the base material. The tests made it possible to identify the effect of the repair welding process on structural changes in the HAZ area and the susceptibility of the HAZ and the weld to crack formation. The tests also enabled the determination of structures of repair welds and their usability when repairing iron casts. The hardness measurements confirmed effects related to structural changes triggered by repair welding in the HAZ and in the weld. In turn, the comparative tests concerning the colour of the weld and that of the repaired cast iron enabled the selection of a filler metal satisfying the above-named criterion.

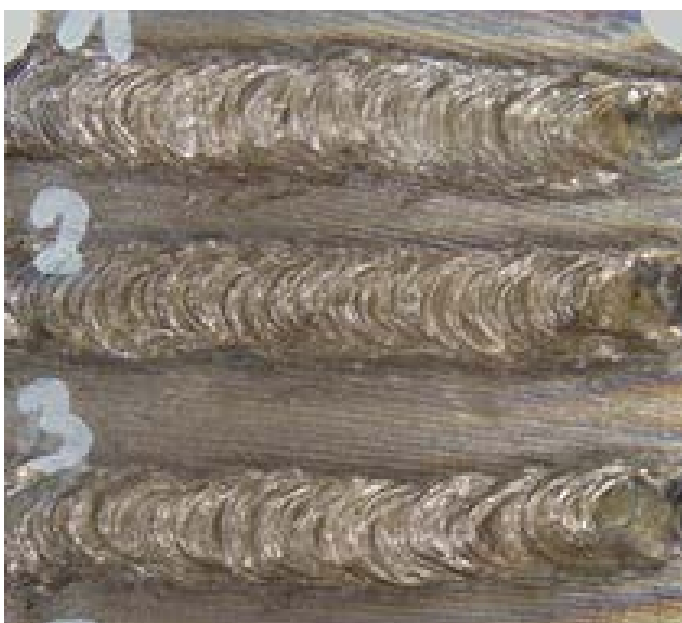
Fig. 2. Repair welds

The process of welding was performed in the flat position, applying welding parameters recommended by the manufacturers of individual filler metals. In cases of all of the electrodes, the welding current amounted to 100 A. A higher welding current of 130 A was applied only in terms of electrode EB 150. The process of welding was performed using straight polarity DC. Welds were subjected to peening performed using a welding hammer, in the direction opposite to that of welding. Exemplary repair welds are presented in Figure 2.

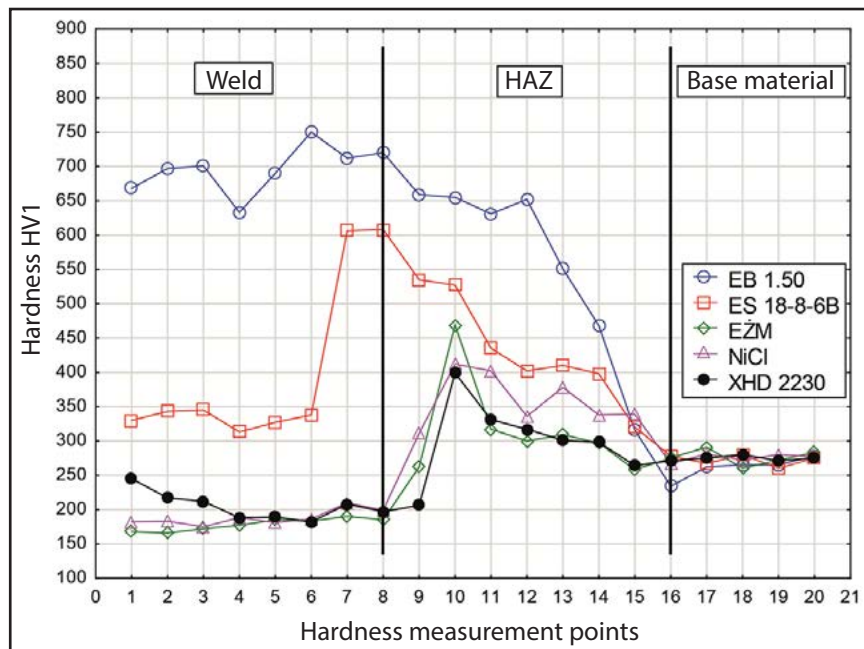
Fig. 8. HV1 hardness distribution in the repair welded cast iron areas

Hardness measurements based on the Vickers hardness test confirmed the results of the microscopic tests. The highest hardness amounting to 700 HV1 was measured in the

weld made using the low-carbon filler metal (EB 1.50). The hardness of the weld made using the austenitic electrode amounted to approximately 350 HV1. In cases of the remaining electrodes, the hardness amounted to approximately 200 HV1. In cases of all of the electrodes used in the tests, the HAZ revealed an increase in hardness, confirmed by the presence of the martensitic structures. The highest value, exceeding 700 HV1, was identified in the HAZ of the weld made using electrode EB 1.50. The hardness in the HAZ area of the weld made using electrode ES 18-8-6B amounted to approximately 600 HV1. In cases of the remaining electrodes, the hardness of the HAZ area was restricted within the range of 450 HV1 to 300 HV1. The lowest hardness values in the HAZ area were identified in the welds made using nickel-based filler metals (NiCl, XHD 2230) (Fig. 8).

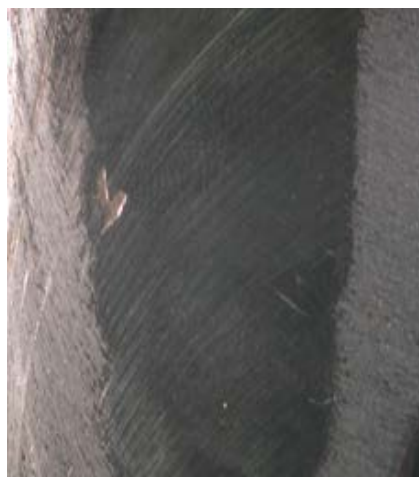
Fig. 9. Surface of the weld made using electrode EB 1.50

The comparison of the weld colour with that of the base material required subjecting the weld faces to mechanical treatment. The observations following the mechanical treatment revealed that the weld colour most similar to that of the base material was obtained in the weld made using electrode EB 1.50 (Fig. 9). In cases of the remaining welds, the above-named difference was more visible (Fig. 10).

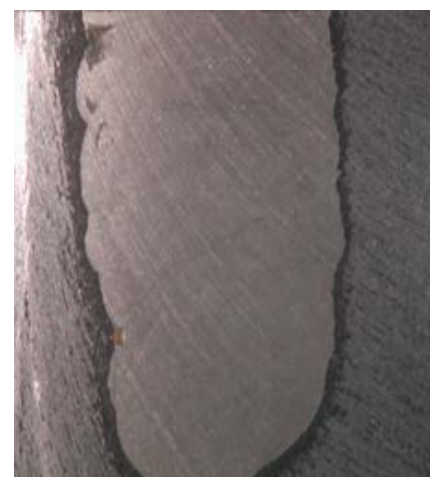
Fig. 10. Surface of the weld made using electrode XHD 2230
