Testing the Quality of Welded Joints in Thick-Walled Pipes Used in the Power Industry

Abstract: The article discusses tests concerning the quality of joints in relation to the service life of thick-walled pipes made of steel P355NH using the TIG welding method (141) and filler metal alloy grade SNI6625 (Inconel 625). Because of its mechanical properties, corrosion resistance and high-temperature resistance, the above-named material is commonly used in various industries. The test joints were subjected to structural, non-destructive and corrosion resistance-related tests.

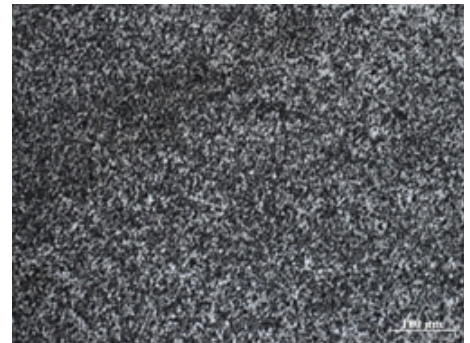
Fig. 6. Heat affected zone, normalisation area; mag. 200x

in Figure 4 was characterised by the ferritic-pearlitic structure of banded nature. During the welding process, the base material was exposed to high temperature, which resulted in the formation of specific areas of the heat affected zone (HAZ), varying in the grain size (see Figures 5, 6 and 7). The HAZ area adjacent to the base material and farthest from the heat source contained traces of annealing within temperature ranges A₁ and A₃. The crystallisation process affected the areas characterised by the lowest transformation temperature, i.e. pearlite (Fig. 5). The areas closer to the fusion line were (along with progressing normalisation) characterised by the decreased grain size of the equiaxial ferritic-pearlitic structure. The area near the fusion line contained the ferritic-bainitic structure with visible boundaries of former austenite grains (Fig. 6). The austenite grains were characterised by a sharp growth resulting from high temperature affecting this area of the joint. The cooling process was accompanied by the formation of the coarse-grained structure, adjacent to the fusion line of alloy SNi6625 (Fig.

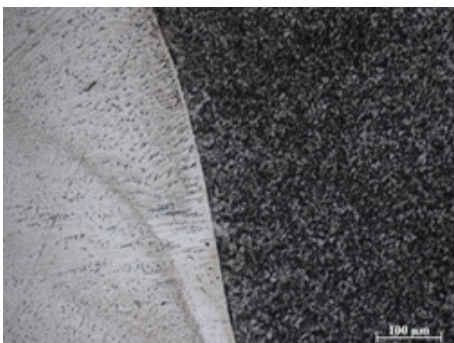
Fig. 7. Weld with the fusion line; mag. 200x

7). The weld structure was consistent with characteristics discussed in related publications concerning alloy Inconel 625. Figures 8–11 present columnar-dendritic structures, characteristic of welds made of high-alloy steels and nickel alloys. It is also possible to observe the multi-run nature of the weld.

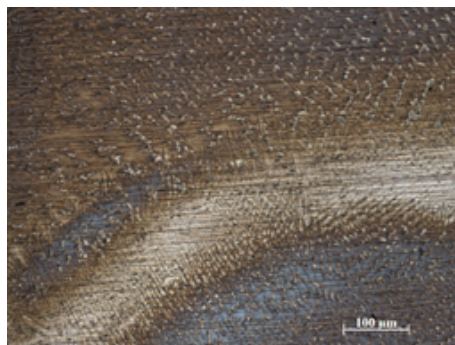
Fig. 10. Weld; mag. 200x

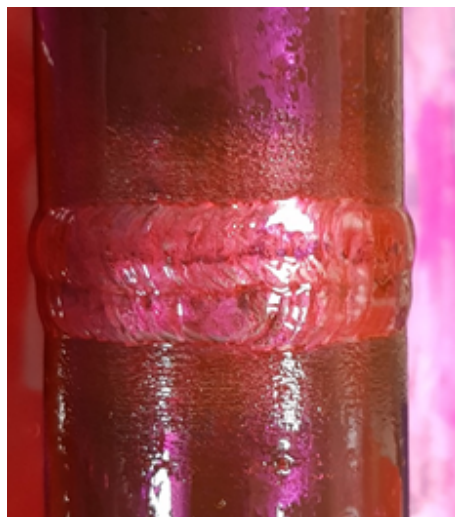
Fig. 12. Specimen with the penetrant applied

The visual test-based assessment of the joint did not reveal the presence of imperfections making the joint inconsistent with the acceptance criteria related to quality level B. The weld was characterised by the proper shape and geometrical dimensions. Individual beads were made carefully and uniformly. The penetrant test, whose stages are presented in Figures 12 and 13, did not reveal the presence of any indication failing to satisfy the requirements of quality level 2X. The time of penetration and development amounted to 15 minutes. Before the test, penetrants and developers (H.Klumpf) were checked using reference specimen no. 2. In spite of using a more precise technique (i.e. wet fluorescent method), the magnetic particle test did not reveal the presence of any indications either. The test was performed using a test rig composed of a rigid coil and a UV-A light source (Figures 14 and 15). To ensure the recognition of the test as

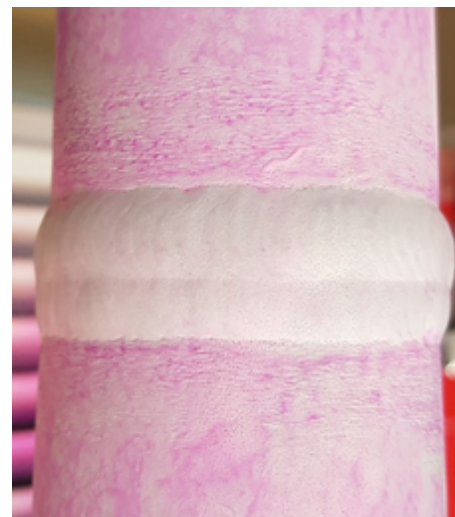
Fig. 13. Specimen with the developer applied

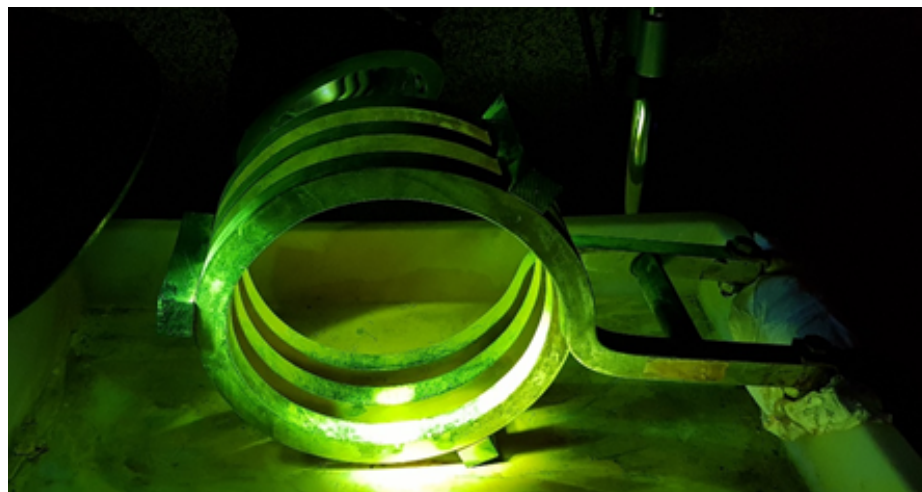
Fig. 14. Magnetic particle test rig – rigid coil

performed properly, the value of illuminance should not exceed 20lx.

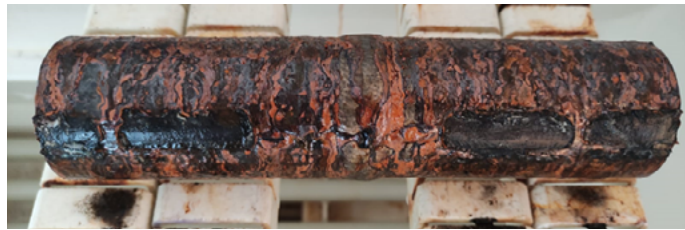
Fig. 16. Specimen after 48 hours' exposure in the salt spray chamber

The test results concerning resistance to the effect of neutral salt spray were observed after 48 hours and 168 hours. The observation was performed by the unaided eye. Already the first test revealed that the specimen underwent significant damage. However, it should be noted that, in terms of corrosion progression, the weld material significantly differed from that of the base material (Fig. 16). After 168 hours, the corrosion process was significantly more advanced; the tarnish of the weld was considerably greater than that observed after 48 hours. Figures 17 and 18 present the specimen before, whereas Figure 19 presents the specimen after the removal of the corrosion products. The weld surface compared with Figure 1, i.e. presenting the specimen before the corrosion test, was more tarnished, which could imply that also the weld underwent corrosion (to a slight extent).

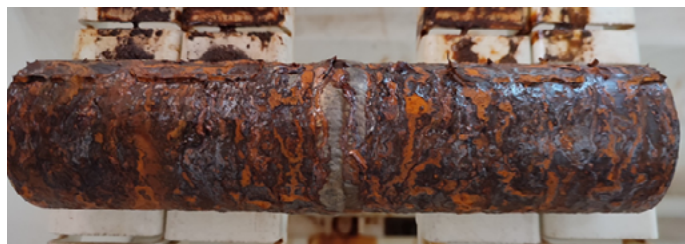
Fig. 17. Specimen after 168 hours' exposure in the salt spray chamber

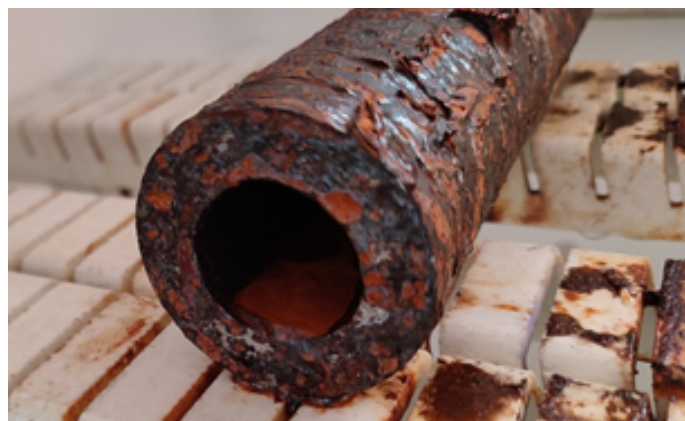
Fig. 18. Face of the specimen after 168 hours' exposure in the salt spray chamber

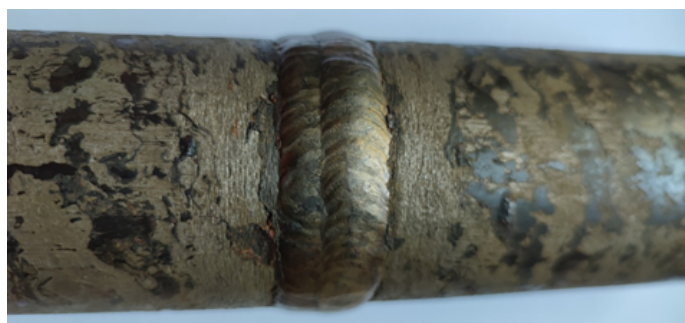
Fig. 19. Specimen of the corrosion resistance test with the corrosion products removed

The corrosion resistance tests, performed in the atmosphere of neutral salt spray for 168 hours, revealed that the base material (BM) was significantly damaged, whereas the weld was considerably less damaged (than BM). The aforesaid process was also manifested by the change of the weld surface. After the test, the initially glossy weld surface was tarnished (mat). The removal of the corrosion products from the specimen revealed the presence of clearly visible corrosion pits in the base material.
