# Analysis of Cracks in Welded Joints of Pipes with Eyes made of S890QL1 Steel

**Abstract:** The analysis presented in the article was concerned with cracks in MAG (135) robotic welded joints of pipes with eyes made of s890QL1 steel and constituting components of the latticework of self-propelled cranes. The text also presents results of tests concerning chemical composition as well as mechanical and metallographic properties of base materials and welded joints. The article contains an assessment of radial and longitudinal cracks of joints based on fractographic tests of cracks and impact-test specimens. The text also discusses the effect of welding process thermal conditions on joint properties. Test results were referred to the theory of hydrogen-induced cracking (mechanism) according to Professor E. Tasak.

The research-related tests involved MAG (135) robotic welded joints of pipes with eyes constituting components of the latticework of self-propelled cranes.

The tests aimed to define reasons for the sporadic formation of cracks in joints.

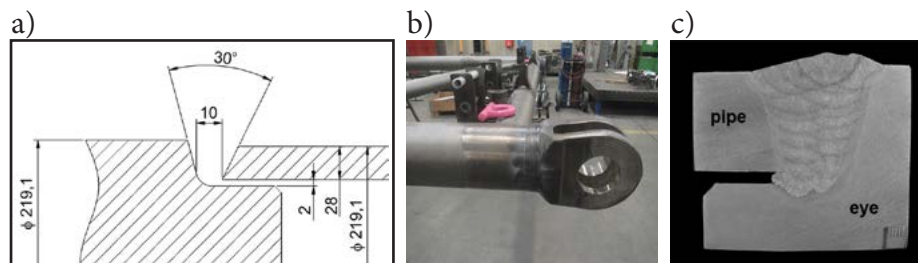
Fig. 1. Welded joint of a pipe with an eye: a – diagram of a joint, b – view of a joint, c – joint macrosection

- joints should be made using medium-thickness runs,
- bevelling of elements being welded should be modified; in particular, it is necessary to decrease the edge gap from 10 mm to 4 mm (Fig. 1a).

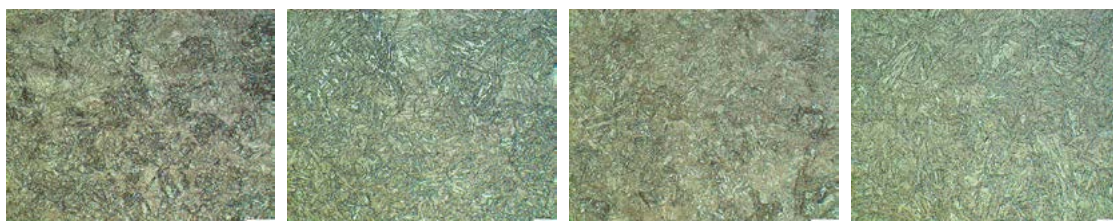
The pipe material revealed a martensitic structure, whereas the eye material revealed

a martensitic structure with locally present bainite and possible traces of ferrite.

Fig. 5. Microstructures of the pipe and eye. Etchant: Nital

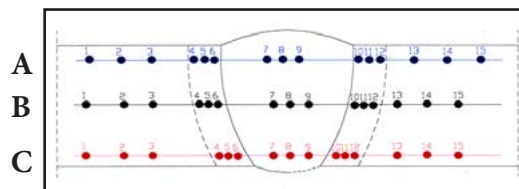
The hardness of the joint metal in its various areas, apart from the HAZ between the eye and the weld (363-442 HV), is similar and relatively low (300-350 HV), in this respect, due to the conditions of the mutual thermal tempering of individual runs. The hardness test results

satisfy the requirements of PN-EN ISO 15614-1 (i.e. max. 450 HV for s890QL1 steel)

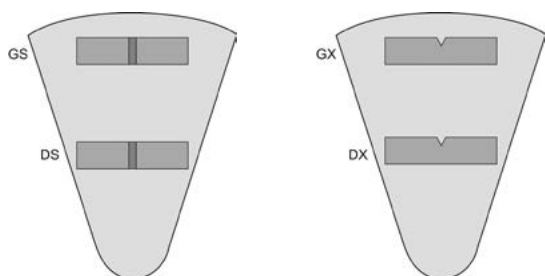
Fig. 13. Sampling locations and manner of making notches in impact test specimens

Figure 13 presents the sampling and designation of specimens.

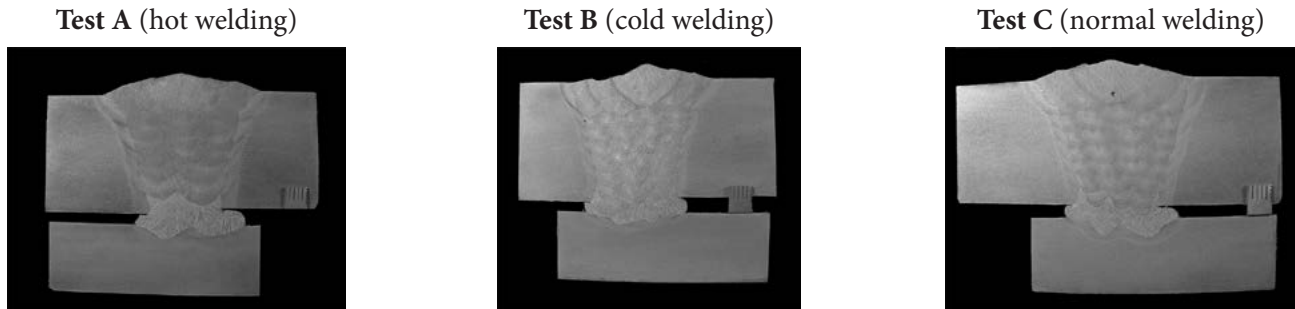
Fig. 26. Macrosections of welded joints

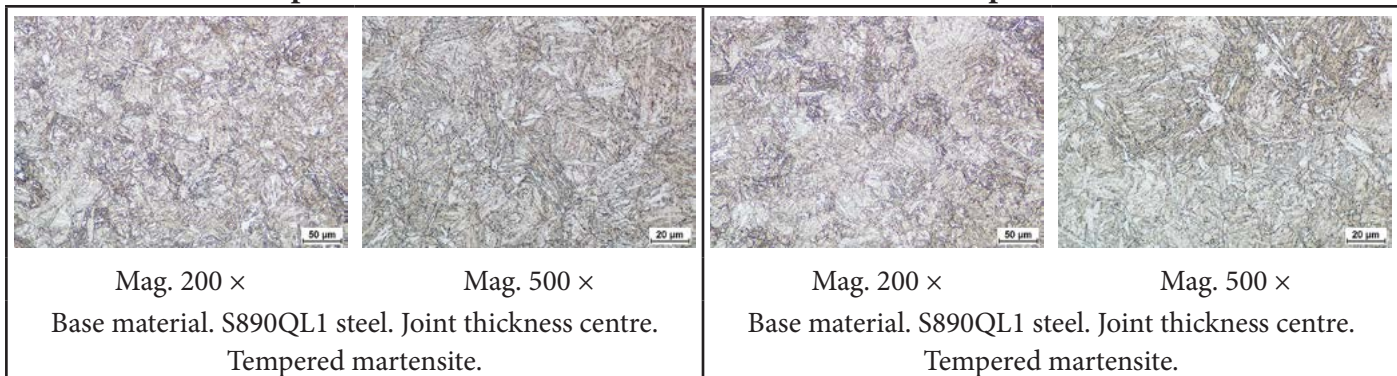
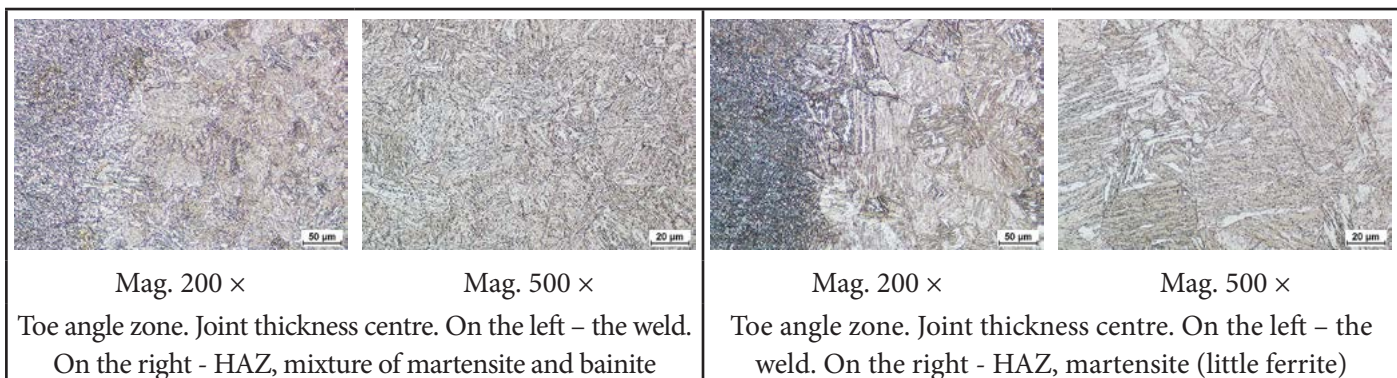
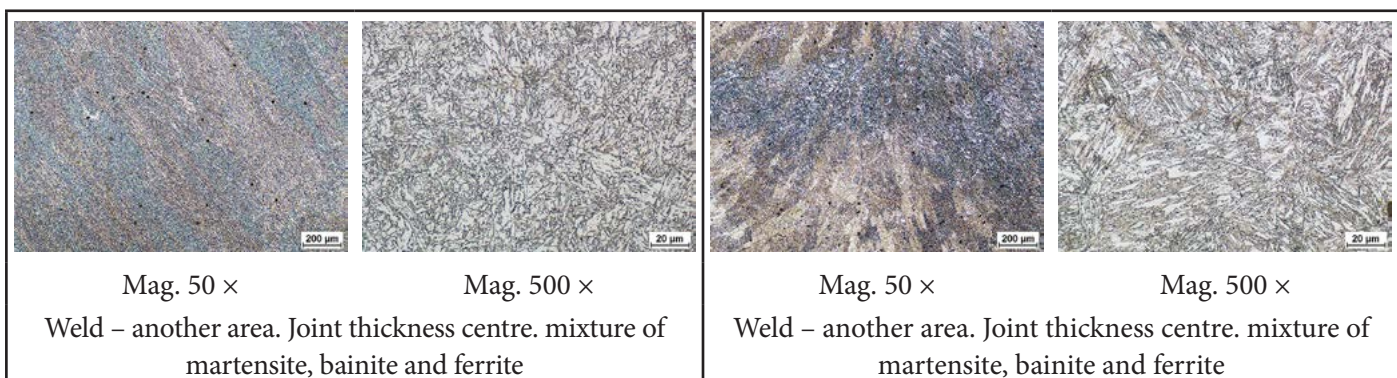
Fig. 27. Microstructures of joints made using various preheating and interpass temperatures

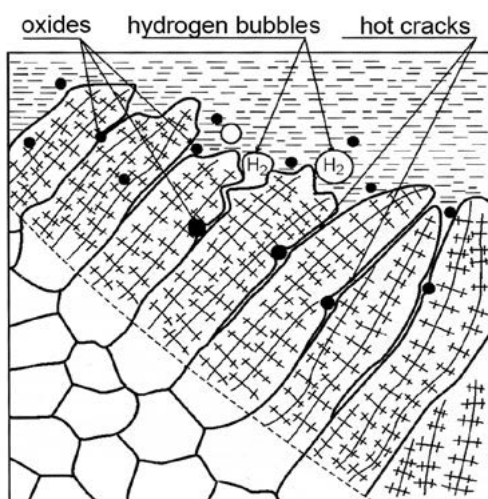
Fig. 28. Hot crack mechanism caused by excess hydrogen content

During solidification, released hydrogen forms a gas layer between crystallites preventing their entire contact. Further diffusion of hydrogen (already in the solid-state) is accompanied by an increase in pressure and the formation of hot cracks. The cracks are thus “containers of hydrogen”, which, when diffusing towards the Heat Affected Zone are responsible for the formation of (post-weld) cold cracks.

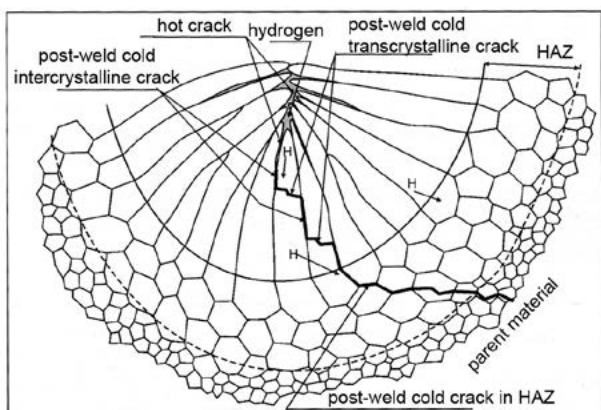
Fig. 29. Cold crack mechanism in bainitic and martensitic steels
