Multiple MAG Repair Welding of Steel S1100QL with the Removal of Defective Fragments of Welds Using Mechanical Treatment

Abstract: The research discussed in the article involved the performance of tests assessing the effect of a one-time and four-time repair welding thermal cycle on mechanical properties of 18 mm thick butt joints made of toughened steel S1100QL. The tests also involved the determination of mechanical properties of a production joint and joints subjected to mechanical treatment-based repair, involving the use of the MAG method (138) and metallic flux-cored wire STEIN-MEGAFIL 1100 M. It was ascertained that the mechanical properties of the joints subjected to mechanical treatment-based repair were similar to those of the joints subjected to repair welding involving the removal of a defective part using arc-air gouging.

Keywords: repair welding, Steel S1100QL, mechanical properties of joints

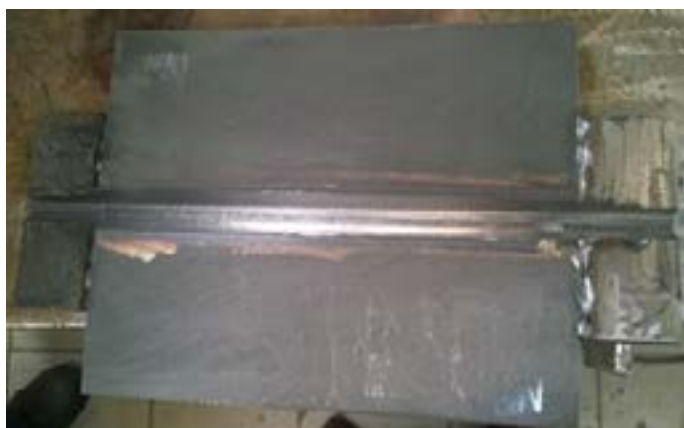
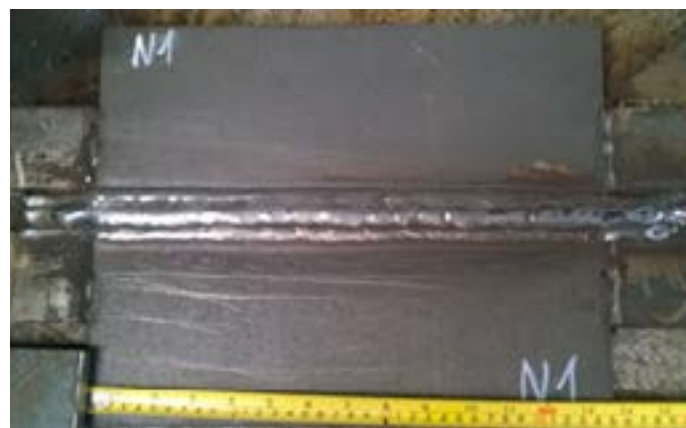
Fig. 3. Test plate: a) with the milled groove according to Fig. 2; b) face of the test joint subjected to one repair (joint no. 1)

The visual, penetrant and radiographic tests of the test joint finished positively. Because of this, the subsequent test joint was provided with a (milled) groove modelling the removal of welding imperfections when repairing the joint (Fig. 2, 3a). The making of the repair joint was performed using parameters presented in Table 2 in relation to filling runs nos. 3÷12, making joints subjected to one (Fig. 3b) and four repairs.
