Laser Welding of Ferritic Stainless Steel 1.4509 Used in the Manufacturing of Catalyst Housings and Diesel Particulate Filters

Abstract: The article discusses the results of tests as well as quality assessments of test joints made of tubes having a nominal thickness of 1.5 mm, a rectangular cross-section and a width of 140 mm and a length of 240 mm, made of ferritic stainless steel grade 1.4509 with the addition of microagents and used in the production of catalyst housings and diesel particulate filters. Test joints were made using a prototype line equipped with a TruDisk 2002 disk laser (TRUMPF) at a ROCH production plant in Tarnowskie Góry. The tests involved the preparation of an experimental batch of tubes. The tubes used in the tests were subjected to various procedures, i.e. only to laser welding (5 specimens), to the rolling of the weld surface after laser welding (5 specimens) and to the additional heat treatment of the joint area after welding (5 specimens). Most of the test welded joints represented high quality level B and were characterised by tensile strength not lower than that of the base material as well as by high plasticity confirmed in the Erichsen cupping test

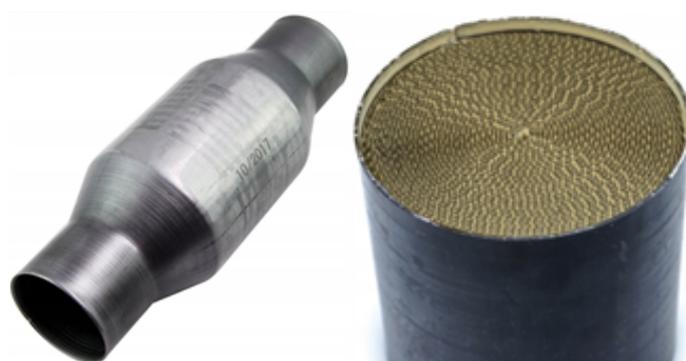
Fig. 1. Catalyst housing made of a tube (through spinning) (a) and the ceramic catalyst insert (b)

The attachment of the catalyst involves putting the catalyst insert inside the housing along with an insulating mat. The forcing of the insert (using a dedicated calibrator) inside the housing is followed by clamping the housing around the insert. The next stage involves the welding of inlet and outlet hoppers. An alternative finishing method consists in the closing of the housing and forming the inlet and outlet hoppers through spinning (Fig. 1). The afore-said method makes it possible to eliminate the welding of subsequent elements (i.e. the formation of welded joints being the most susceptible to perforation and unsealing). However, the method, being less popular than the welding of the joints, yet increasingly often preferred by customers, requires the improvement of strength-related parameters of the welded joint.

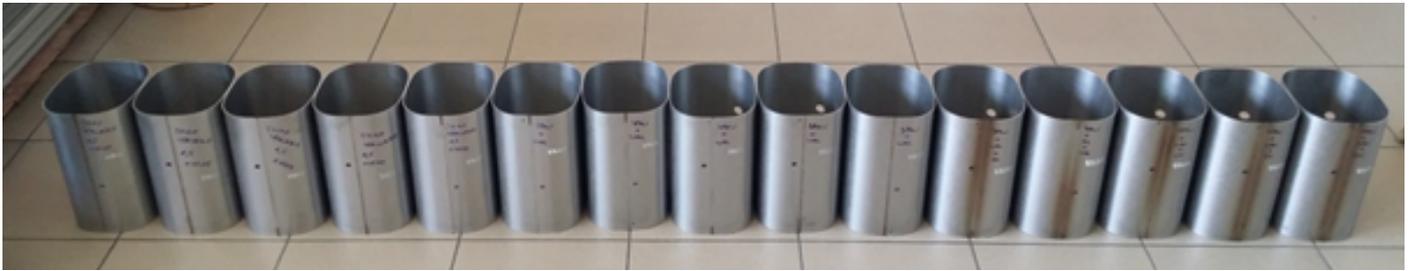
Fig. 2. Test tubes made of 1.5 mm thick stainless steel 1.4509 in the ROCH company, prepared for joint quality-related tests and assessment; laser welded test tubes not subjected to any other treatment (five on the left), laser welded test tubes with the weld subjected to rolling (five in the middle) and laser welded test tubes with the welded joint subjected to additional heat treatment (five on the right)

to additional procedures such as the rolling of the weld (designated as VAI11-VAI15) and heat treatment (designated as VAII11-VAII15). The purpose of the above-named procedures was to reduce welding stresses and improve plastic properties of the material in the joint area (weld, HAZ) (Fig. 2).

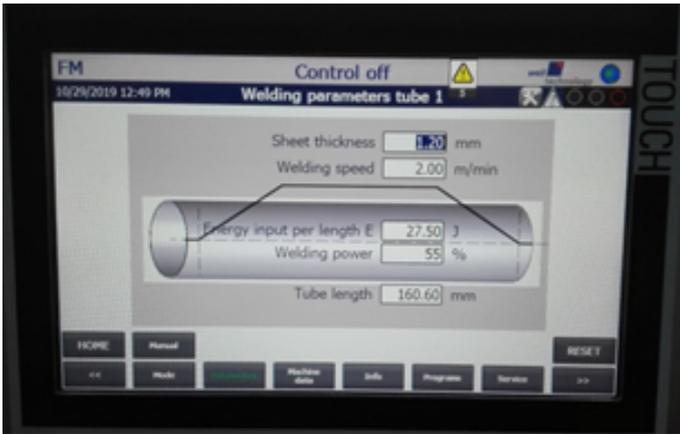
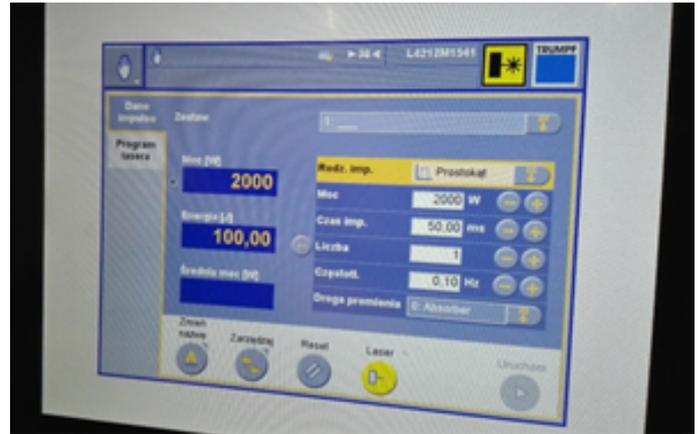
Fig. 3. Window of the panel for controlling welding process parameters (a) and windows of the laser operation control panel (b)

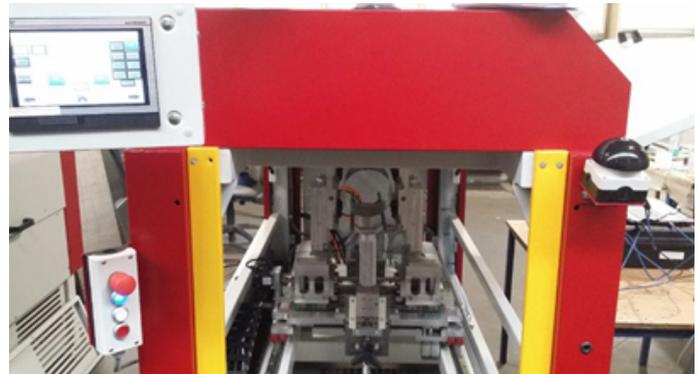
Fig. 4. Prototype station for the heat treatment of tube fragments (designed and made at the ROCH company)

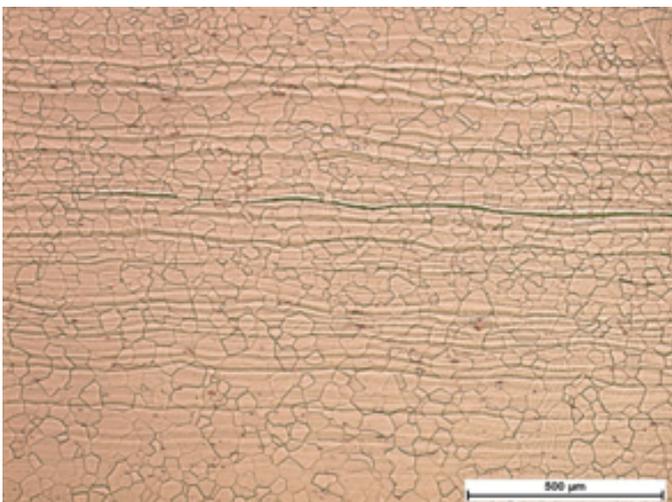
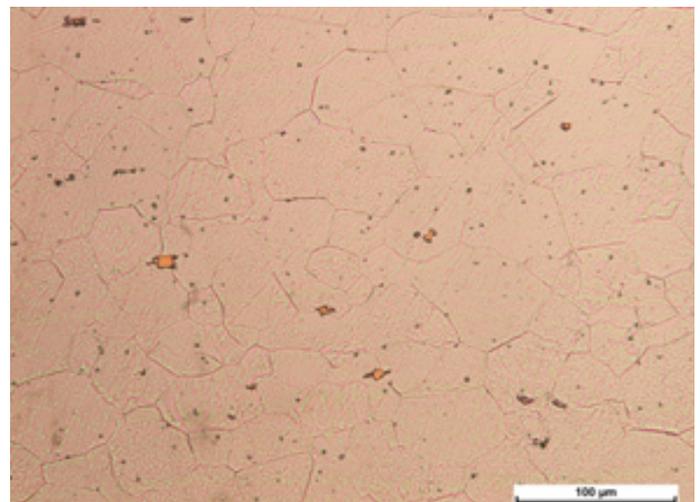
Fig. 5. Microstructure of the base material of 1.5 mm thick stainless steel 1.5409macrostructure

The morphology of base material grains was typical of ferrite. However, at the same time, both the base material and the HAZ contained significant amounts of precipitates located primarily along the grain boundaries. In the microstructural images, the aforesaid precipitates were visible as fine golden particles of various (i.e. triangular, trapezoidal or polygonal) shapes. Because of the chemical composition of the steel and the mechanism of its hardening during production, the precipitates were probably highly dispersed carbides or carbonitrides. The weld areas did not contain precipitates of similar morphology. Observations of the weld microstructure performed at high magnification revealed the presence of single gas pores of small diameters (not longer than 80 μm) as well as the presence of inclusions both in the HAZ and in the base material. The diameter of the inclusions did not exceed 20 μm .

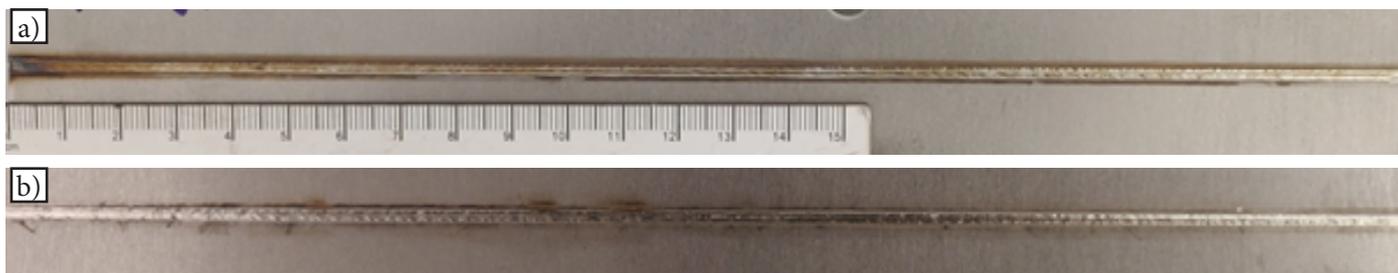
Fig. 6. Surface of the weld face (a) and of the weld root (b) of the butt welded joint (designated as AVI) made of 1.5 mm thick steel 1.4509 (tube), directly after laser welding

The quality of the laser welded joints was assessed in accordance with the PN-EN ISO 5817 standard. The test joints subjected to visual tests are presented in Figures 6 through 8. Each test joint was sampled for three specimens used in metallographic tests, i.e. one sampled in the initial area (30 mm from the welding process starting point), one sampled at the half of the joint length and one sampled in the final area

The visual tests revealed that the width of the weld on the face side did not exceed 1.5 mm. In turn, on the root side, the weld was even narrower and amounted to 1.2 mm in relation to all the test joints. The width of the weld face and that of the weld root were uniform along the entire length of the test joints. The weld face surface was flat and even, with a clearly visible line in the weld axis, formed as a result of the solidification of the weld pool and related to a fast laser welding rate. It was also possible to observe the slightly incompletely filled groove. Because of the narrow width of the weld and the shallow depth of the incompletely filled groove, the performance of measurements was impossible during visual tests (VT). As regards the laser welding of butt joints without the filler metal,

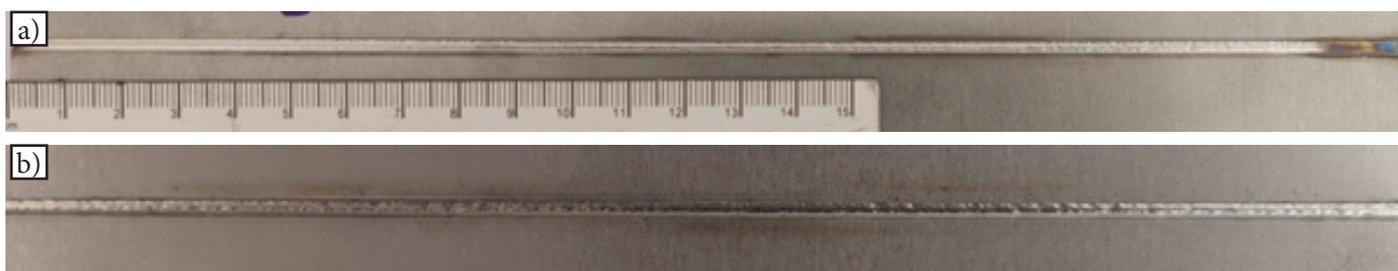
Fig. 7. Surface of the weld face (a) and of the weld root (b) of the butt welded joint (designated as AVI) made of 1.5 mm thick steel 1.4509 (tube) after the rolling of the weld

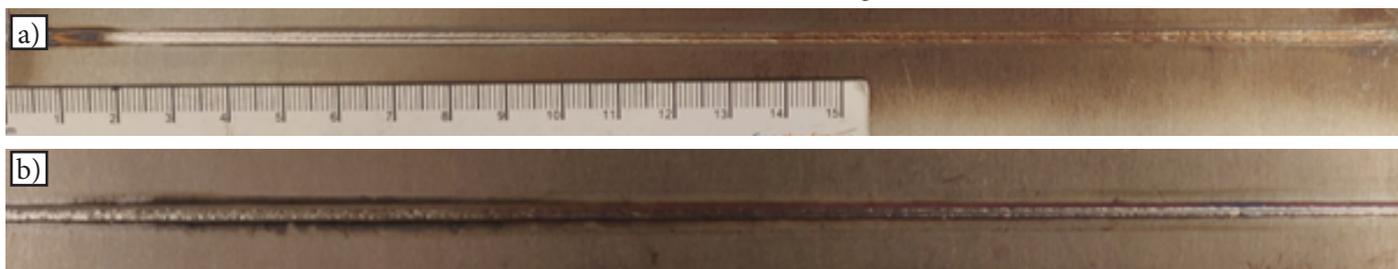
Fig. 8. Surface of the weld face (a) and of the weld root (b) of the butt welded joint (designated as AVI) made of 1.5 mm thick steel 1.4509 (tube) after the rolling of the weld and heat treatment

The visual tests also revealed the presence of discolouration on the weld face surface and in the areas along the face of the joints. In the joints subjected to heat treatment, the area containing discolouration was even wider (restricted within the range of approximately 10 mm to 15 mm on each side of the weld). The heat treatment-triggered oxidation was strictly present on the surface and should not adversely affect the mechanical properties of the joints.

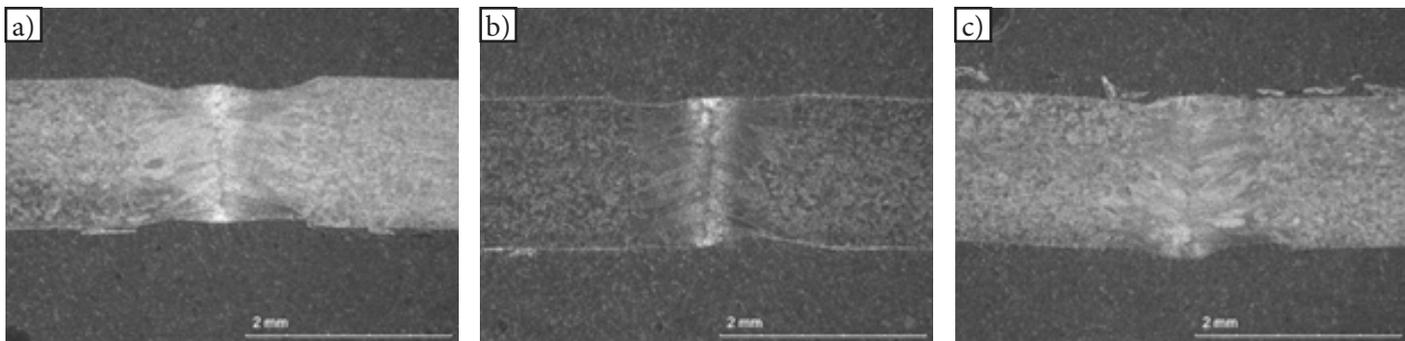
Fig. 9. Macrostructure of the longitudinal butt welded joint (designated as AVI) made of 1.5 mm thick steel 1.4509 (tube) directly after laser welding: a) initial area of the weld, b) central area of the weld and c) final area of the weld

(approximately 30 mm away from the edge of the tube). Representative macrostructures of the test joints are presented in Figures 9 through 11, whereas the images of microstructures are presented in Figures 12 through 14. The microstructure on the surface of the metallographic specimens was revealed through the process of electrolytic etching.

identified during the visual tests, i.e. the incompletely filled groove. Measurements involving the surface of the metallographic specimens sampled from various areas of the test joints (initial (initial area – I, central area – C and final area – F) revealed that the depth of the incompletely filled groove in the central area of the weld did not exceed 0.15 mm, i.e. the value acceptable in accordance with the adopted quality-related criteria. The measurements concerning the width of the weld on the surface of metallographic specimens revealed that the width of the weld face of the test joints was restricted within the range of approximately 1.1 mm to 1.5 mm. In turn, the weld root was significantly narrower, with its width being restricted within the range of approximately 0.5 mm to a maximum of 1.2 mm in relation to all of the test joints.

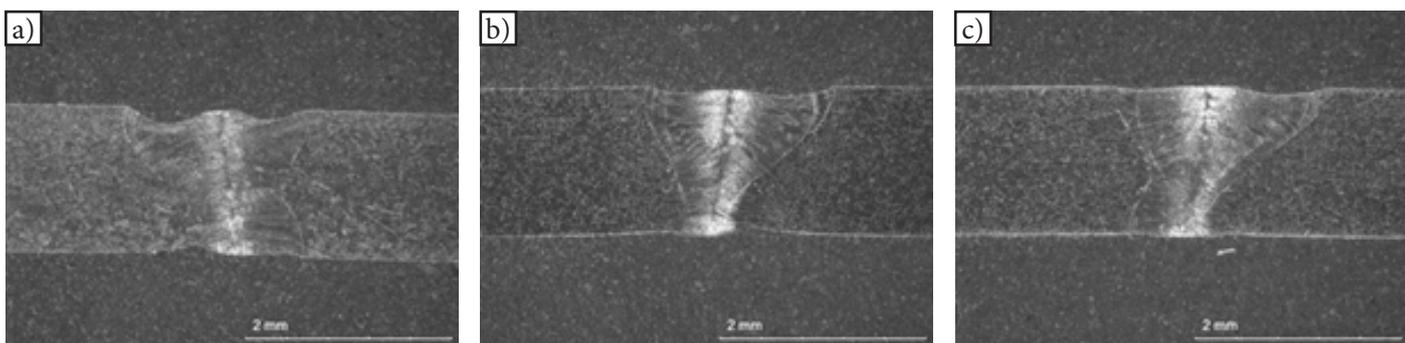
Fig. 10. Macrostructure of the longitudinal butt welded joint (designated as AVI) made of 1.5 mm thick steel 1.4509 (tube) after laser welding and the additional rolling of the weld surface: a) initial area of the weld, b) central area of the weld and c) final area of the weld

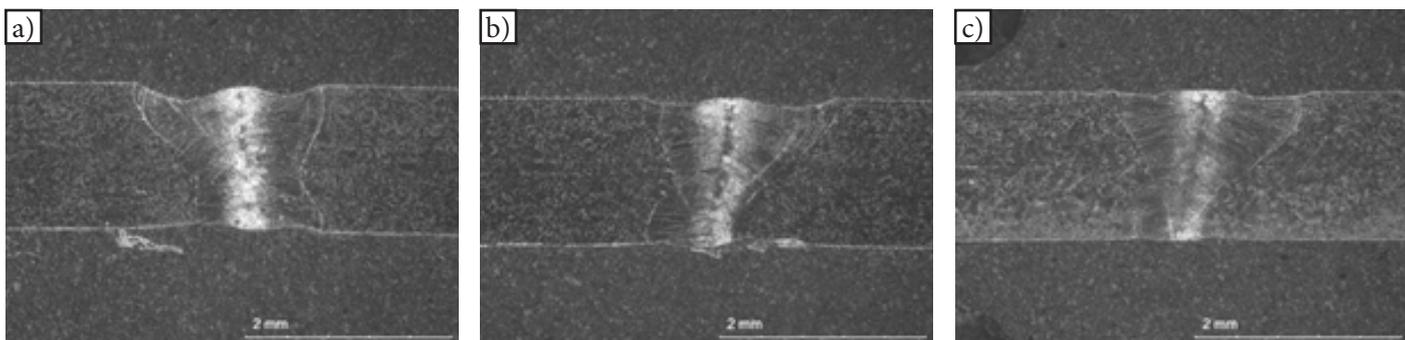
Fig. 11. Macrostructure of the longitudinal butt welded joint (designated as AVI) made of 1.5 mm thick steel 1.4509 (tube) after laser welding, the additional rolling of the weld surface and the heat treatment of the joint: a) initial area of the weld, b) central area of the weld and c) final area of the weld

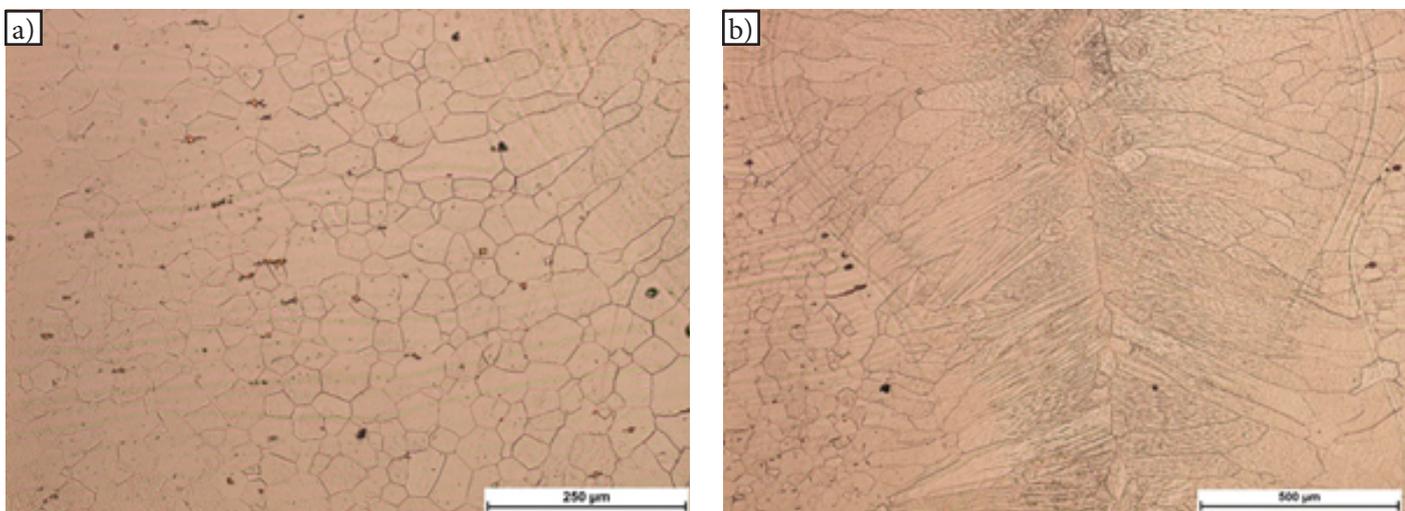
Fig. 12. Microstructure of the longitudinal butt welded joint (designated as AVI) made of 1.5 mm thick steel 1.4509 (tube) directly after laser welding: a) from the left: BM, HAZ, fusion line, weld and b) weld area

The method applied during the electrolytic etching of the metallographic specimens and the use of polarising filters of microscopic images made it possible to obtain the contrast of the individual areas of the joint and determine the width of the HAZ. The measurements revealed that the width of the zone characterised by structural changes was restricted within the range of approximately 0.4 mm to 0.6 mm. It was also possible to observe a narrow zone of grain growth in the area adjacent to the fusion line and a zone of grain refinement (in relation to the grain size observed in the base material).

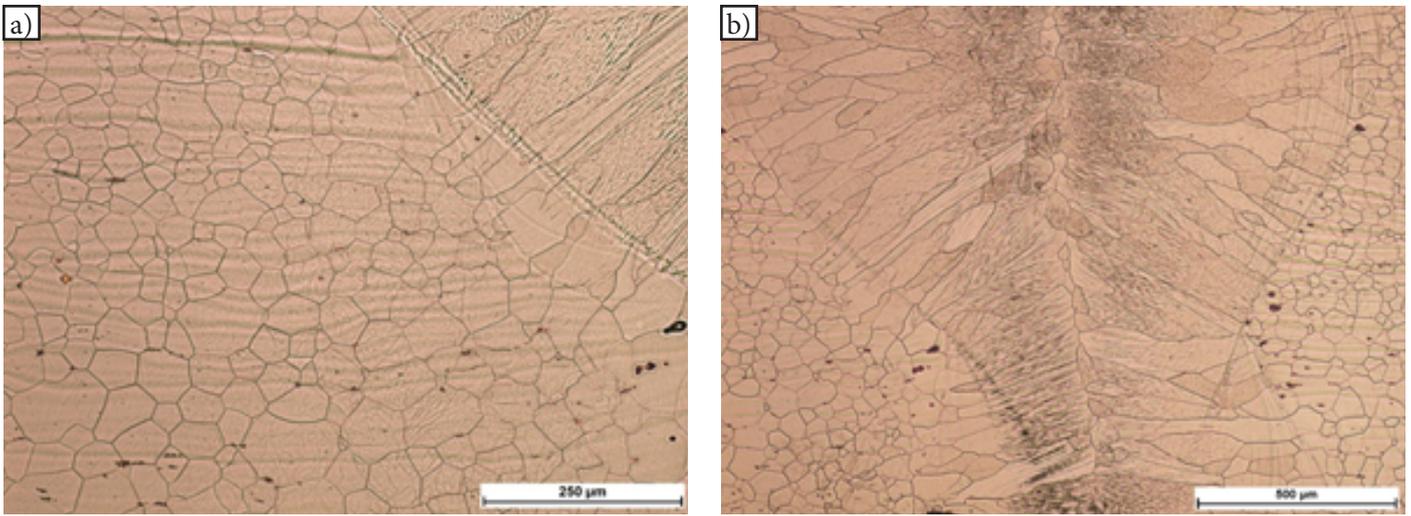
Fig. 13. Microstructure of the longitudinal butt welded joint (designated as AVI) made of 1.5 mm thick steel 1.4509 (tube) directly after laser welding and the additional rolling of the weld surface: a) from the left: BM, HAZ, fusion line, weld and b) weld area

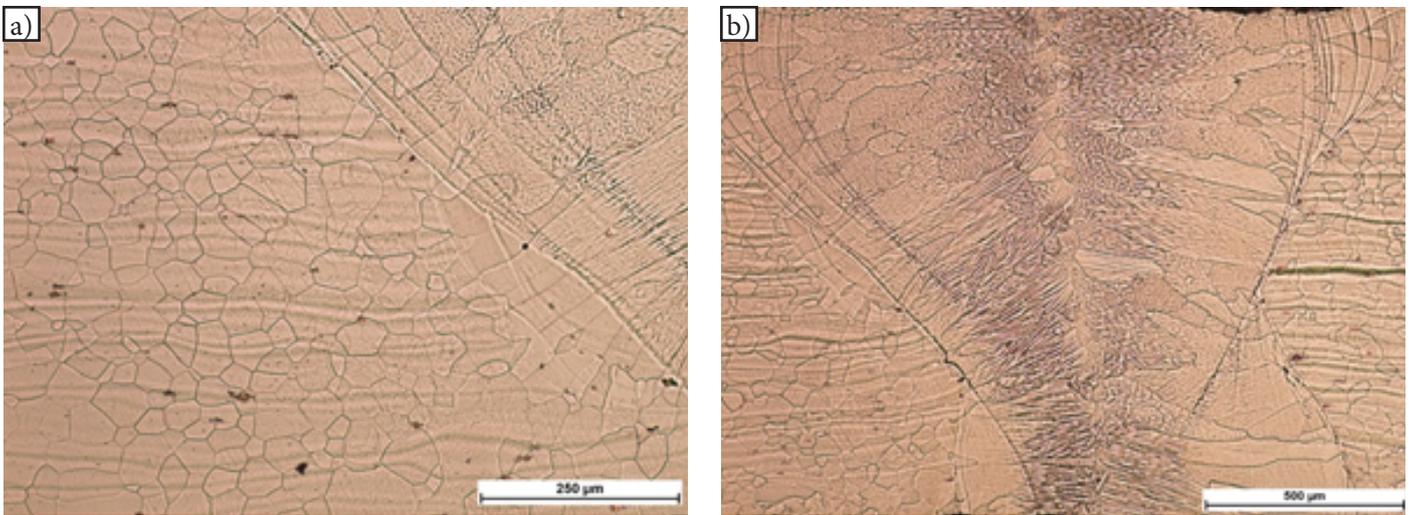
Fig. 14. Microstructure of the longitudinal butt welded joint (designated as AVI) made of 1.5 mm thick steel 1.4509 (tube) directly after laser welding, the additional rolling of the weld surface and the heat treatment of the joint: a) from the left: BM, HAZ, fusion line, weld and b) weld area

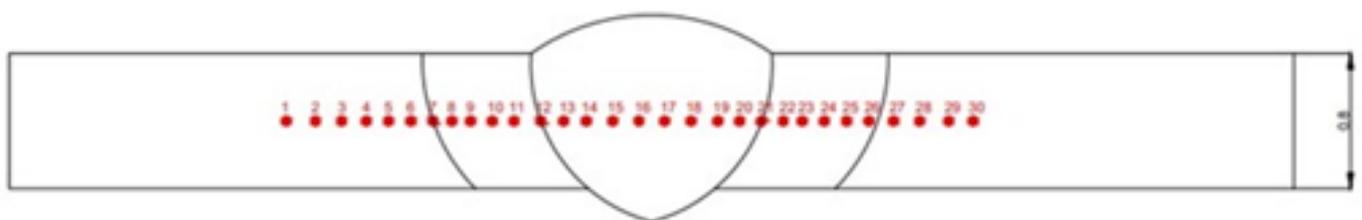
Fig. 15. Schematic diagram presenting hardness measurements in the cross-section of the test joints (test direction from left to right)

Wolpert), calibrated directly before the measurements. The measurements, involving the use of a diamond indenter load of 200g (HVo.2) and a load operating time of 10 s, were performed along the entire length of the specimen, with measurement points located every 0.5 mm. In relation to all the specimens, the measurements involved the base material, the

heat affected zone (HAZ) and the weld. The schematic diagram presenting the performance of the measurements is presented in Figure 15, whereas the measurement results are presented in Figure 16.

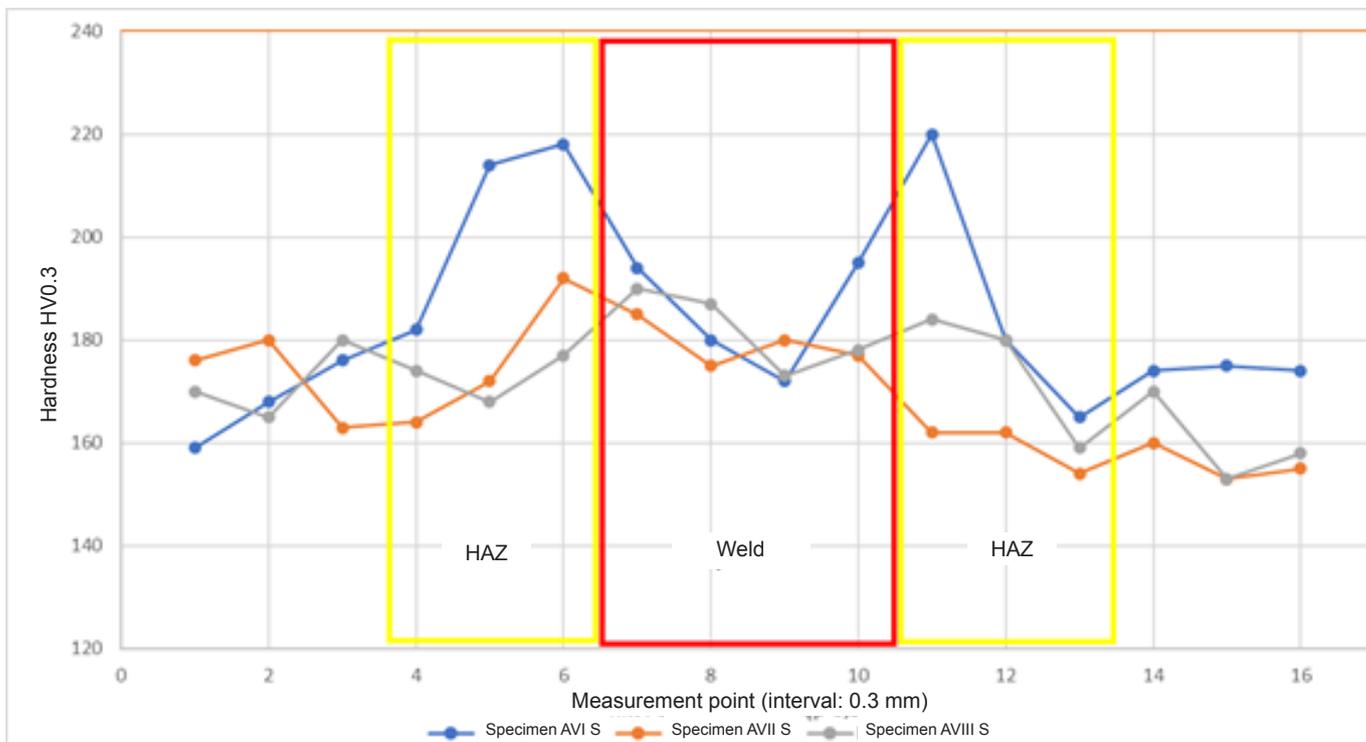
Fig. 16. Changes of microhardness in the cross-section of the test joints made of 1.5 mm thick stainless steel (tube) (designated as AVI – directly after laser welding, AVII – after laser welding and the rolling of the weld, AVIII – after laser welding, the rolling of the weld and additional heat treatment)

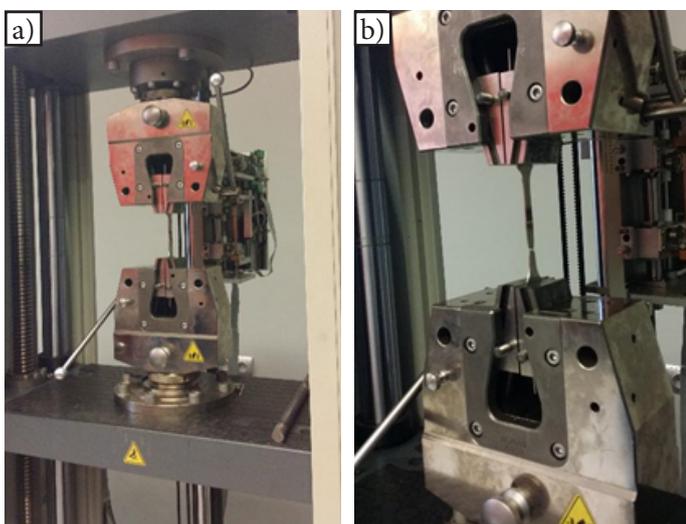
Fig. 17. Specimen in the clamps of the Z 100 testing machine (Zwick) (a) and the specimen ruptured in the static tensile test (b)

The test rig and the tensile test itself are presented in Figure 17. In turn, the specimens after rupture are presented in Figure 18. The tensile test-related diagrams are presented in Figures 19 and 20. The specimens after the Erichsen cupping test are presented in Figure 21.

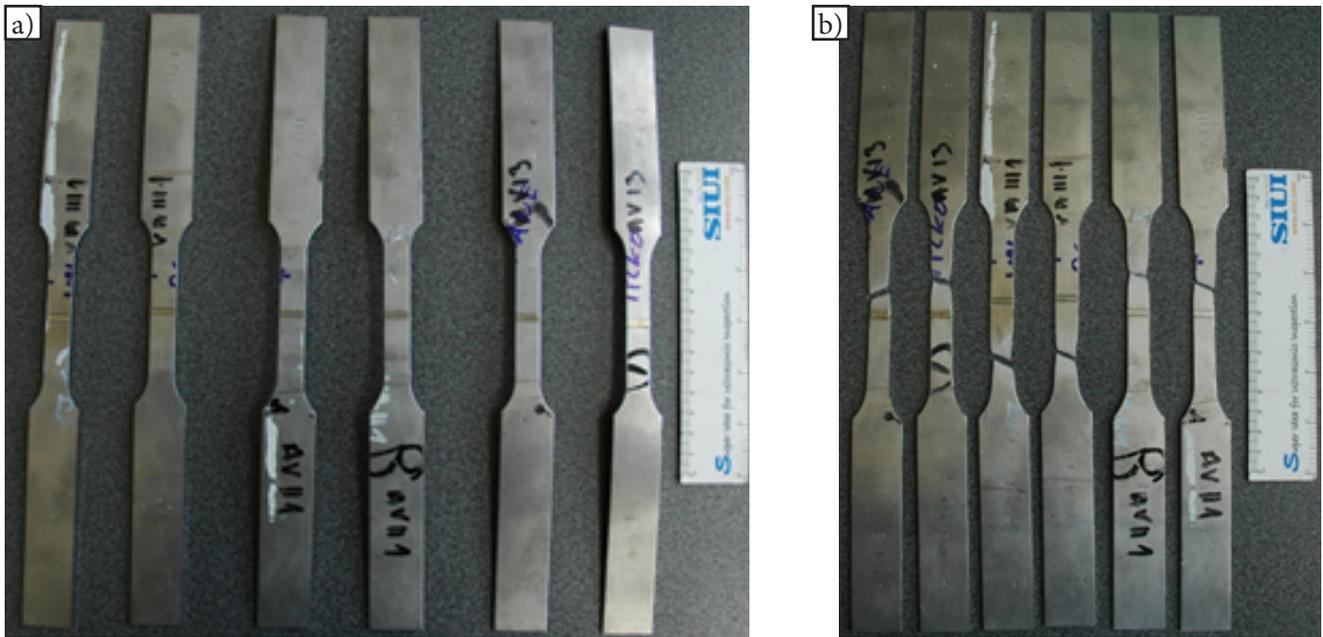
Fig. 18. Specimens used in the static tensile test, sampled from the laser welded test tubes made of 1.5 mm stainless steel 1.5409 (a) and the specimens after the static tensile test – rupture outside the weld (b)

All of the specimens ruptured outside the joint area, away from the weld. The test results revealed that the tensile strength of the base material was not lower than 450 MPa. The rupture of the specimens outside the joint area resulted from the hardening of the weld area and of the HAZ during the laser welding process.

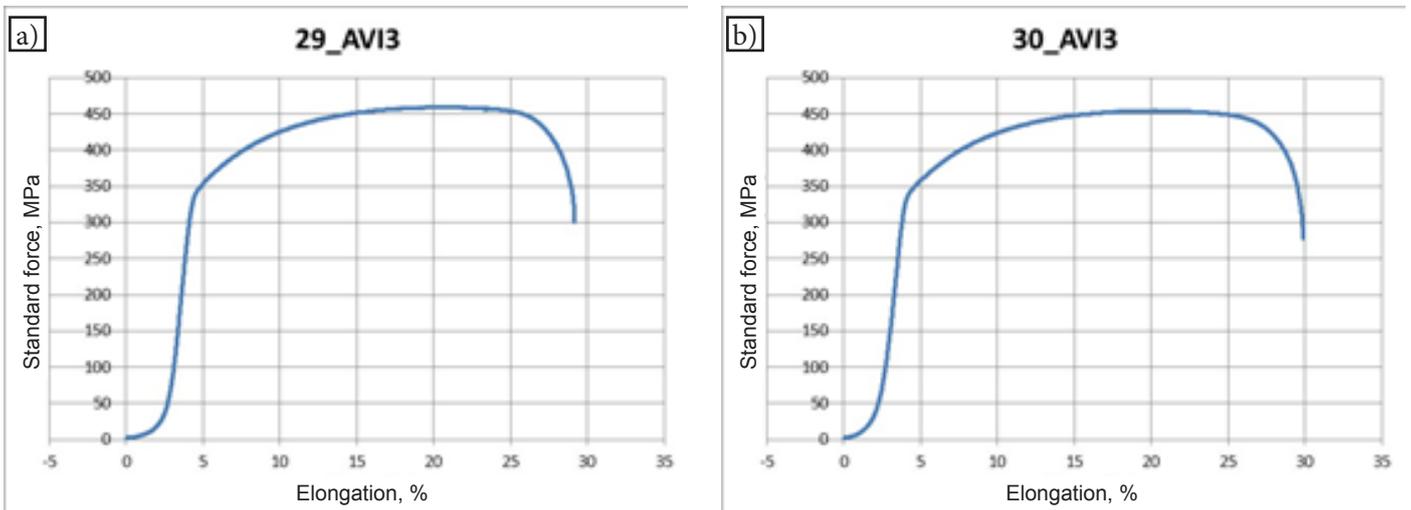
Fig. 19. Results of the static tensile test of the longitudinal test butt joint made of 1.5 mm thick stainless 1.4509 (tube); the test was performed directly after laser welding (tensile strength (rupture in BM) $R_m \sim 450$ MPa)

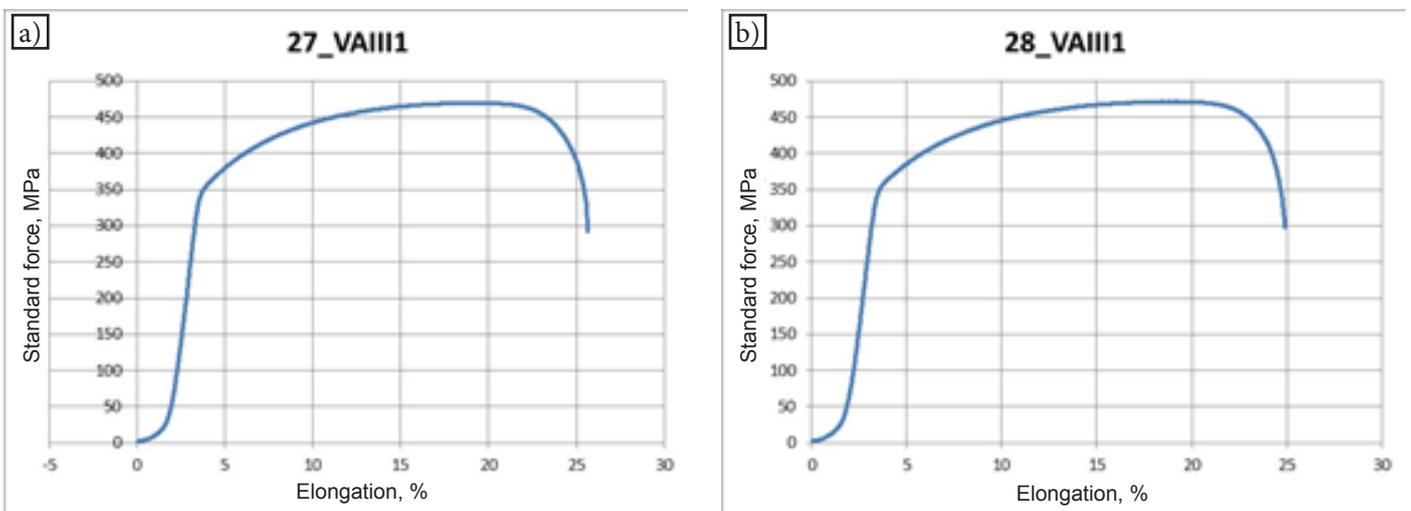
Fig. 20. Results of the static tensile test of the longitudinal test butt joint made of 1.5 mm thick stainless 1.4509 (tube); the test was performed after laser welding, the rolling of the weld and the heat treatment of the joint area (tensile strength (rupture in BM) $R_m > 450$ MPa)

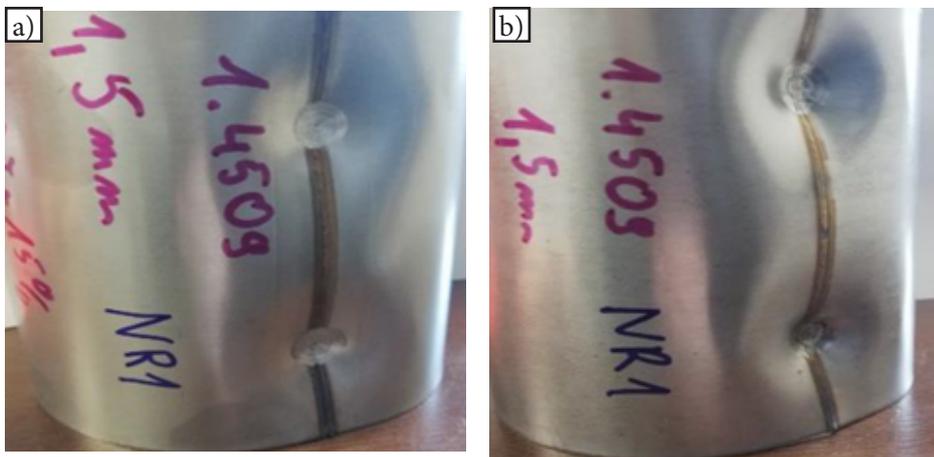
Fig. 21. Specimens after the Erichsen cupping test performed along the longitudinal butt joint of the tube: a) joint after the rolling of the weld (IE: 16.0 mm) and b) joint after the rolling of the weld and additional heat treatment (IE: 16.5 mm)
