Assessment of the Structure and Properties of Manually Laser-Beam-Welded Joints of Steel DOCOL 1200M

Abstract: The research work aimed to determine the effect of manual laser beam welding process parameters on the properties of butt joints made of 1.8 mm thick steel DOCOL 1200M. The test joints were subjected to non-destructive (visual and penetrant) tests as well as destructive tests including static tensile tests, bend tests, hardness measurements as well as macro and microscopic metallographic tests. The optimisation of welding process parameters enabled the obtainment of joints satisfying both visual and strength-related quality requirements. The tests revealed that the use of the so-called continuous-wave laser beam helped minimise the number of welding imperfections. As a result of the laser beam welding process, the hardness in the heat affected zone (HAZ) decreased to approximately 260 HV, if compared to that of 360 HV in the base material and 370 HV in the weld.

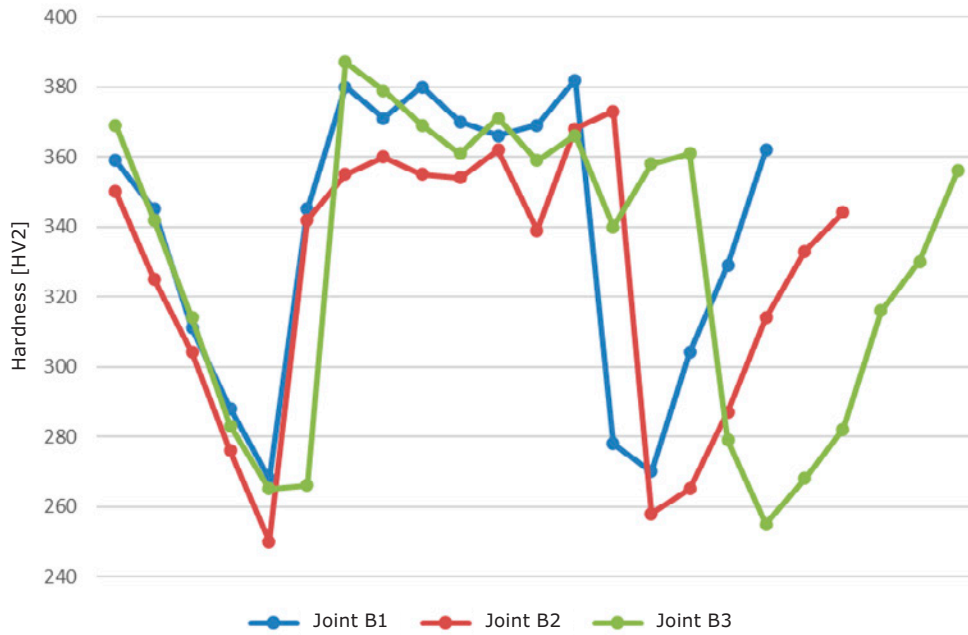
Fig. 7. Hardness distribution in the test joints

The analysis of hardness measurement results revealed that the hardest area in each of the test joints was the weld (370 HV). The heat affected zone (HAZ) softened and its hardness dropped to 260 HV. The hardness of the base material amounted to 350 HV (Fig. 7).
